Safety Recall

Code: 69BY

Passenger Occupant Detection System (PODS)

December 17, 2021

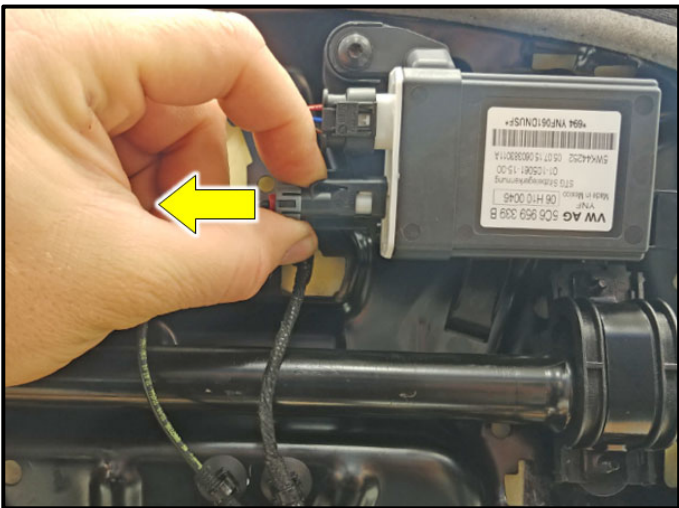
The connector must be removed exactly parallel with the PODS ECU. The center pin in the PODS ECU is fragile and must not be bent during removal. A damaged center pin will cause PODS faults. Damage to PODS ECU is not covered under this action.

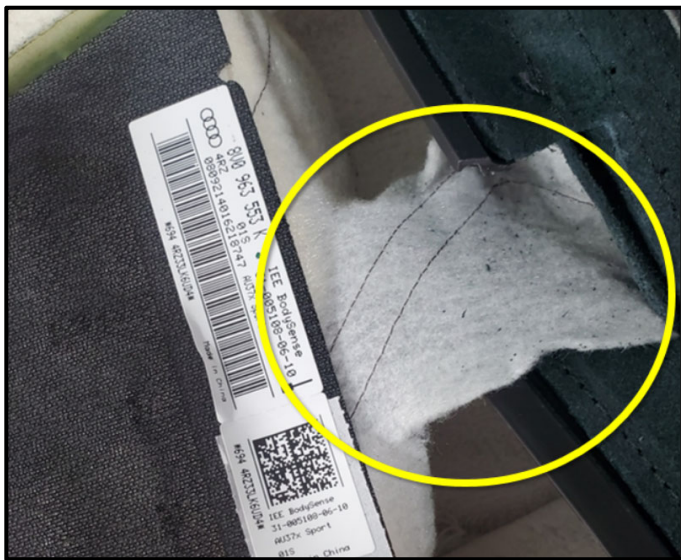
Sport/Supersport seats:
Ensure the seat heating element bridge <circle> is not twisted or damaged.

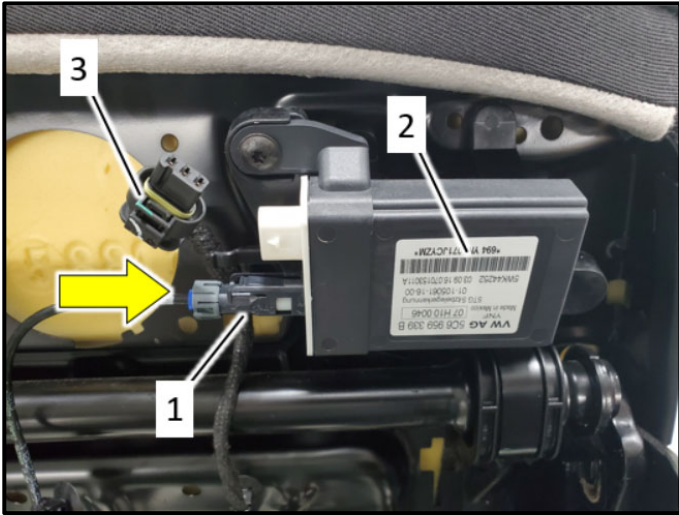
The connector must be installed exactly parallel with the PODS ECU. The center pin in the PODS ECU and connector is fragile and must not be bent during installation. A damaged center pin will cause PODS faults. Damage to the PODS ECU is not covered under this action.

The PODS ECU will be updated using the PODS Programmer at PODS ECU connection <3>.

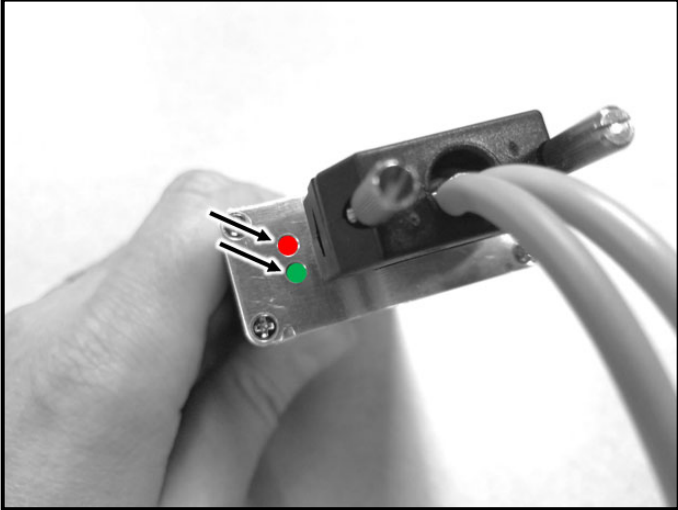
- If the start-up procedure fails, the red and green lights will flash simultaneously.
- This means the maximum number of stored records has been reached.
- If this situation is encountered, contact Audi Technical Assistance for further direction.

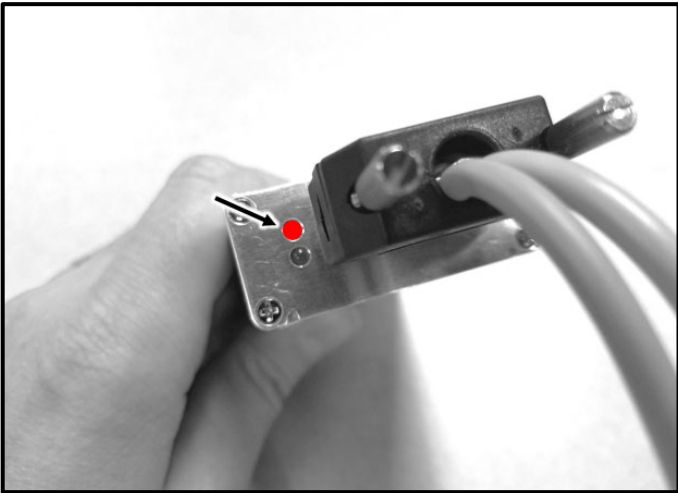
- If the programming has failed the red light will flash and one of the following may have occurred:
 - Red light flashes 2 times:
 - Battery voltage is too low.
 - Programmer not connected to PODS seat harness.
 - Red light flashes 3 times:
 - Wrong PODS kit was installed.
 - Red light flashes 4 times:
 - Seat was not empty.
 - Sensor not connected to the ECU.
- Once a problem is corrected, repeat the programming.
- If the above issues are all addressed and the programming still fails, contact Audi Technical Assistance for further direction and attach the following to the ATA case:
 - Photo of the Programmer lights.
 - Photo showing the battery voltage is above 12.5 volts.
 - Photo showing an EMPTY seat fully installed.
