Product Safety Recall

N212327220 Driver Airbag Emblem May Separate During Deployment

Release Date: March 2021

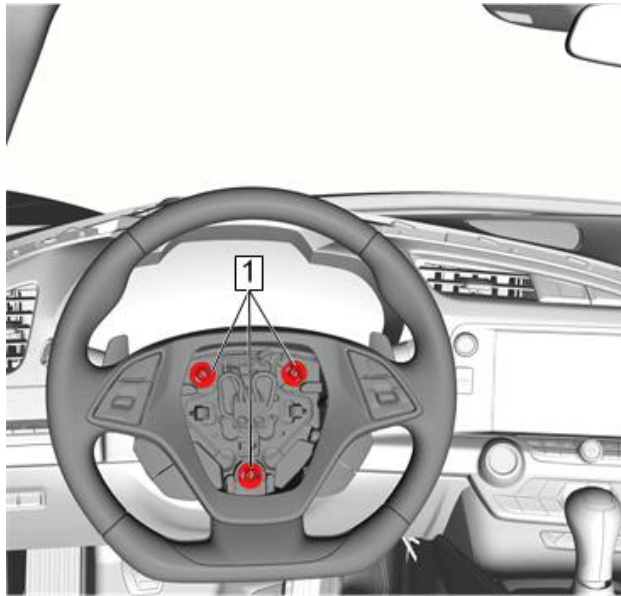
4776466

Warning: When removing the Drivers Airbag (DAB), the airbag guide sleeves (1) may get stuck in the steering wheel armature. Failure to remove the guide sleeves from the armature and properly reinstall them onto the DAB may result in damage or inoperable components related to airbag retention to the steering wheel. DAB retention failure during airbag deployment could cause injury.

2. Install the new service steering wheel airbag. Refer to *Steering Wheel Airbag Replacement* in SI.
