RE: **Recall Campaign Launch Notification**
Check Starter Wiring Harness
MY18-21 213, 290 (E-Class, GT-Class)

Campaign No. 2021040013, May 2021

SUBJECT: **Model AMG E-Class and AMG GT 4-door Coupe (213 and 290 platform)
Model Year 2018-2021
Check Starter Wiring Harness**

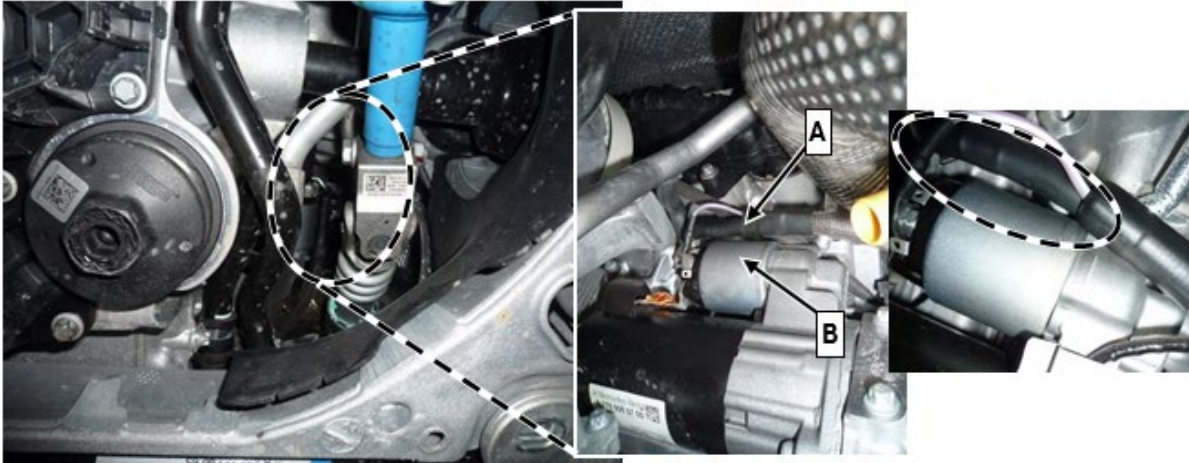
Figure 1

1. Remove lower engine compartment lining
 - i** For basic data for model 213, see **AR61.20-P-1105LWE**.
 - i** For basic data for model 290, see **AR61.20-P-1105FRX**.
2. Check starter wiring harness, circuit 30 (**A, figure 1**) at starter.
 - i** The starter wiring harness, circuit 30 must **not** be in contact with the solenoid switch (**B**) of the starter.

- a. Starter wiring harness, circuit 30 is in contact with starter: Carry out **check/test procedure B**.
- b. Starter wiring harness, circuit 30 is **not** in contact with starter: **End measure**.

1. Disconnect ground line of battery
 - i** For basic data for model 213, see **AR54.10-P-0003LW**.
 - i** For basic data for model 290, see **AR54.10-P-0003FR**.
2. Unscrew starter wiring harness, circuit 30 at starter and check for damage in area of insulation.
 - i** The insulation must **not** be damaged. To improve accessibility, remove the quick-release fastener of the steering shaft if necessary.
 - a. Insulation of starter wiring harness, circuit 30 damaged: Carry out **work procedure**.
 - b. Insulation of starter wiring harness, circuit 30 **not** damaged: **End measure**.

i If the insulation is **not** damaged, the starter wiring harness, circuit 30 **must** be reinstalled correctly and in such a way that it does not chafe, taking the anti-twist lock at the solenoid switch into account.
