RE: **Recall Campaign Launch Notification**

Check Tailgate Side Spoilers

MY20-21 247(GLB-Class)

Campaign No. 2021050009, June 2021

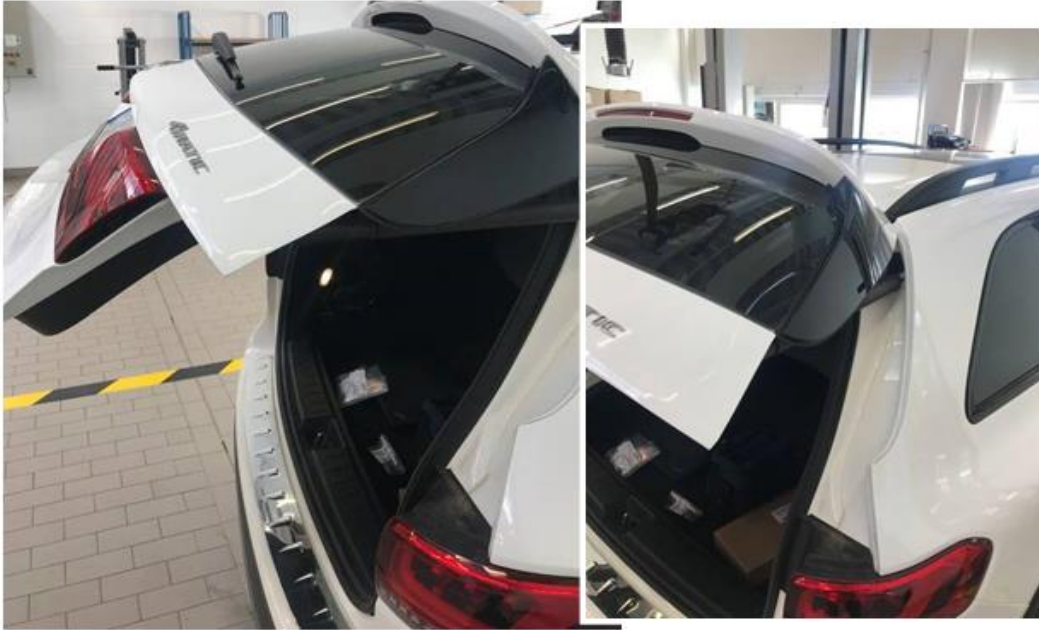
**Figure 1**

i Tailgate **must** be open for the test (**Figure 1**).

1. Open tailgate so that side spoilers are at working height.

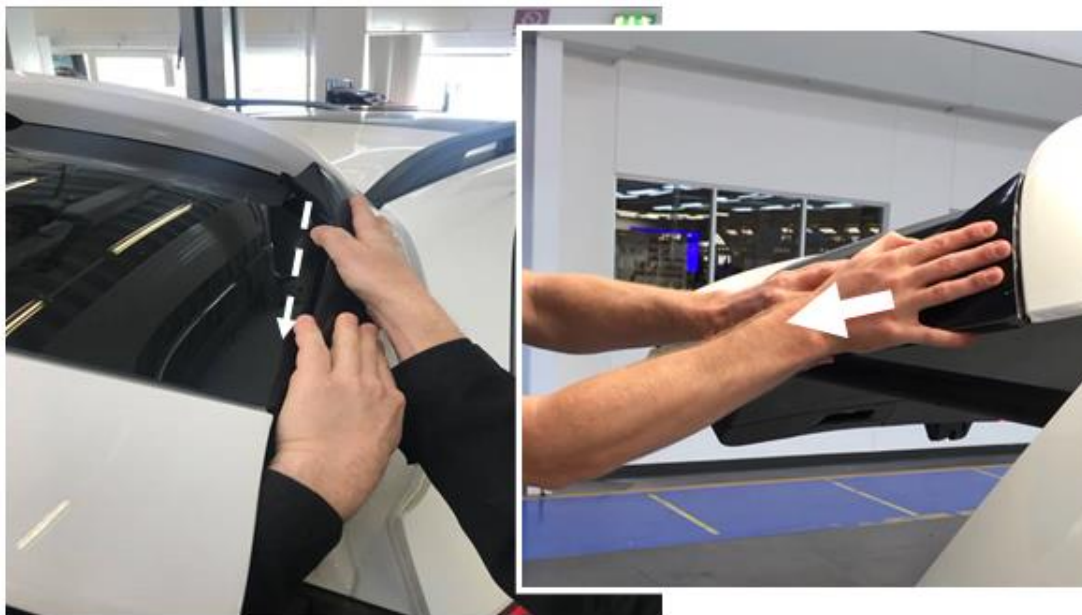
**Figure 2**

2. Pull side spoiler downward slightly using both hands and check whether the outer shell of the side spoiler detaches from the basic carrier (**Figure 2**) on both the left and right side.

i The outer shell must **not** detach from the basic carrier.

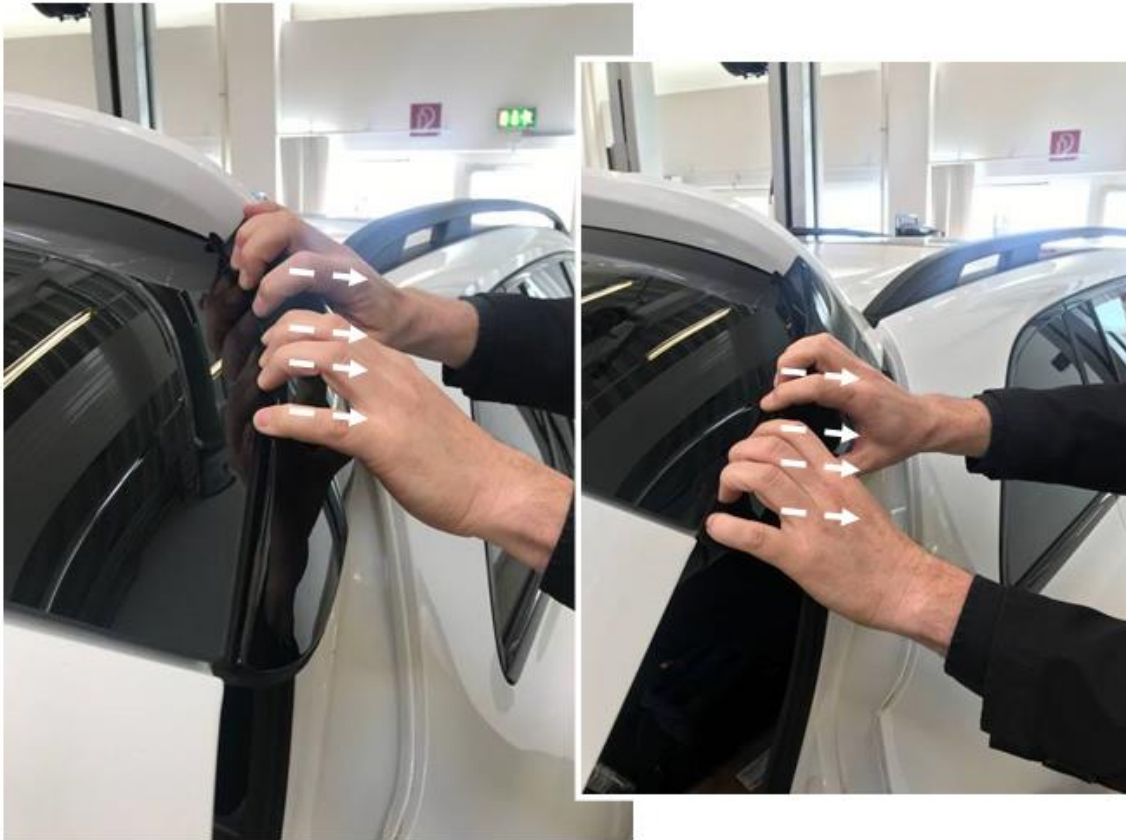
Figure 3

3. Using both hands, pull outward *slightly* in upper and lower areas (**Figure 3**).

i The side spoiler must not detach from the tailgate.

- a. Outer shell detaches from basic carrier **or** brackets for clips on side spoiler are broken out: Carry out **work procedure A**.
- b. Side spoiler detaches from tailgate too easily: Carry out **work procedure B**.
- c. Check on side spoilers revealed no problems: **End measure**.
