RE: **Recall Campaign Launch Notification**  
**Check Front Wheel Arch Cover**  
**MY20-21 247 (GLB-Class)**

Campaign No. 2021040015, May 2021

SUBJECT: **Model GLB-Class vehicles (247 platform)**  
**Model Year 2020-2021**  
**Check Front Wheel Arch Cover**

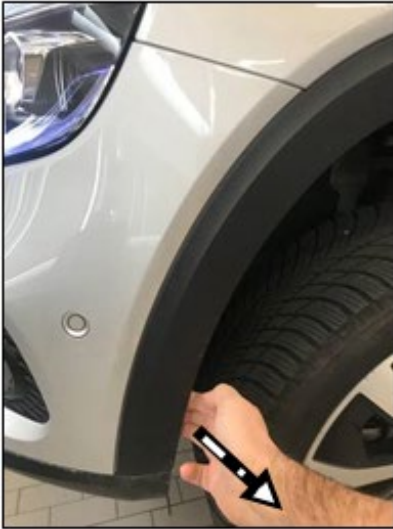
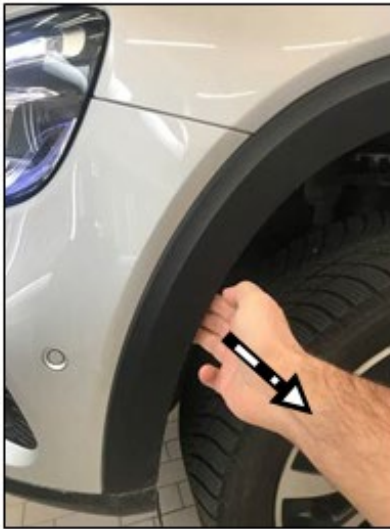
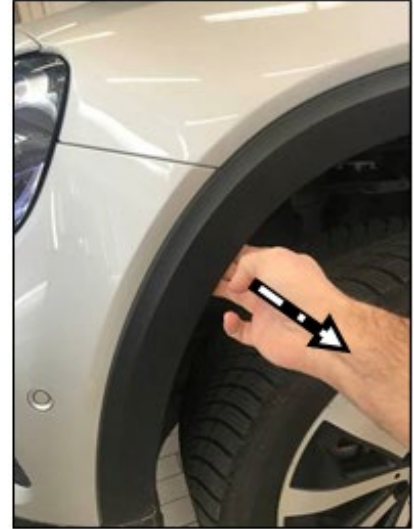
1. Check left and right front wheel arch liner in area of bumper as to whether correctly installed.
  - i** Pull wheel arch liner outward, starting at the bottom up to the top area of the bumper (**figures 1 to 3**).
  - i** If the wheel arch liner is not correctly installed, it will be possible to easily pull this out of the bumper.

- a. Left and/or right wheel arch liner **not** correctly installed: Carry out **work procedure**.
- b. Left and right wheel arch liner **correctly** installed: **End measure**.
