TO: Freightliner Principals, General Managers, Sales Managers, Service Managers, Parts Managers	FROM: Anthony Washington, Department Manager, Regulations and Certifications
Re: Launch Recall Campaign Notification Model 907 (Sprinter) Model Years 2019-2020 Inspect Power Steering Hose Clamps	DATE: May, 2021

Campaign No. 2021050003, May, 2021

SUBJECT: **Model 907 Sprinter, Model Year 2019-2020**
Inspect Power Steering Hose Clamps

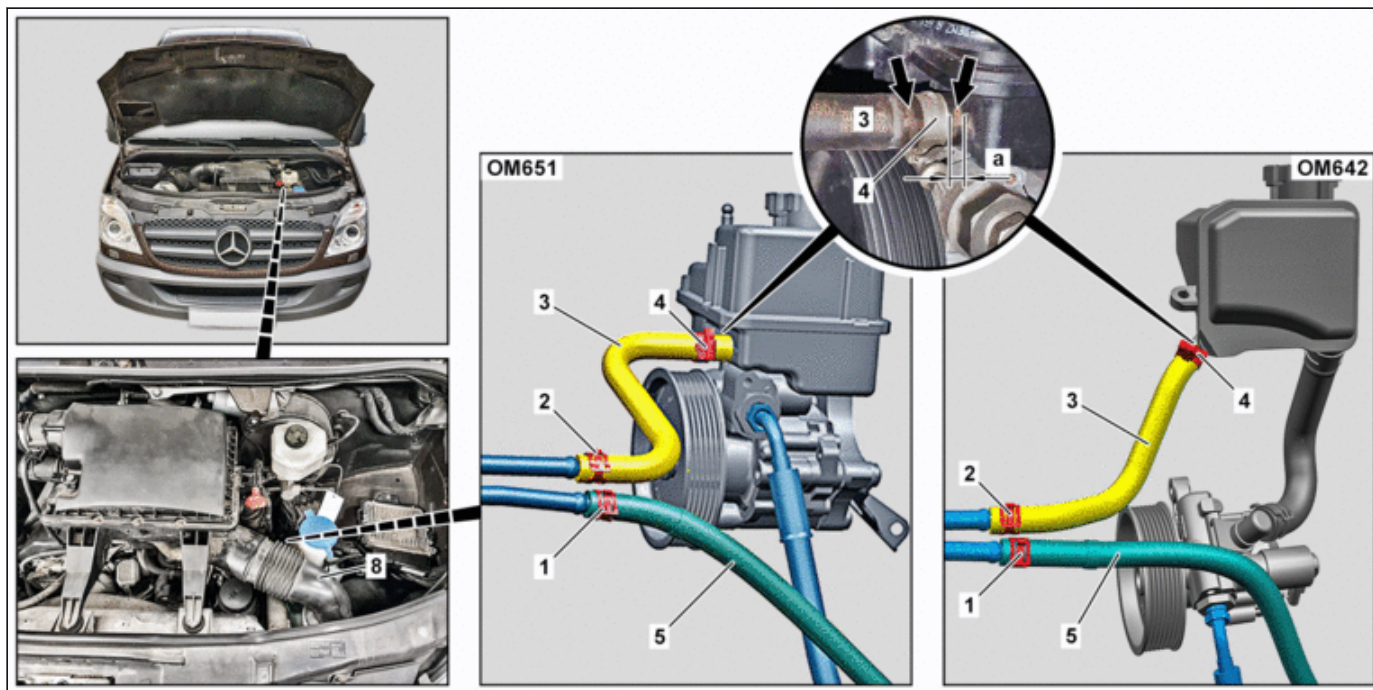
D46.25-A008-79

All 3 clamps (1, 2, 4) together with the listed connections must always be checked.

On vehicles with engine 642, the as-built configuration may deviate slightly (see first picture), which does not impair the procedure shown here.

Check the following points: → Check both connections of hydraulic lines for leak tightness. → Check installation position of clamps (1, 2) on respective hydraulic hose. The clamps must be seated centrally between the markings (arrows) on the hoses. Also check whether the distance indicated by dimension (b) is maintained. See specification in picture.</p> <p>If clamps (1, 2) are not correctly positioned or if there is a leakage (see fail image above), ↓ replace affected clamp (1, 2). To do so, see operation step 5 onward in reference document. Replace clamps on hydraulic hoses of power steering (code: NV3LETULPX, acc. no.: 46 950 80)</p>	<p>SM46.25-D-0032-02SG</p>

2	Remove air ducting (8).		
3	Check hydraulic hoses and clamps (1, 2) of power steering.	<p>
