| TO: Mercedes-Benz Principals, General Managers, Sales Managers, Service Managers, Parts Managers | FROM: Anthony Washington, Department Manager, Regulations and Certifications |
|---|---|
| Re: Launch Recall Campaign Notification Model 907 (Sprinter) Model Years 2019-2020 Inspect Power Steering Hose Clamps | DATE: May, 2021 |

Recall Campaign Bulletin

Campaign No. 2021050003, May, 2021

Inspect Power Steering Hose Clamps

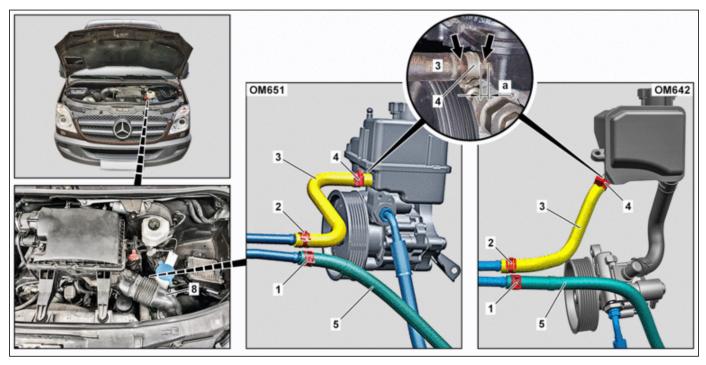
D46.25-A008-79

- 1 Clip
- 2 Clip
- 3 Return hose
- 4 Clip
- 1 Clip
- 2 Clip
- 3 Return hose
- 5 Low-pressure hose
- b Dimension (2 to 7 mm)

| 4 | Check | | |
|---|--|--|---|
| 3 | Check hydraulic hoses and clamps (1, 2) of power steering. | Check the following points: → Check both connections of hydraulic lines for leak tightness. → Check installation position of clamps (1, 2) on respective hydraulic hose. The clamps must be seated centrally between the markings (arrows) on the hoses. Also check whether the distance indicated by dimension (b) is maintained. See specification in picture. If clamps (1, 2) are not correctly positioned or if there is a leakage (see fail image above), ↓ replace affected clamp (1, 2). To do so, see operation step 5 onward in reference document. Replace clamps on hydraulic hoses of power steering (code: NV3LETULPX, acc. no.: 46 950 80) | SM46.25-D-0032-02SG |

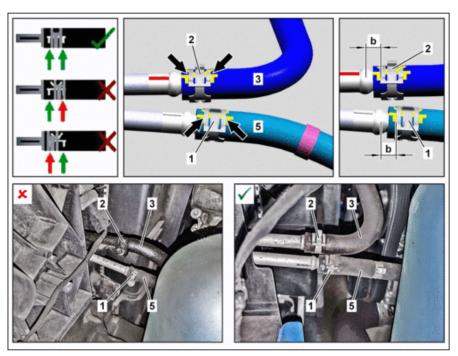
D46.25-A009-76

- 5 Low-pressure hose
- 8 Air ducting
- a Dimension (2 to 4 mm)

| 7 | Install air ducting (8). | | |
|---|--|--|---|
| | | the markings (arrows) on the return hose (3). See specification in picture. If markings (arrows) are no longer visible, then check distance against dimension (a). | |
| | | → Check installation position of clamp (4) on power steering expansion reservoir. The clamp (4) must be seated centrally between | |
| | | → Check whether return hose (3) is pushed on power steering expansion reservoir up to end stop. | |
| | reservoir. | → Check connection of return hose (3) at power steering expansion reservoir for leak tightness. | |

| 7 | Install air ducting (8). | | |
|---|--|--|---|
| | | reposition affected clamp (4). To do so, see operation steps 1 to 4 in reference document. Replace clamps on hydraulic | SM46.25-D-0032-02SG |
| | | If clamp (4) is not positioned correctly or if a leakage is present, | |
