Product Safety Recall

N202321201 Passenger Side Roof Rail Air Bag Bolts Not Installed

Release Date: May 2021

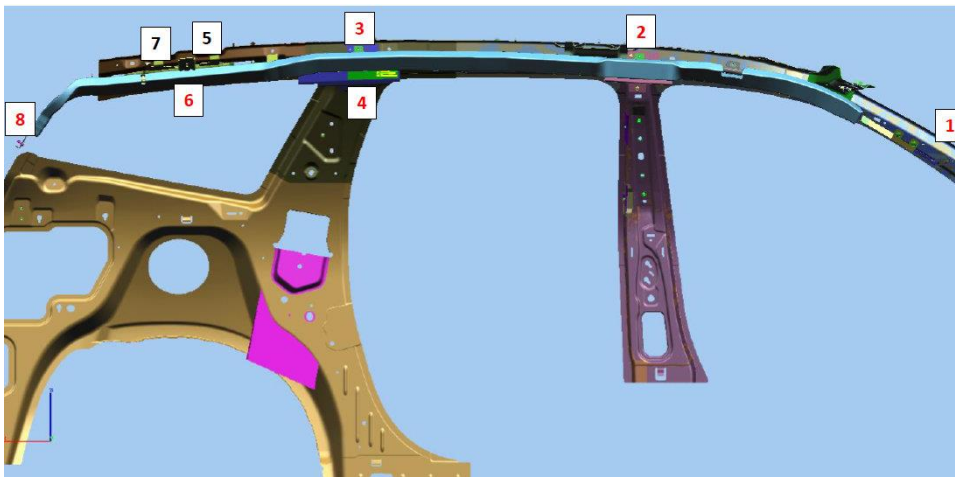
5834454

2010 - 2011 Traverse and Enclave bolt locations (Qty=8 total). Red Numbered locations indicate an M6x20mm bolt, Black Numbered locations indicate an M6x14.5mm bolt. NOTE: Driver side shown, passenger side bolt locations are the same.

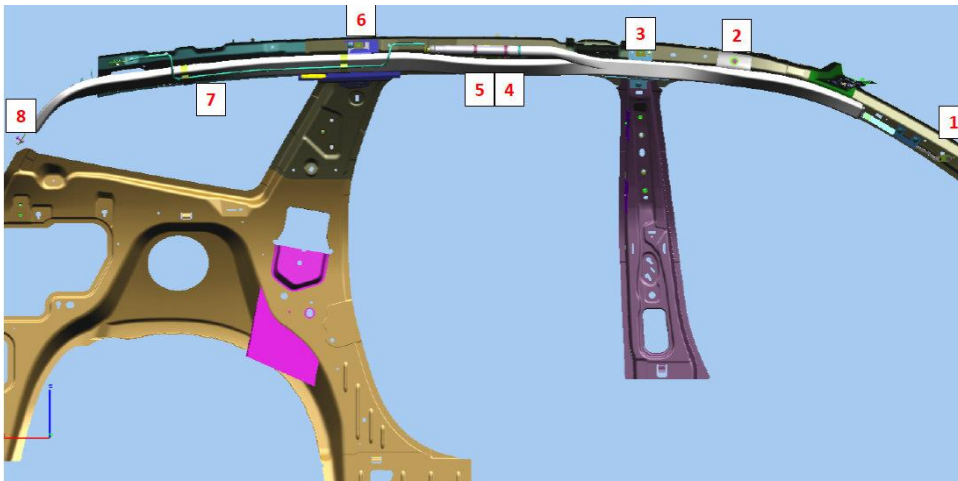
5834456

2012 - 2017 Traverse and Enclave bolt locations (Qty=8 total). Red Numbered locations indicate an M6x20mm bolt. NOTE: Driver side shown, passenger side bolt locations are the same.

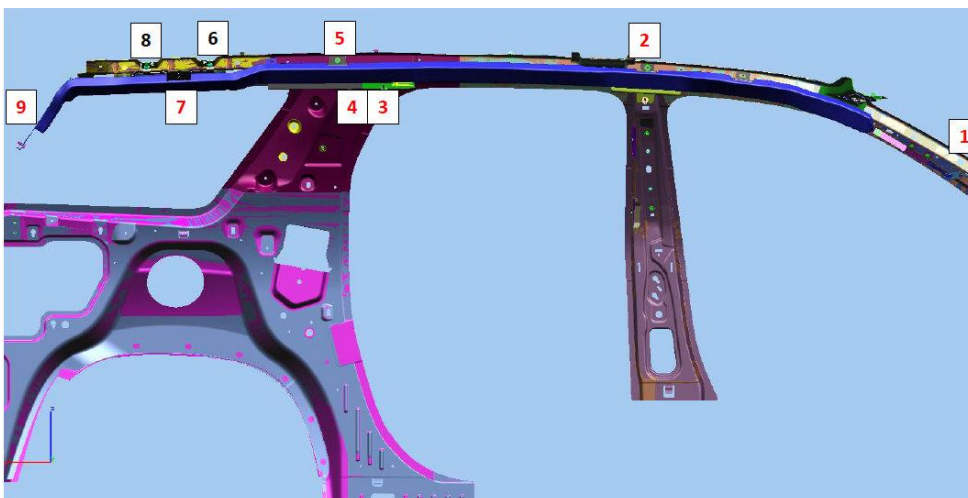
5834458

2011 Acadia bolt locations (Qty=9 total). Red Numbered locations indicate an M6x20mm bolt, Black Numbered locations indicate an M6x14.5mm bolt. NOTE: Driver side shown, passenger side bolt locations are the same.

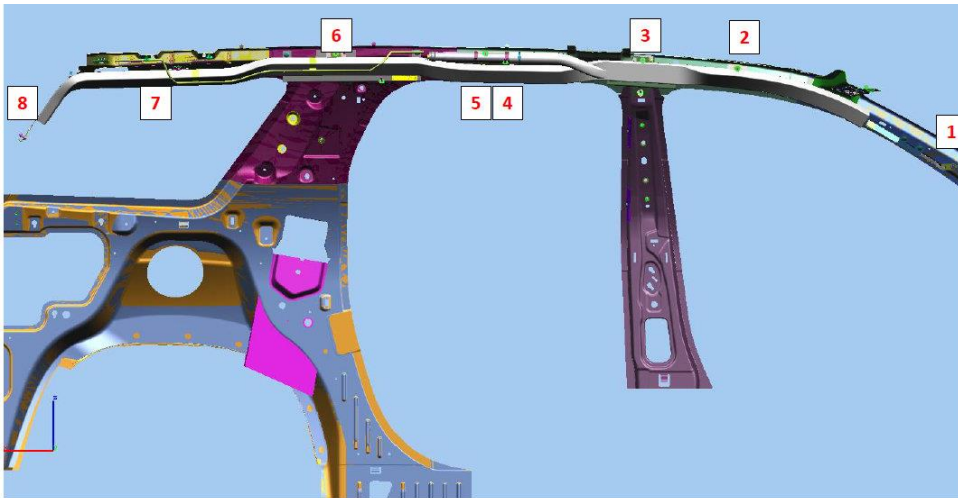
5834459

2012 - 2016 Acadia bolt locations (Qty=8 total). Red Numbered locations indicate a an M6x20mm bolt. NOTE: Driver side shown, passenger side bolt locations are the same.

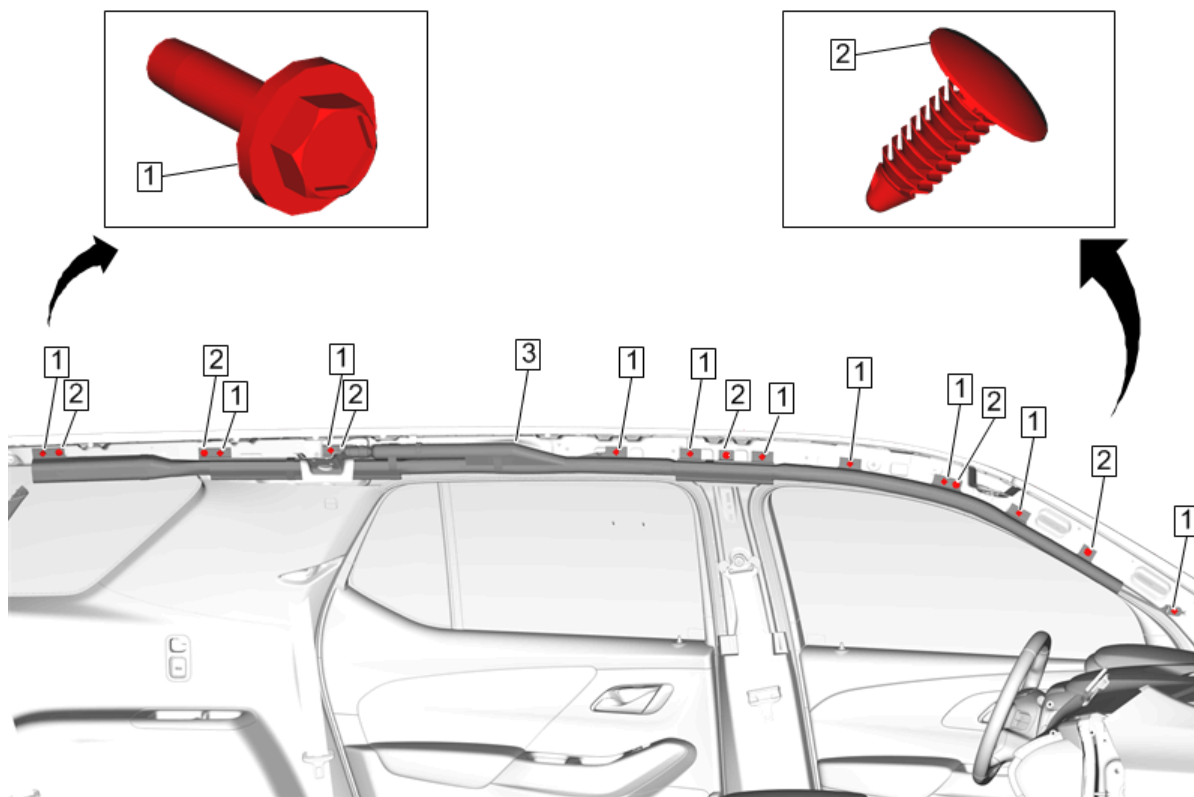
4774019

Model Year 2018 - 2019 Traverse (1) Bolt 10 Locations

NOTE: Driver side shown, passenger side bolt locations are the same.

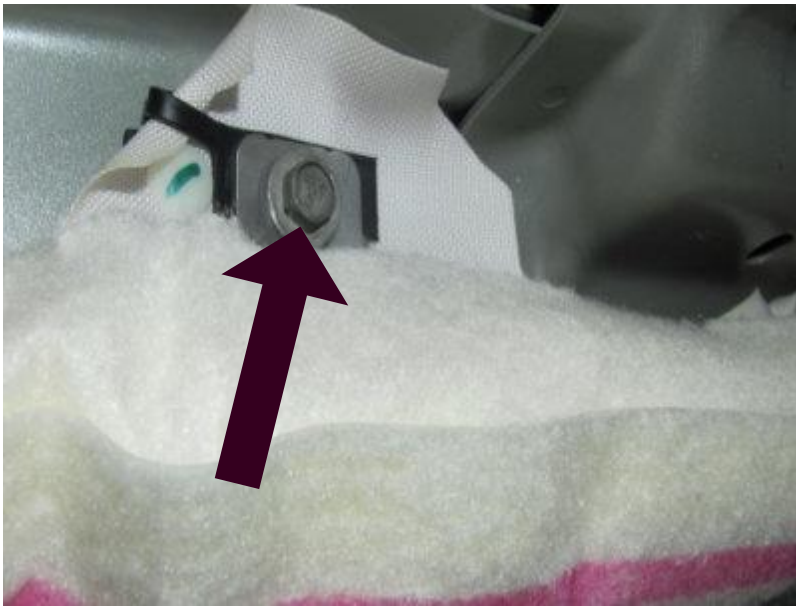
5823445

- Verify the fastener is installed into the body and the weld nut is present.

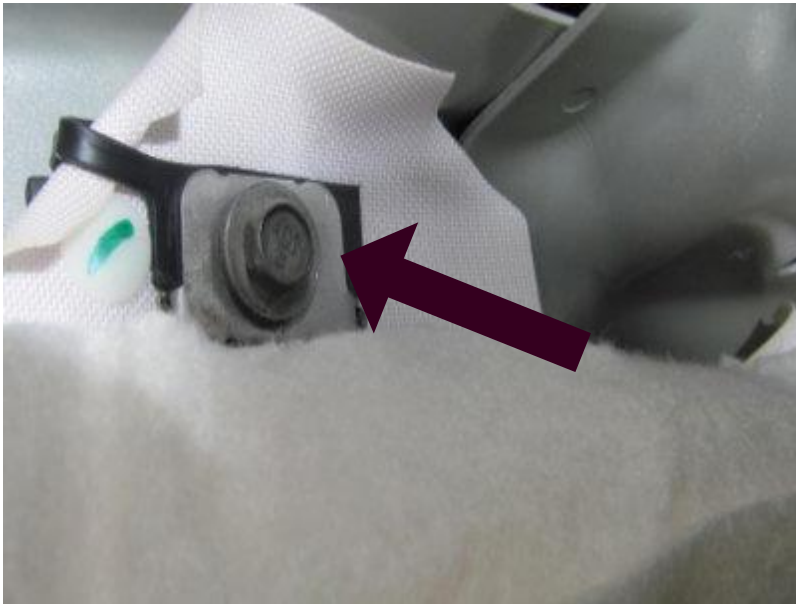
5823616

- Verify that the airbag mounting tab is secure and can't rotate.

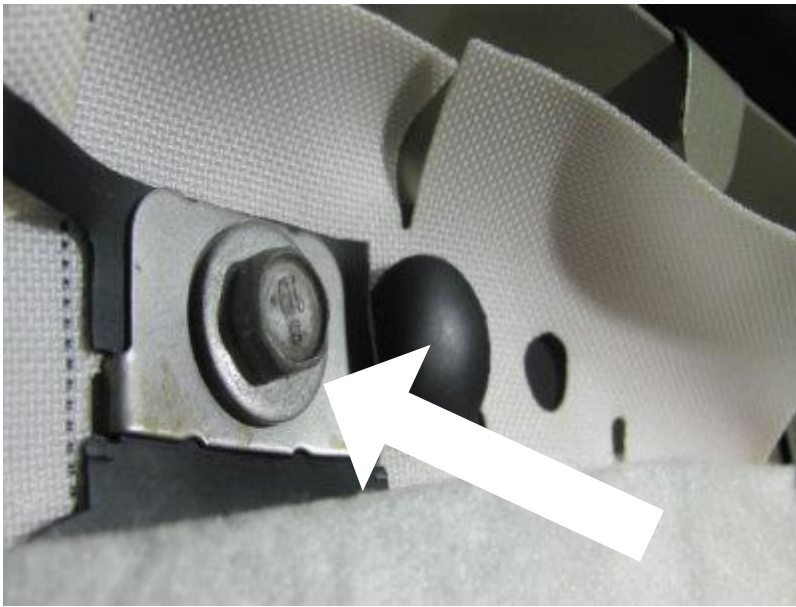
5823617

- Verify that the washer is secure and tightened down onto the mounting tab.
3. If a bolt is not present or is present on the roof rail airbag mounting tab, but not installed into the weld nut, and the weld nut is correctly installed, discard any existing bolts and proceed to the Thread Repair section below. The bolt retaining washer holding the bolt to the roof rail airbag mounting tab, if present, should be discarded and will not need replacement.
