**SAFETY RECALL**

**2021 CBR1000RR-R (SP) - REAR CUSHION CONNECTING PLATES**

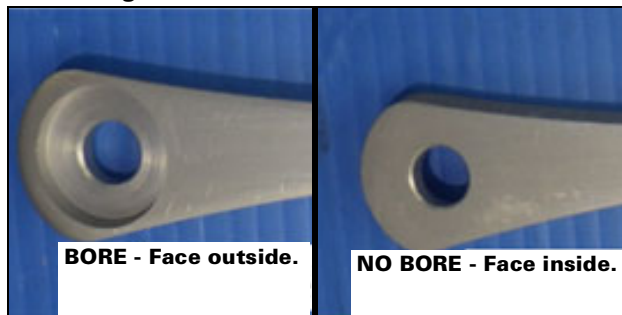
1. Visually check that the bores of the left and right rear cushion connecting plates are facing outside.

- If the motorcycle has the plates installed correctly, no repair is needed. Immediately file warranty template claim KL9A for INSPECTION ONLY.
- If the motorcycle does not have a plate installed correctly, a repair is needed. Contact TechLine for repair determination and parts information. **DO NOT** file a warranty claim at this time.

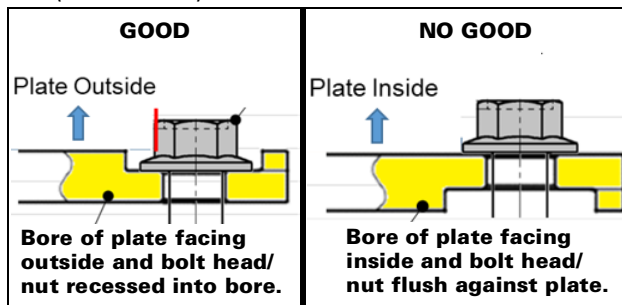
The cushion connecting plate bolt head and nut should both be recessed into the bores of their plates if installed correctly (as shown).
