# Keystone RV Company

## SAFETY ADVISORY # 21-407

### Bullet Egress Window Crank

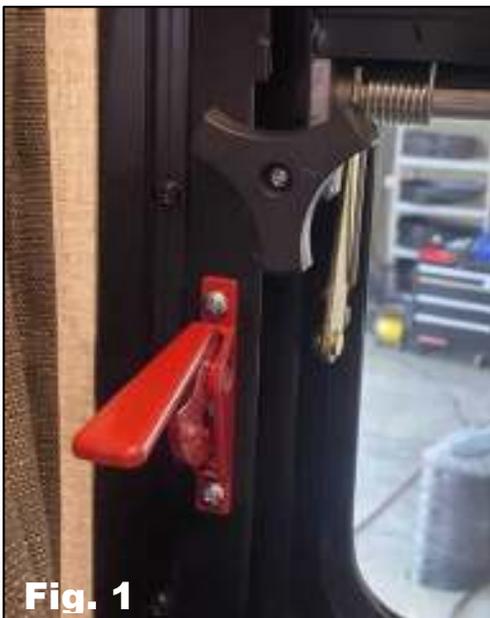
**Fig. 1**

Keystone is conducting a voluntary RECALL notification campaign in accordance with the National Highway Transportation and Safety Act. It has been decided that the vehicles in the recall population have an egress window installed in the bedroom and did not have the correct crank handle installed. If an emergency situation arises the emergency exit may be difficult to open as the current black round knob may impede the ability to open the window, which could result in an increased risk of personal injury.

Locate the bunk bedroom egress window. Figure 1

The remedy is to replace the black round knob on the bedroom egress window with the narrow crank handle.
