GROUP	MODEL
Safety Recall Campaign	2020-2021MY Soul (SK3) and 2021MY Seltos (SP2) w/2.0L Nu MPI engine
NUMBER	DATE
SC209 (Rev 3, 09/02/2021)	June 2021

### ENGINE VIBRATION INSPECTION AND REPLACEMENT (SC209)

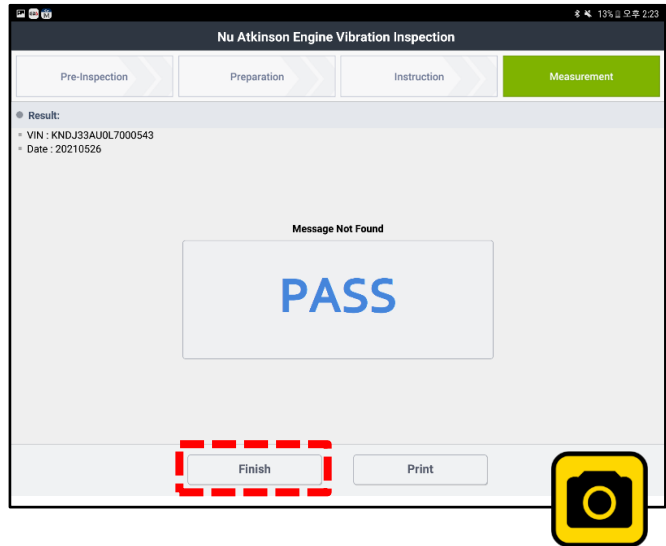
10a. **PASS:** If the measured engine vibration test has a normal condition, capture the screen image/screenshot for record keeping and attach to the warranty claim using Attachment Type - 'XX': Other. Select 'Finish'.

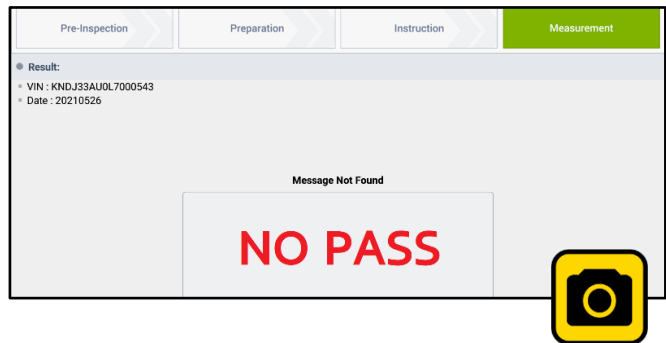
10b. **NO PASS:** If the measured engine vibration test is abnormal capture the screen image/screenshot for record keeping and attach to the warranty claim using Attachment Type - 'XX': Other. → **Open a Techline case online for further instructions.**

Select 'Finish' and replace the engine long block by referring to the "Engine Mechanical System → Engine And Transaxle Assembly → Repair procedures" chapter in the applicable Shop Manual on KGIS. Refer to page 7 information.
