PRODUCT CAMPAIGN BULLETIN

APPLICABILITY: 2017-2019 MY Impreza
2018-2019 MY Crosstrek

NUMBER: WRE-21R

SUBJECT: Ignition Coil Replacement

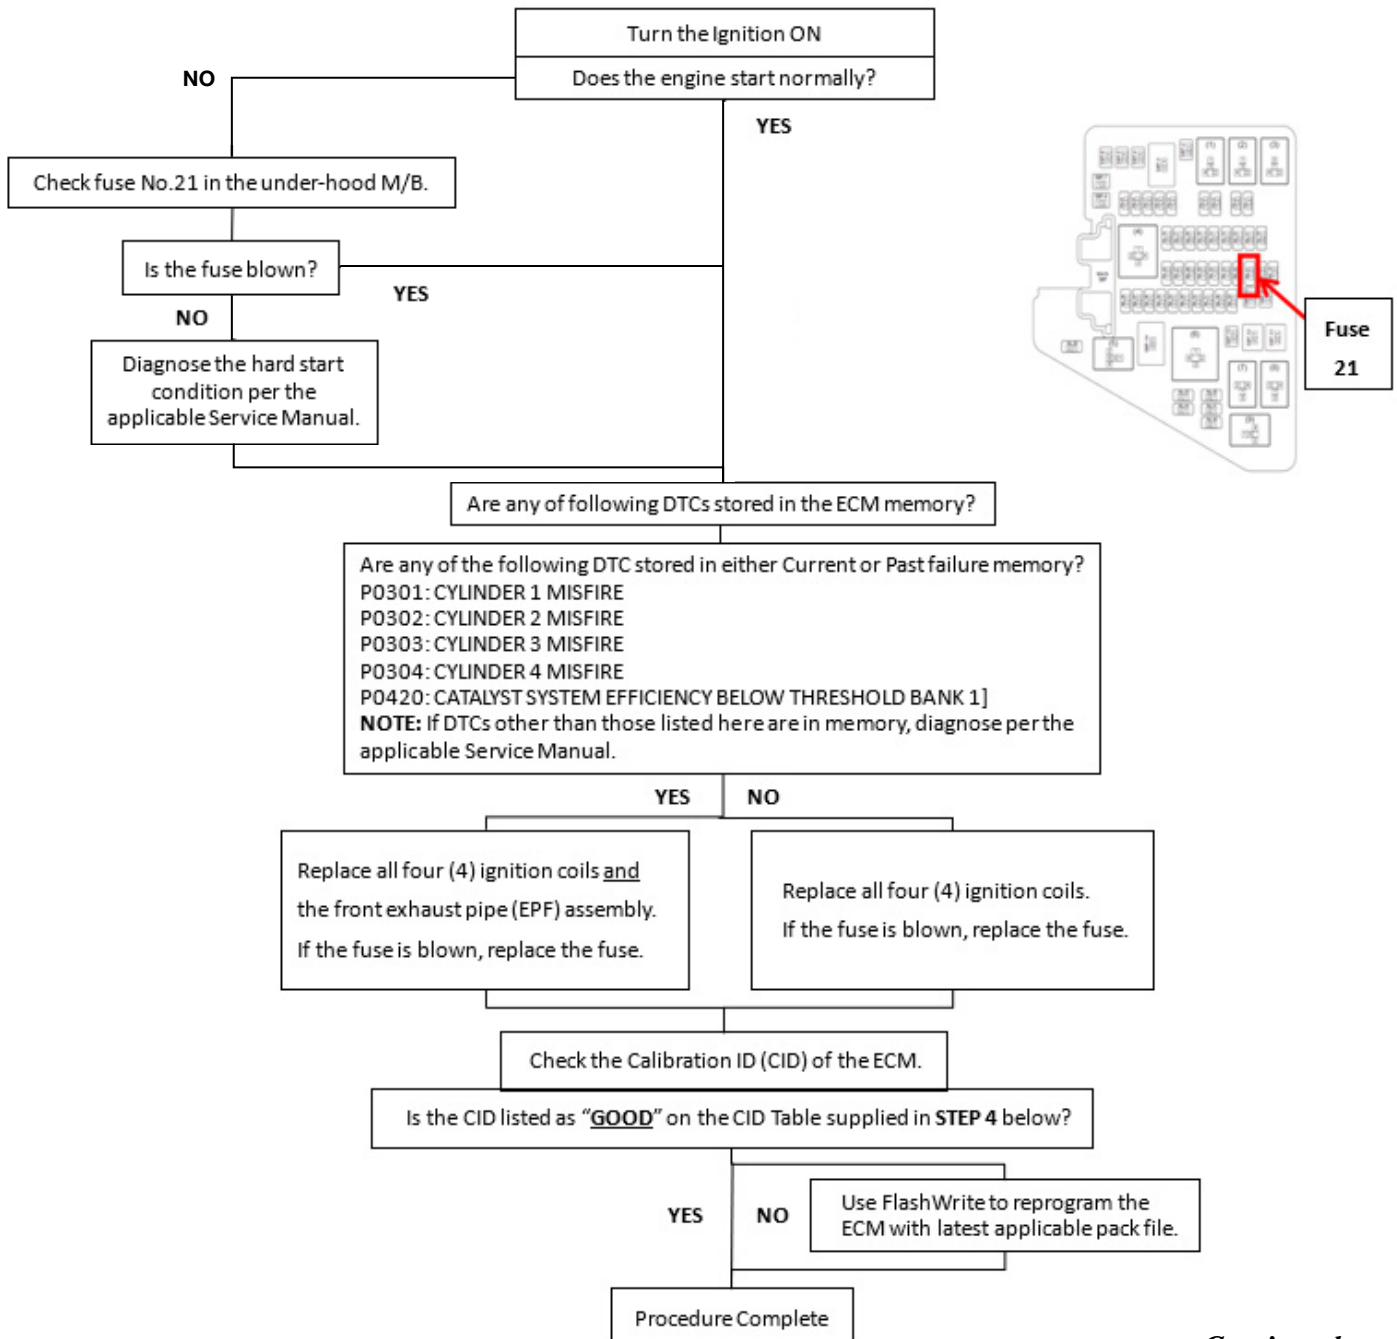
The following Flow Chart is provided as an overview of the procedures required to perform this Recall. A detailed Service Procedure is also supplied below.

STEP 1) Does the engine start normally?

No → The engine does **NOT** start normally: Proceed to **STEP 2** (inspection of fuses in M/B).

Yes → The engine starts normally: Proceed to **STEP 3**.

STEP 2) Inspect the M/B fuse #21 (15A) for **IMPREZA** and **CROSSTREK**. Is the fuse blown?

No → The fuse is **NOT** blown: Diagnose the hard starting condition per the applicable Service Manual then proceed to **STEP 3**.

Yes → The fuse **IS** blown: Proceed to **STEP 3**. After checking DTCs, replace the fuse.

STEP 3) Using the SSM scan for DTCs. Are any of the following DTCs current or stored in the ECM memory?

No → **NONE** of the DTCs are current or stored: Replace all four (4) ignition coils following the procedure in the applicable Service Manual.

Yes → **ANY** of DTCs are current or stored: Replace all four (4) of the ignition coils AND the Exhaust Pipe Front assembly following the procedure in the applicable Service Manual to perform the work
