Product Safety Recall

N202325161 Battery Cable Short Circuit

Release Date: April 2021

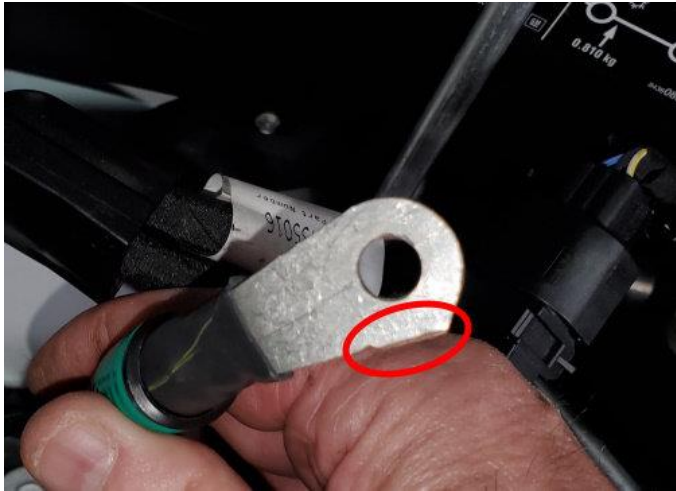
5693961

* If one or both anti-rotation tabs has been cut completely off, or measures less than 6mm as shown in the first graphic in this step, replace the positive battery cable assembly. Refer to Battery Positive Cable Replacement in SI. When installing the new cable assembly, follow steps 6-9 below.
