AMA9 – Replacing Threaded Connections on Rear Trailing Arm (Stop Delivery/Recall Campaign)

Model Line: **Cayenne (9YA)/Cayenne Coupé (9YB)**

Model Year: **2021**

Concerns: **Rear-axle trailing arms**

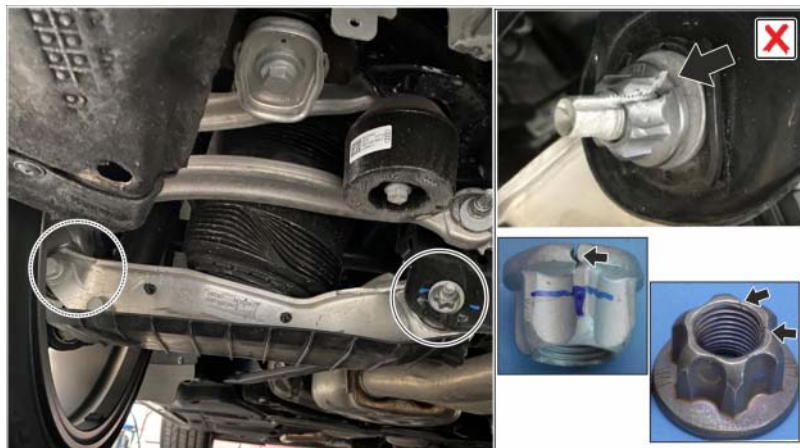
This can result in stress corrosion cracking on the clamping nuts, which may cause the clamping nuts to break over the service life of the vehicle. A broken clamping nut can result in increased play between the trailing arm and wheel carrier and as a result, vehicle handling may suddenly be impaired.

Stress cracks on clamping nuts

- If you see **no sign of damage** at the clamping nut, **only the clamping nut must be replaced**. To do this, **continue with Step 3.2**.
- If the **clamping nut is damaged** or if the clamping nut has come loose or was lost, get in touch with your contact person at **Technical Support** to agree on how to proceed. In this case, a **PRMS ticket** for repair approval must be sent to PAG_Support_Campaign_TI_SY.
