21-037

June 16, 2021

Subject: RECALL CAMPAIGN – Bentley 21MY Bentayga Rear Axle Trailing Arm Lock Nut (RE20/21)

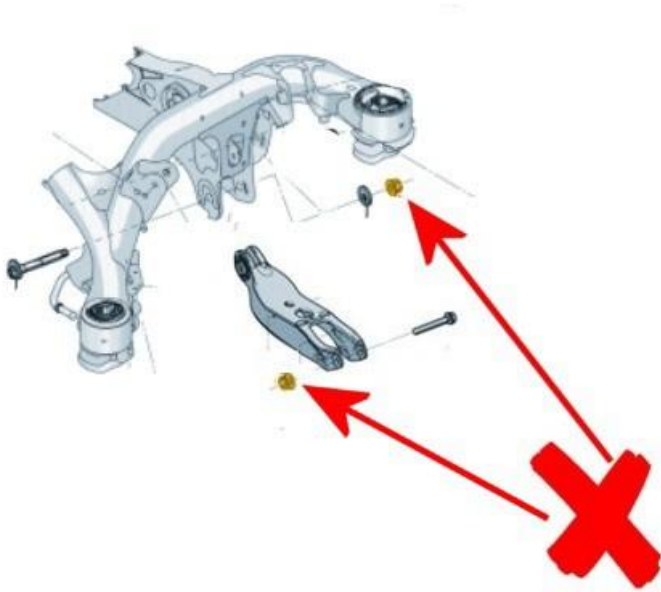
A new specification part (WHT 010 234) is now available, the inspection of the original nuts (Figure 1) prior to removal is imperative as this will confirm if any other components require replacement.

NOTE: For photographic purposes Figure 1 shows one side only

Replacement of WHT 007 610 (x4) nuts is mandatory on all vehicles

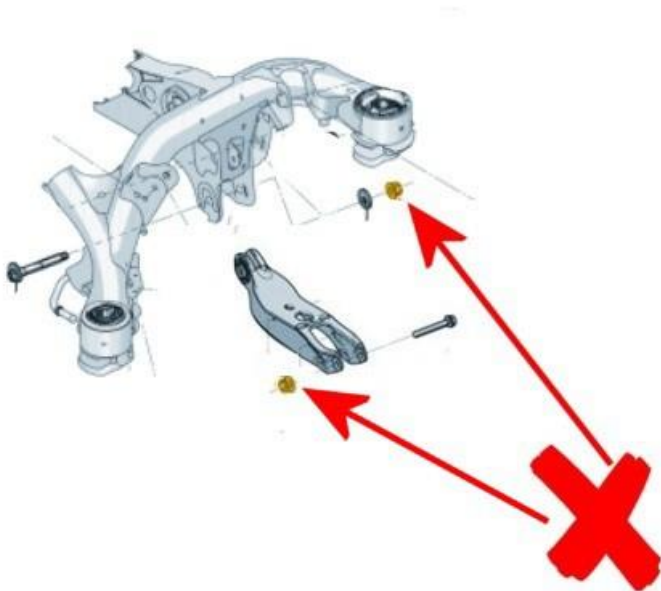
A new specification part (*WHT 010 234*) is now available, the inspection of the original nuts (Figure 1) prior to removal is imperative as this will confirm if any other components require replacement.

NOTE: For photographic purposes Figure 1 shows one side only

■
Replacement of *WHT 007 610* (x4) nuts is mandatory on all vehicles

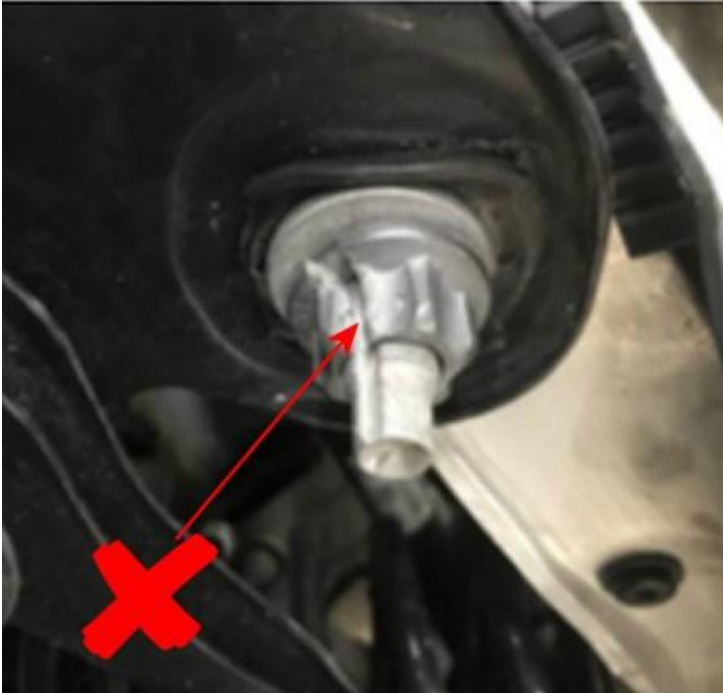
- Set the vehicle in "Jack" mode and position the vehicle on a wheel free ramp
- Discharge the air from the left and right air spring dampers - Refer to "Air suspension system - To discharge and charge".
- Carry out a visual inspection of the left and right hand rear lower lever inner and outer nuts (x4) as Figure 1 IMPORTANT: Check for fracturing or signs of reduced torque, see the example shown in Figure 2 of a fractured nut

In the event that any of the left and/or right hand side nuts are found to be fractured - Conduct Section 2

The following MUST be conducted and all fixings replaced (Bolts, Nuts and Washers) in the event that any of the nuts are found to be fractured or have signs of reduced torque

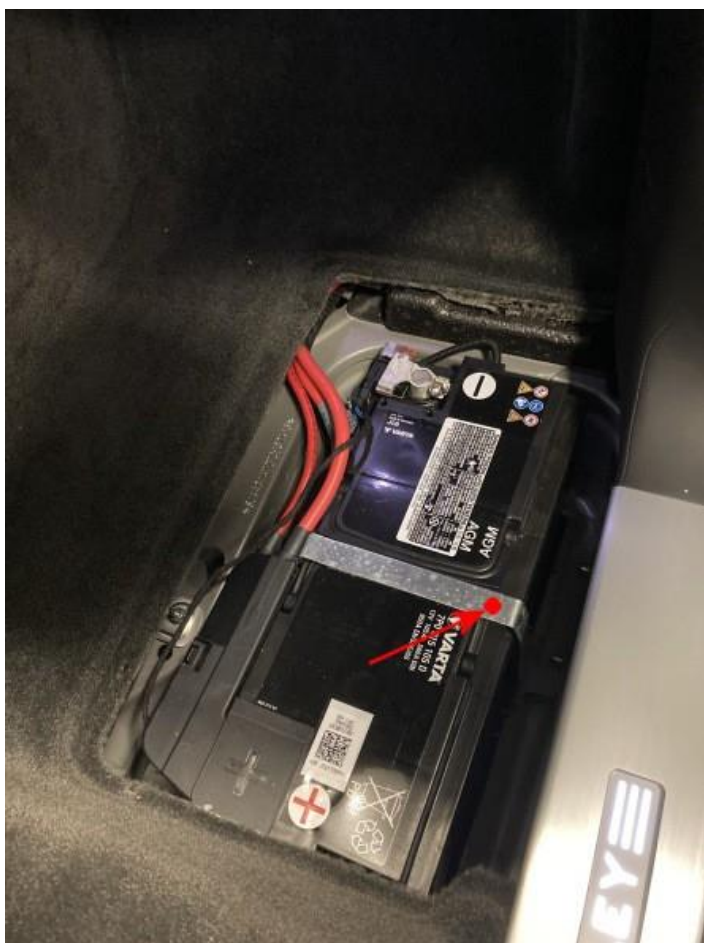
Red paint completion mark on the 12 volt battery retaining strap
