Dealer Service Instructions for:

Safety Recall Y16 / NHTSA 21V-280

Side Curtain Air Bag Fastener

2020-2021 (WD) Dodge Durango

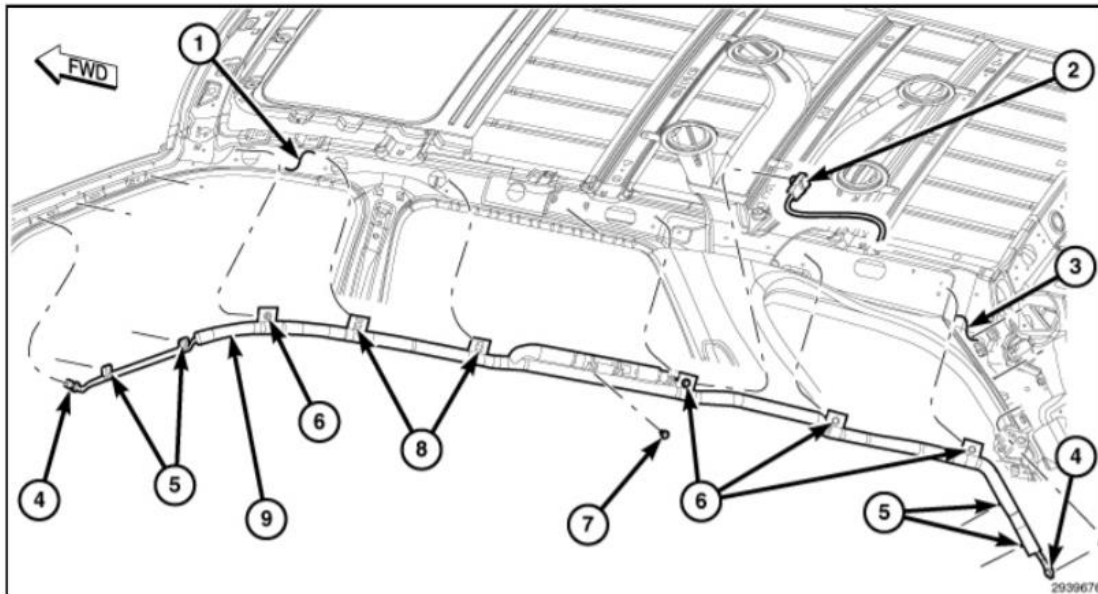
Figure 1 – Side Curtain Airbag Overview

The Side Air Bag Inflatable Curtain (SABIC) on about 2700 of the above vehicles may have been built with a loose or missing fastener. A loose or missing SABIC fastener may result in an irregular SABIC deployment, which may increase the risk of occupant injury in certain types of crashes.
