Safety Recall

Code: 42L1

Audi

Subject Rear Axle Trailing Arm Lock Nut

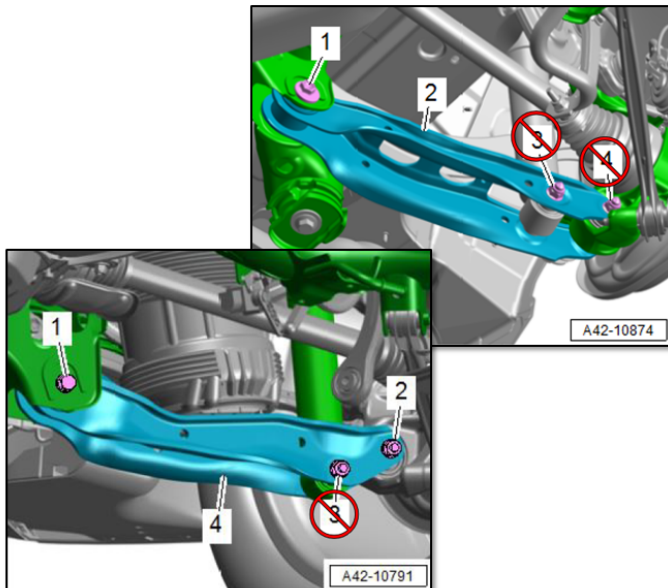
Problem Description	<p>Due to stress corrosion cracking on lock nuts of particular production batches, the nut of the eccentric bolt on the trailing arm of the rear axle may break which may cause alterations in the wheel alignment of the rear axle. This could be noticed by a steering wheel misalignment when driving straight ahead or by the vehicle pulling to one side when braking or accelerating.</p> <p>It cannot be ruled out that the rear axle could suddenly and uncontrollably move in the wrong direction at higher speeds. This can lead to a loss of vehicle control and a crash without warning.</p>
Corrective Action	The affected lock nut will be replaced. If the screw connection is already damaged, it will be replaced completely.
Precautions	If this condition is present in the vehicle, the driver may notice a steering wheel misalignment when driving straight ahead or the vehicle pulling to one side when braking or accelerating. Should this occur, owners are advised to contact an authorized Audi dealer without delay and make arrangements to have the vehicle inspected/repaired.

- A4 and A5 variants: Replace left and right control arm nuts at the connection to the subframe.
- All other models: Replace left and right control arm nuts at the subframe and at the wheel bearing housing.
