HYUNDAI
Technical Service Bulletin

GROUP RECALL	NUMBER 21-01-052H
DATE JUNE, 2021	MODEL(S) SANTA FE SPORT (AN)

SUBJECT: ABS MODULE INSPECTION AND MULTI-FUSE INSTALLATION
 (RECALL CAMPAIGN 205)

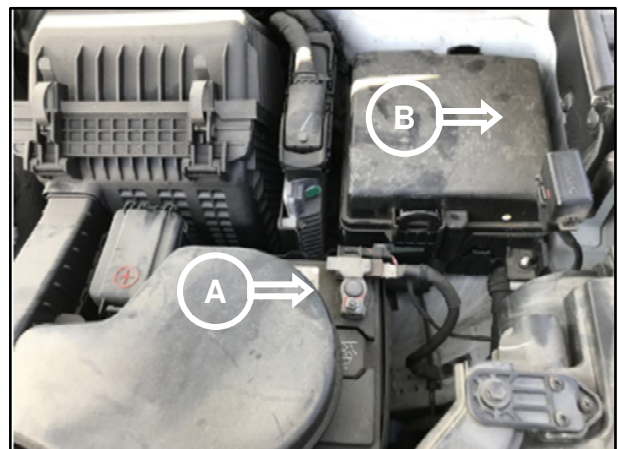
2. Disconnect the battery negative (-) terminal (A) and remove the junction box upper cover (B).

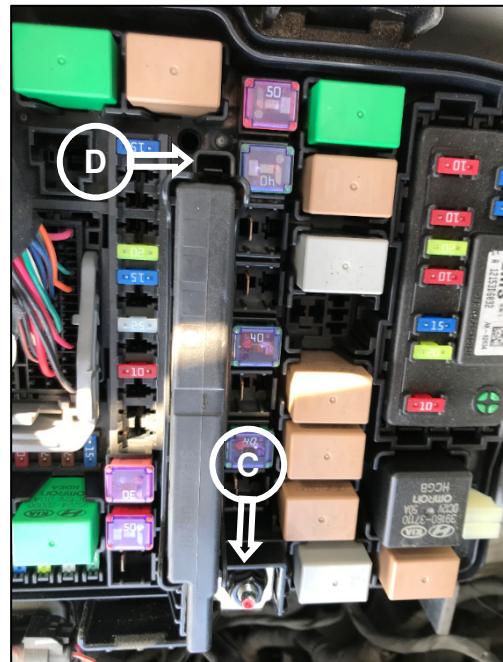
3. Remove the 10 mm nut (C) and lift the cable over the stud. Release the locking tab (D) and remove the multi-fuse.

Do not re-use the multi-fuse. A new multi-fuse and upper cover from the service kit must be installed after completion of the ABS module inspection and (if applicable) replacement.

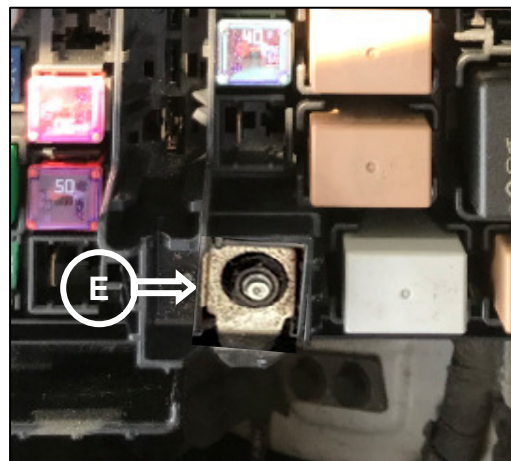
4. Place the junction box cable over the junction box stud (E), reinstall the nut and reconnect the battery negative (-) terminal.

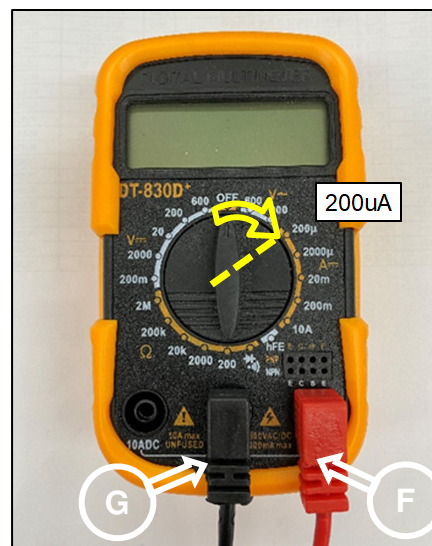
5. Connect the red multimeter lead to VΩmA (F) and the black lead to COM (G). Turn the dial to 200μA.

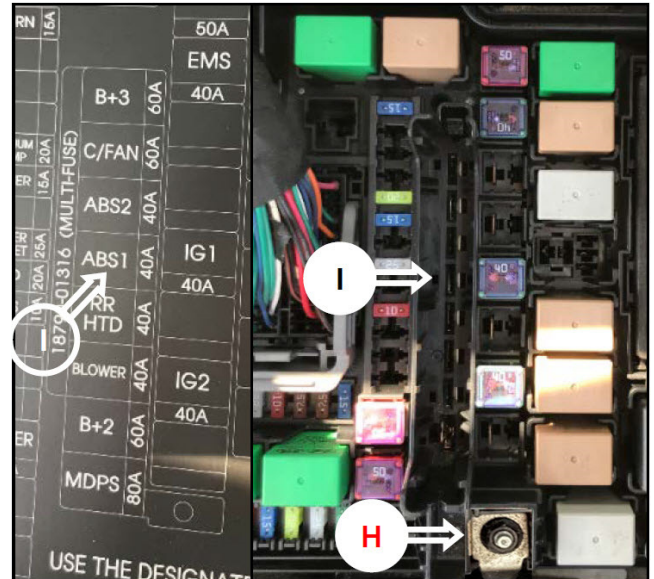
6. Place the **red** lead probe of the multimeter against the side of the junction box stud (H).
- Place the **black** lead probe on the ABS1 terminals (I) in the junction box.

- If no current is detected or if the measured value is less than 1.0µA, ensure the junction box cable is connected to the junction box stud and the 12V Battery (-) terminal has been reconnected.

8. ➤ If the measured current value is **70 μ A or greater, replace the Hydraulic Unit Assembly (HECU), then continue to step 9 to replace the multi-fuse and upper cover (Service Kit).**
- If the measured current value is **less than 70 μ A**, HECU replacement is not needed at this time. **Continue to step 9 to replace the multi-fuse and upper cover (Service Kit).**

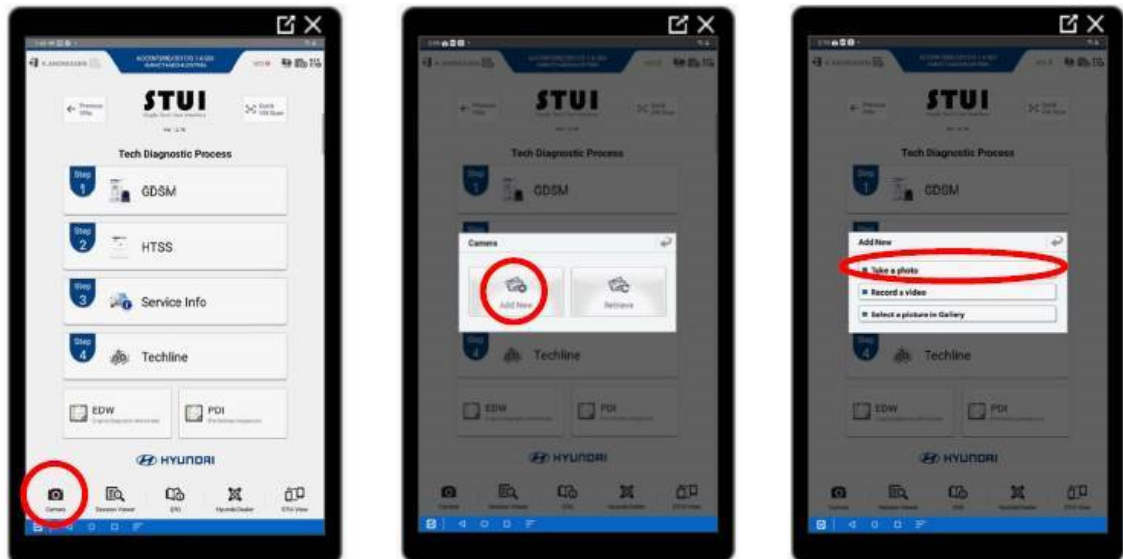
7. Using STUI in the GDS, take and submit a picture of the multimeter's measured value and the VIN in the background of the photo.
