**SUBJECT: NEW VEHICLE DEMONSTRATION / DELIVERY HOLD -  
 Safety Recall 21S22**

Certain 2016 - 2019 Model Year Explorer Vehicles equipped with Painted Roof Rail Covers  
 Roof Rail Cover Detachment

## CERTAIN 2016-2019 MODEL YEAR EXPLORER VEHICLES — ROOF RACK REPAIR

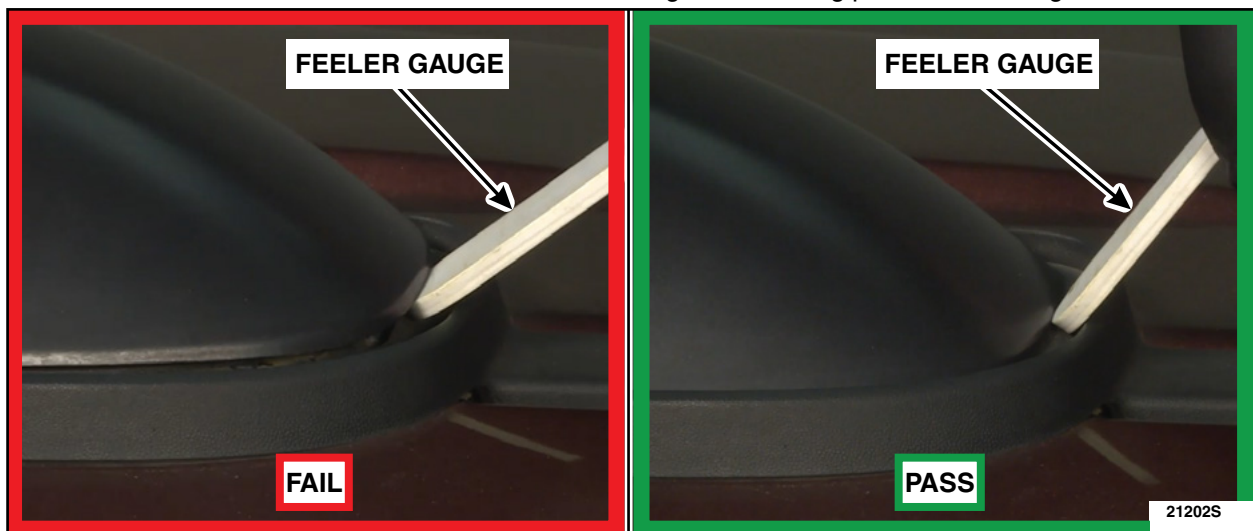
**FIGURE 4**

1. Using a 2 mm feeler gauge, check the spacing on the front and rear of both the RH and LH roof rail covers. See Figure 4. If the feeler gauge fits between the roof rail cover and the roof rail base then it fails inspection. Does the roof rail covers pass or fail?

**NOTE:** A failing roof rail cover does not require replacement at this time, further investigation is required.

If FAIL - For RH roof rail cover, take a picture of the feeler gauge in position of the failing roof rail cover, then Proceed to Step 2.

- For LH roof rail cover, take a picture of the feeler gauge in position of the failing roof rail cover, Proceed to Step 2.

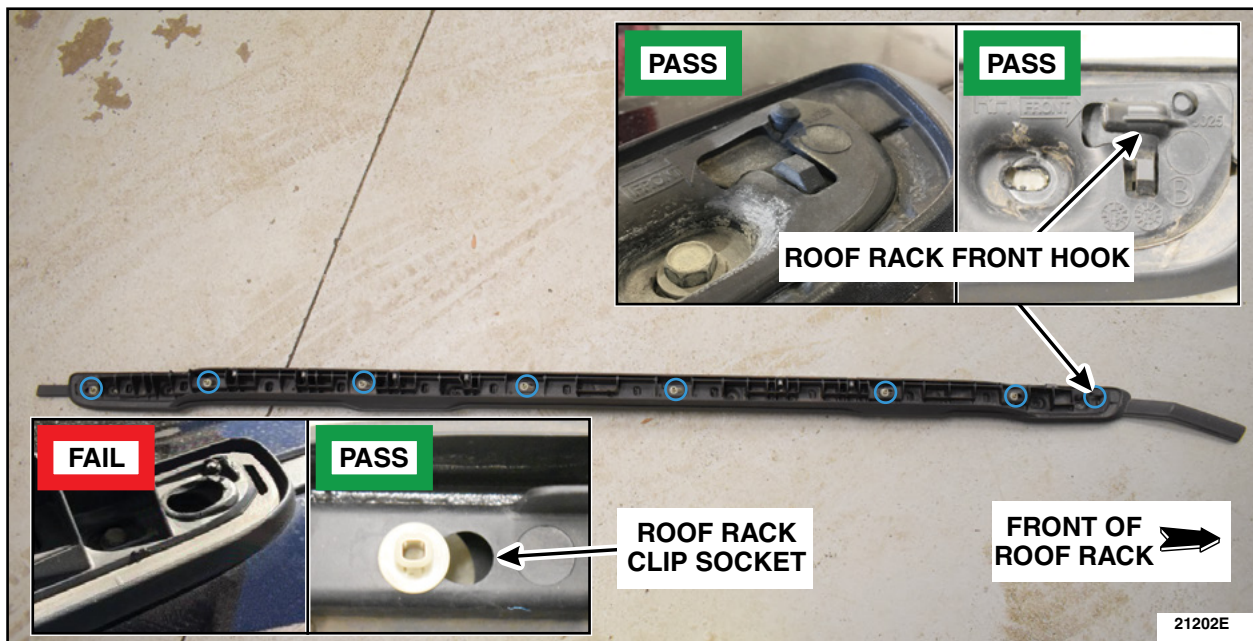
**FIGURE 6**

**NOTE:** A broken roof rail base hook does not need to be replaced.

i. If broken, take photos of roof rail base for both the RH and LH.

1. Photos must be clearly labeled RH or LH.

2. Damaged roof rail bases must be clearly identified with a bright highlighter or similar.

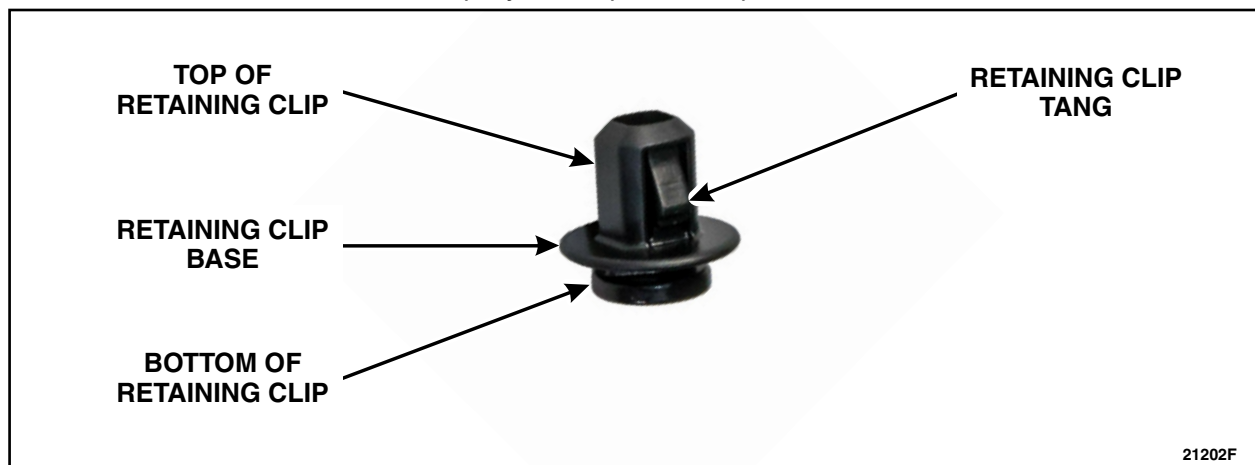
FIGURE 7

- Different colors.
- Different styles.
- No major damage identified.

ii. Clips that cannot be reused:

- Missing.
- All or partial of the top missing from the clip base.
- Broken retaining tang.
- Covered in epoxy from a previous repair.

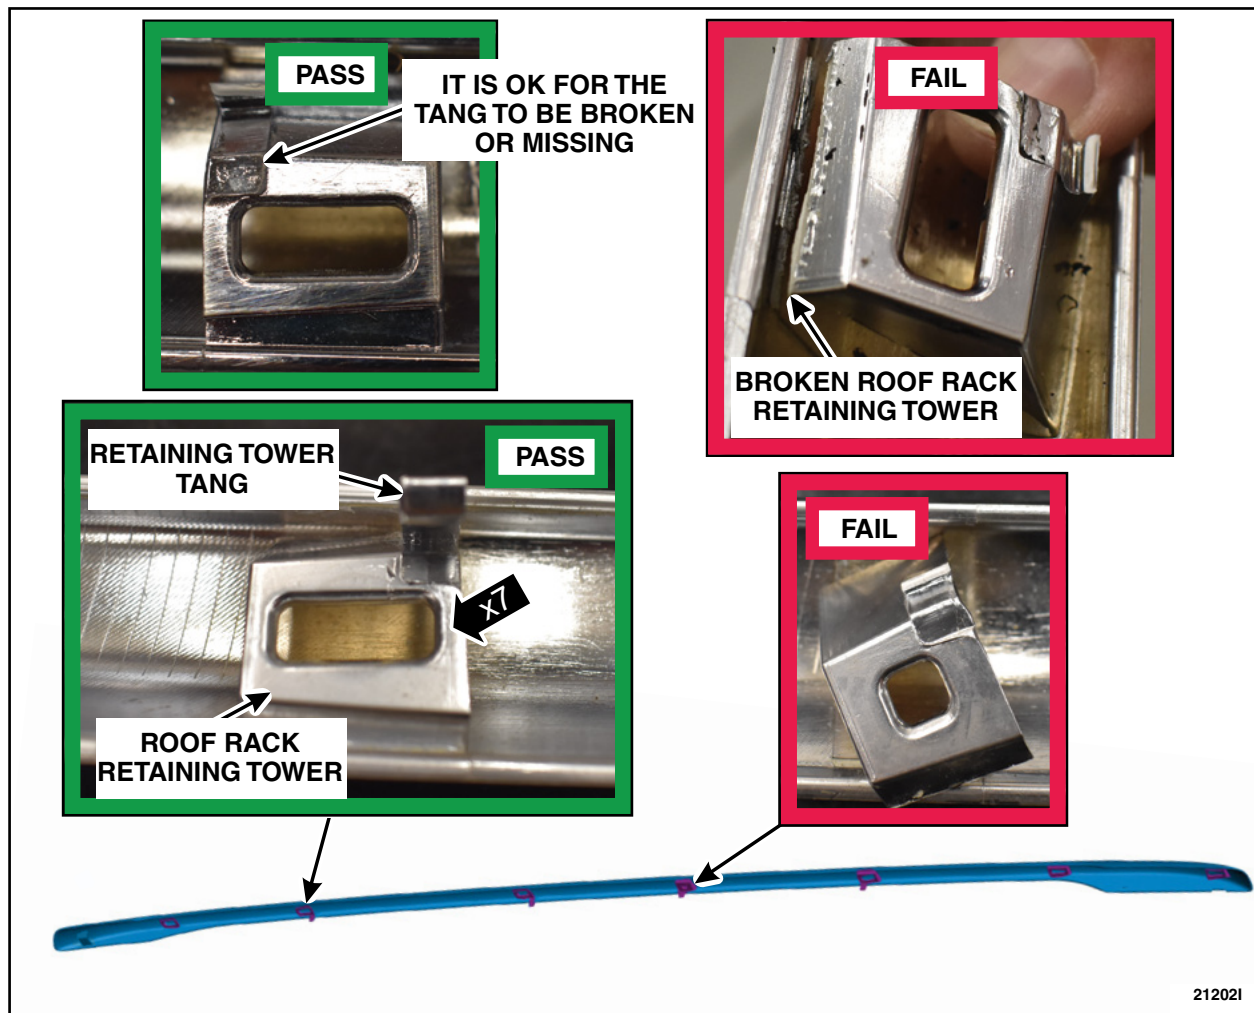
FIGURE 9

i. Broken tangs do not require replacement.

ii. If broken, take photos of retaining towers on the roof rail covers.

1. Photos must be clearly labeled RH or LH.

2. Broken retaining towers must be clearly identified with a bright highlighter or similar.
