SIB 51 08 21

RECALL 21V-342: HEADLINER

2021-05-17

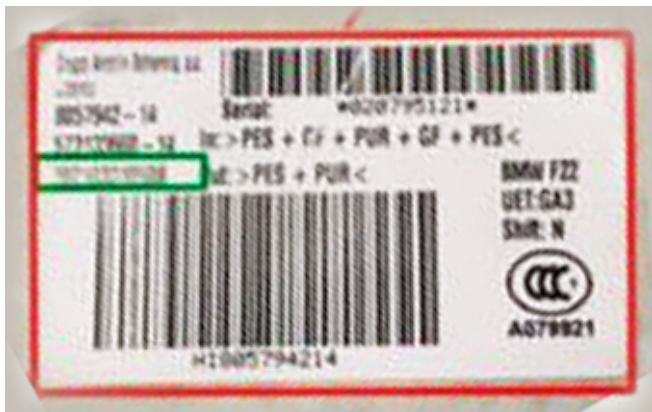
2. Carefully push the headliner downwards at the driver's seating position. Use an inspection mirror or endoscope to read the DATE on the supplier's ID label (circled in green) located above the driver's sunvisor position.

- If the MFR label date is **NOT** 20210304 (year/month/day = March 4, 2021) the headliner needs to be reworked, then reattached. The windshield can remain installed. Continue to Step 3.

- If the MFR label date **IS 20210304** (March 4, 2021) the headliner needs to be replaced following ISTA/AIR Repair instructions. No further correction is needed after.

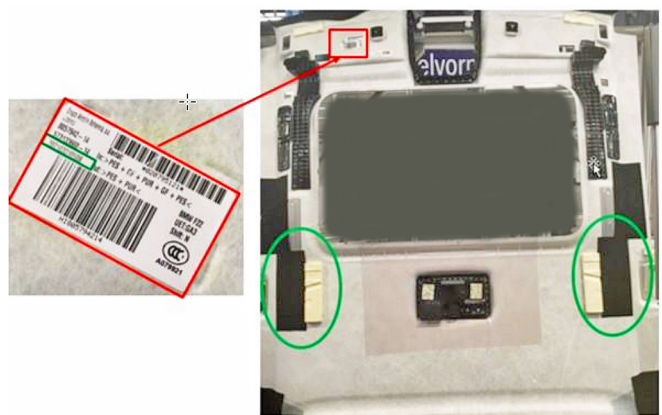
Disregard the 2 green circles in the rear section of the headliner for this step.

3. If the MFR label date is **NOT** 20210304, add 2 felt buffers to the headliner.
- 2 felt packs are needed
 - Select the 1 mm high-nap black needlepoint felt 200 x 120 mm

- Cut a 60 mm length so you are left with 2 felt strips measuring 200 x 60 mm.
 - Apply both buffer segments onto the rear portion of the reinforcement plates (circled below) in overlapping position

- Press firmly on the felt for maximum adhesion, using your other hand on the underside of the headliner as counter-pressure
 - Repeat on the reinforcement plate on the other side of the headliner
