Campaign No. 2021060014, July 2021

SUBJECT: **Model G-Class vehicles (463 platform)**
Model year 2019-2020

Replace Rear Door Lock – Code XZ8/XZ9 (MY19/MY20)

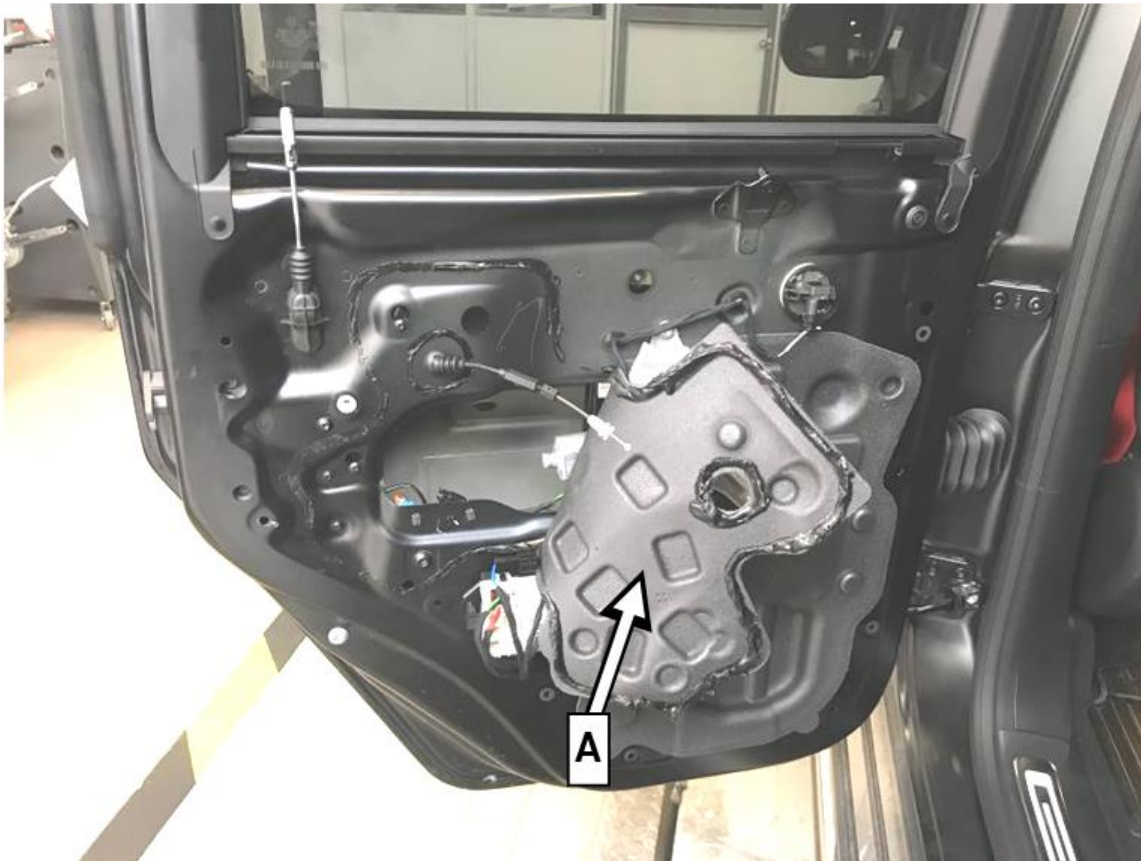
Figure 1

2. **Carefully** pull off door foam sheeting (**A, Figure 1**) from rear doors as shown.

i Door foam sheeting does not have to be completely removed and is reused.
