July 2021
FL887A
NHTSA #21V-357
Transport Canada #2021-290

Subject: Cascadia Halogen Headlights

Models Affected: Specific model year 2017-2022 Freightliner Cascadia vehicles manufactured March 8, 2016, through May 10, 2021, and equipped with halogen headlights.

Work Instructions

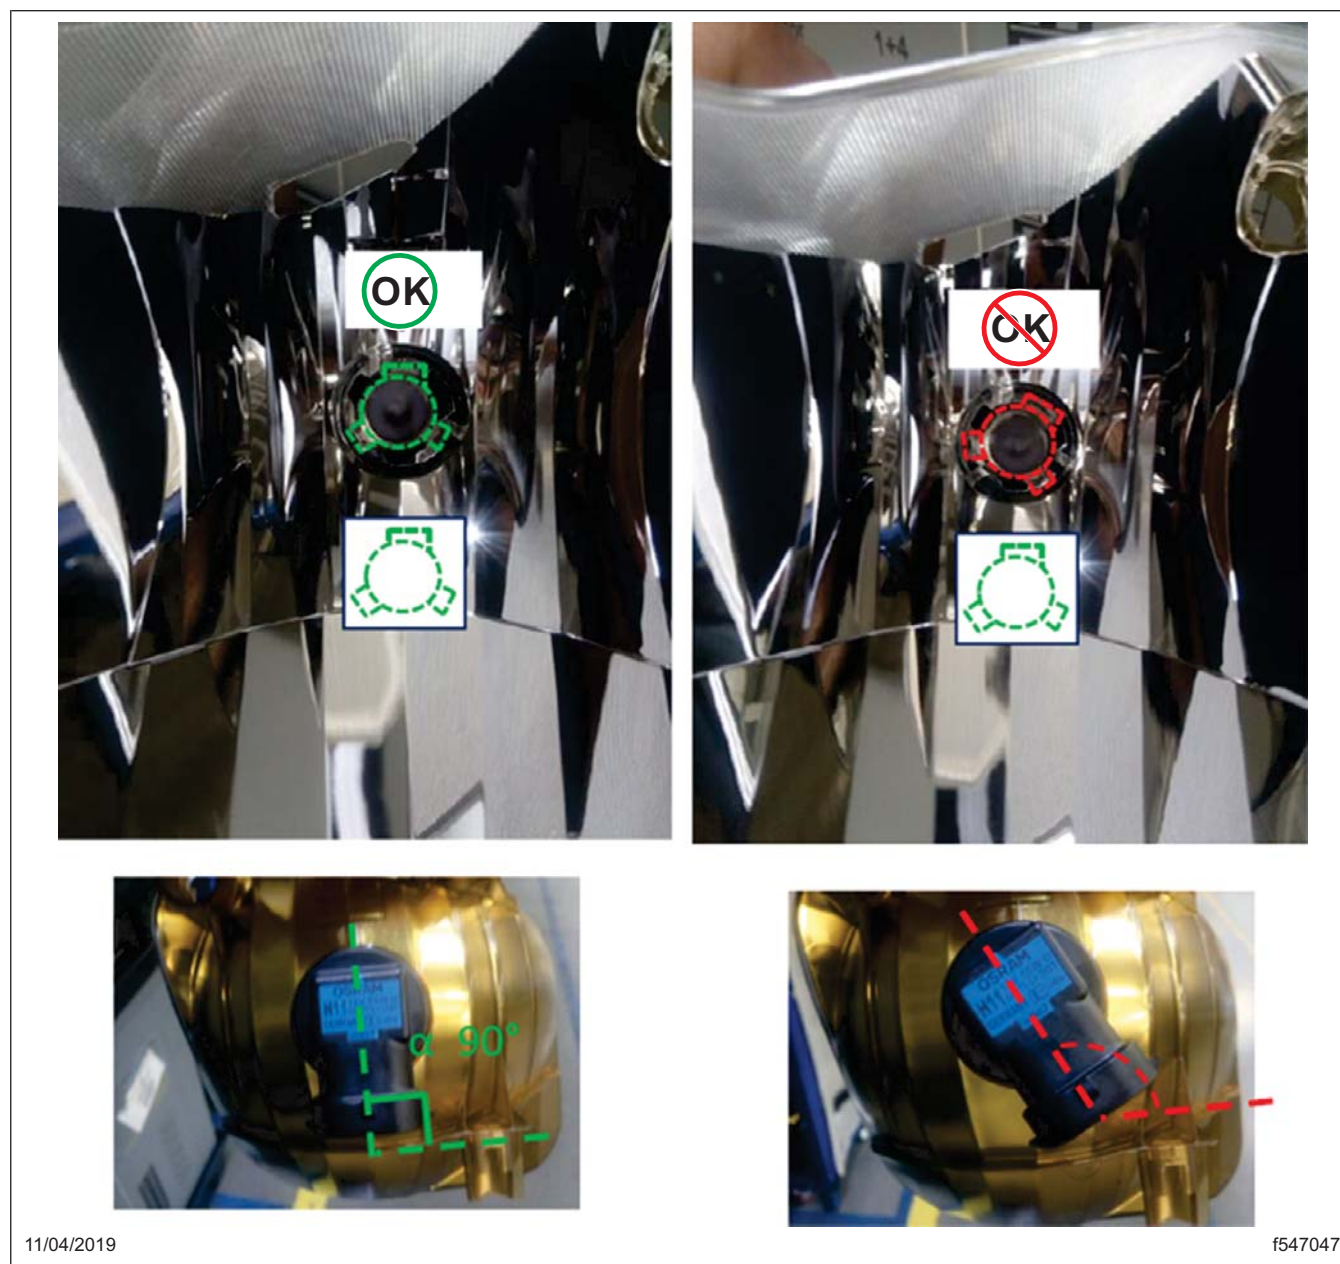
Fig. 14, Correctly (LH) and Incorrectly (RH) Seated Headlamp Bulbs

18. Verify all four headlight bulbs are fully seated by looking through the headlamp lens from the front of the vehicle. See [Fig 14](#). If not properly installed, remove and install them properly.
