| Re: Recall Campaign Launch Notification Model 907 (Sprinter) Model Year 2020 Check Torque on Front Door Hinge Screws | DATE: June, 2021 |

Campaign No. 2021060008 June, 2021

SUBJECT: **Model 907 Sprinter, Model Year 2020**
Check Torque on Front Door Hinge Screws

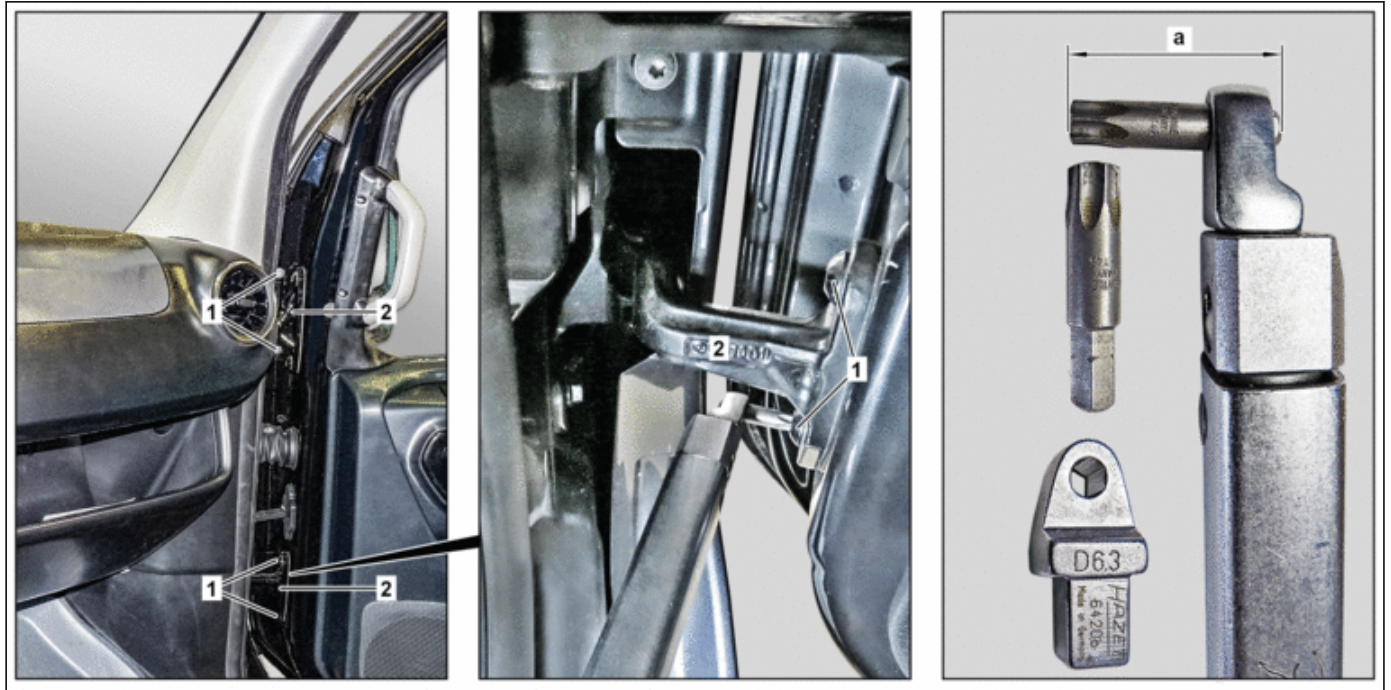
D72.10-A007-79

Shown on right side of vehicle

1 Bolts

2 Hinge

a Dimension (approx. 35 mm)

Check threaded connections of hinges (2) on **both** front doors.

| 3 | Check front door for play on screws (1) and hinges (2). AR | To do so, move front door e.g. abruptly. If front door exhibits play on the screws (1) or hinges (2), ↓ Adjust front door. If front door does not exhibit any play on the screws (1) or hinges (2), ↓ continue with operation step 4. | AR72.10-D-0550TS |
| 4 | Tighten screws (1). Note on calculation of tightening torque when using insertion or socket tools with various effective lengths | If the respective front door does not exhibit any play on the screws (1) or hinges (2). Use torque wrench attached at low eye-level height. Observe dimension (A). Screw/bolt, hinge to front door | AH00.00-P-0015-01CW BA72.10-N-1010-01TS |

| Number | Designation | Model 907 |
|---|---|---|
| BA72.10-N-1010-01TS | Screw/bolt, hinge to front door | Nm 23 |
