# Keystone RV Company

6/15/21

## SAFETY ADVISORY # 21-409

### HC Montana 120VAC Slide Room Connectors

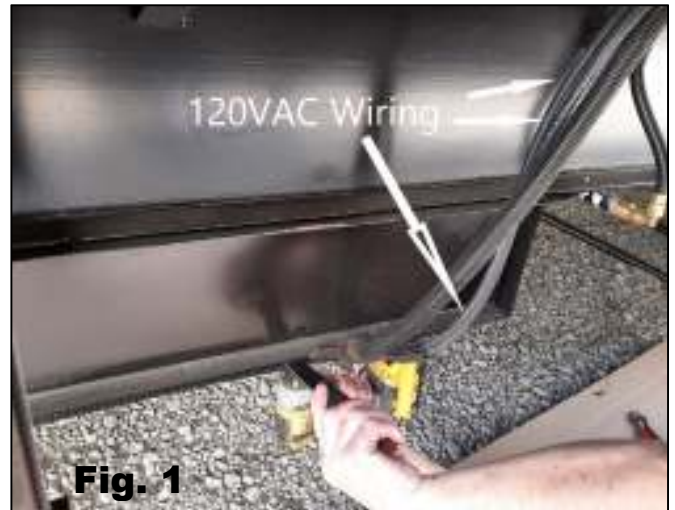
Locate the 120VAC wiring under the slide room, note the lower level frame may have multiple slides with 120 VAC. Remove approximately 3 foot of the underbelly using a 1/4" screw bit to remove the fasteners. See Figure 1. Inspect the wiring connectors from the slide room. See Figure 2. If wiring connectors are mounted up off of the underbelly reattach the underbelly and proceed to warranty reimbursement. If connectors are not mounted to the frame rail (up off the under belly) and/or are damaged take clear photos of the damaged connectors and replace them using the parts listed above. Once they are replaced or if they are not damaged proceed to Step 3.
