August 2021

Safety Recall Y60 / NHTSA 21V-398

Wheel Studs for Fleet Vehicles

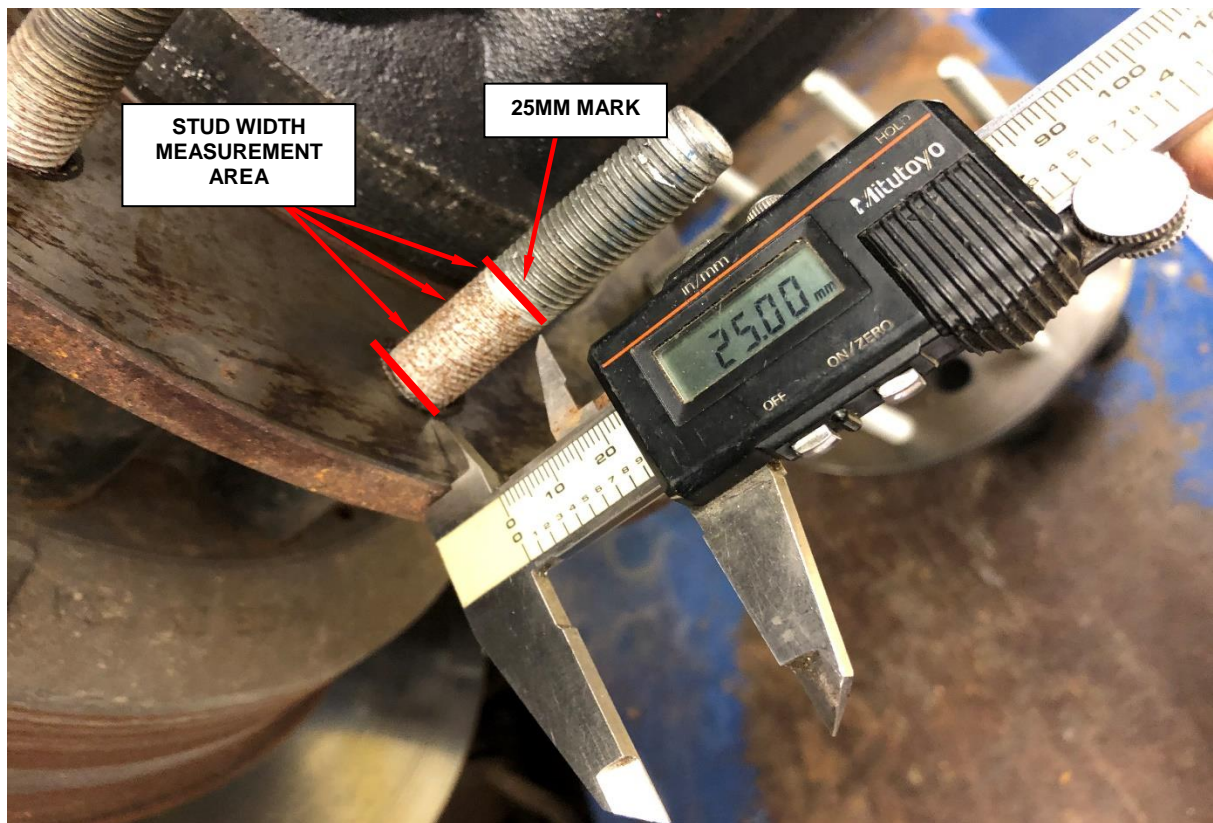
Figure 2 Stud Measurement Area

1. Remove the front and rear wheel and tire assemblies.
2. Using a wire brush clean the threads on all of the wheel studs.
3. Measure approximately 25mm from the axle flange surface up the stud and place a mark (Figure 3). If no measurement tool is available, use the color of the stud to identify the measurement area (Figure 2).

4. Attempt to insert the stud measurement tool in the following locations of the stud at different angles: (Figure 2).
 - a) At the base of the wheel stud.
 - b) At the center of the 25mm measurement area.
 - c) Near the 25mm mark.

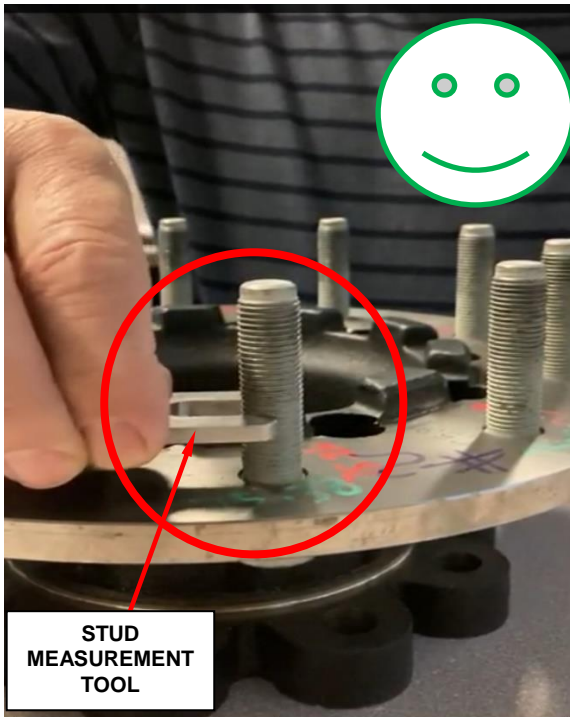
FIGURE 3 – Good Stud

5. Did the measurement tool insert fully into the wheel stud at any of the three locations for *any* of the 4 wheel hubs? See sample illustrations below

- **If yes, Claim LOP 22-Y6-6L-81 This LOP (22-Y6-6L-81) will NOT close the Y60 campaign and the VIN will be placed in a hold status.**
 - Instructions for remedy of these vehicles will be provided at a later date.
- **If no**, reinstall the wheel and tire assemblies and tighten all of the lug nuts to 175N·m (129ft. lbs.). Attach a label over the existing lug nut torque information page in the owner’s/user’s manual and insert and staple an addendum card to the same page (Figure 6 thru 9). Recall can be closed using LOP 22-Y6-01-82.
 - **All studs on all 4 wheel hubs must pass to proceed forward with closing the recall.**
 - **INFORMATION LOCATION MAY VARY FROM VEHICLE FAMILY AND MODEL YEAR.** Please ensure the label is placed over the existing incorrect torque information. The following two examples are variances in location of the lug nut torque specification.

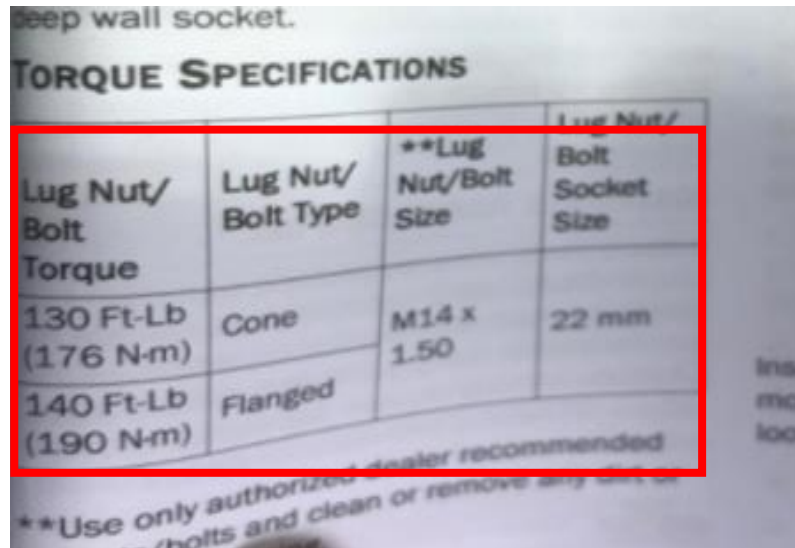
Figure 5A – Owner’s Manual Page

ADHERE THE NEW INFORMATION LABEL TO THIS SECTION
 PAY SPECIAL ATTENTION TO COVERING THE FLANGED LUG NUT TORQUE 140 FT-LB / 190 N-m.

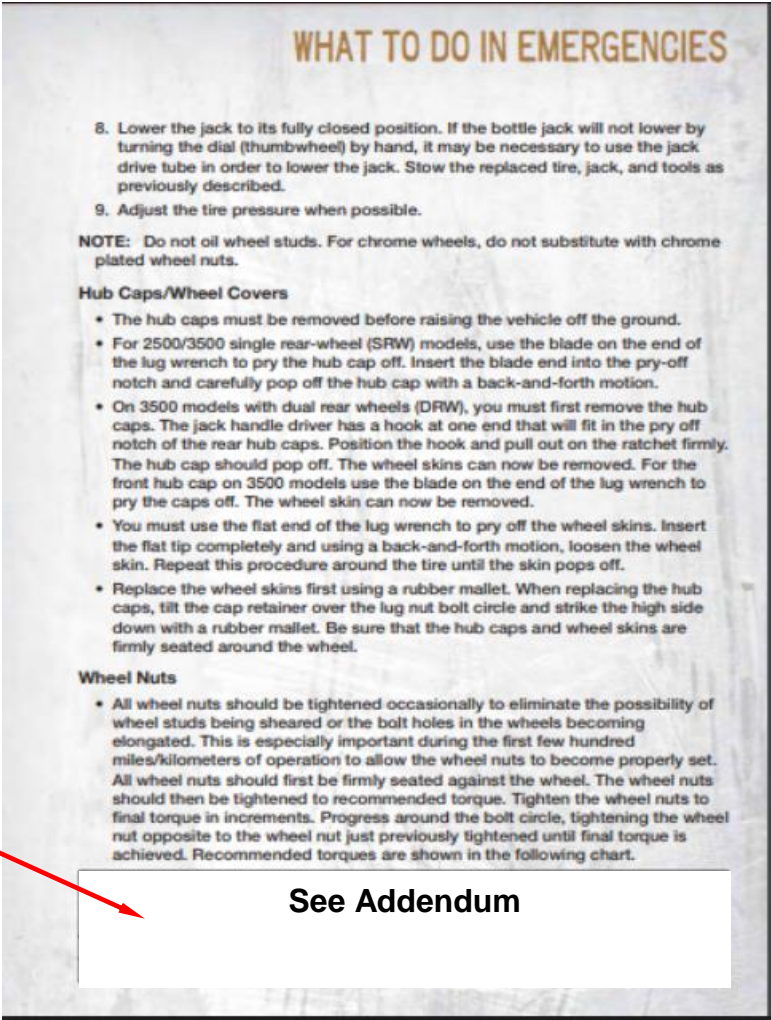
Figure 7B – User’s Guide

ADHERE THE NEW INFORMATION LABEL TO THIS SECTION
 PAY SPECIAL ATTENTION TO COVERING THE FLANGED LUG NUT TORQUE 140 FT-LB / 190 N-m.
