RE: **Recall Campaign Launch Notification**
Check Guide Bushing on Rear Head Restraints
MY21 205 and 238 (C-Class and E-Class)

Campaign No. 2021060010, July 2021

SUBJECT: **Model C-Class Convertible and E-Class Convertible (205 and 238 platform)
Model year 2021**

Check Guide Bushing on Rear Head Restraints

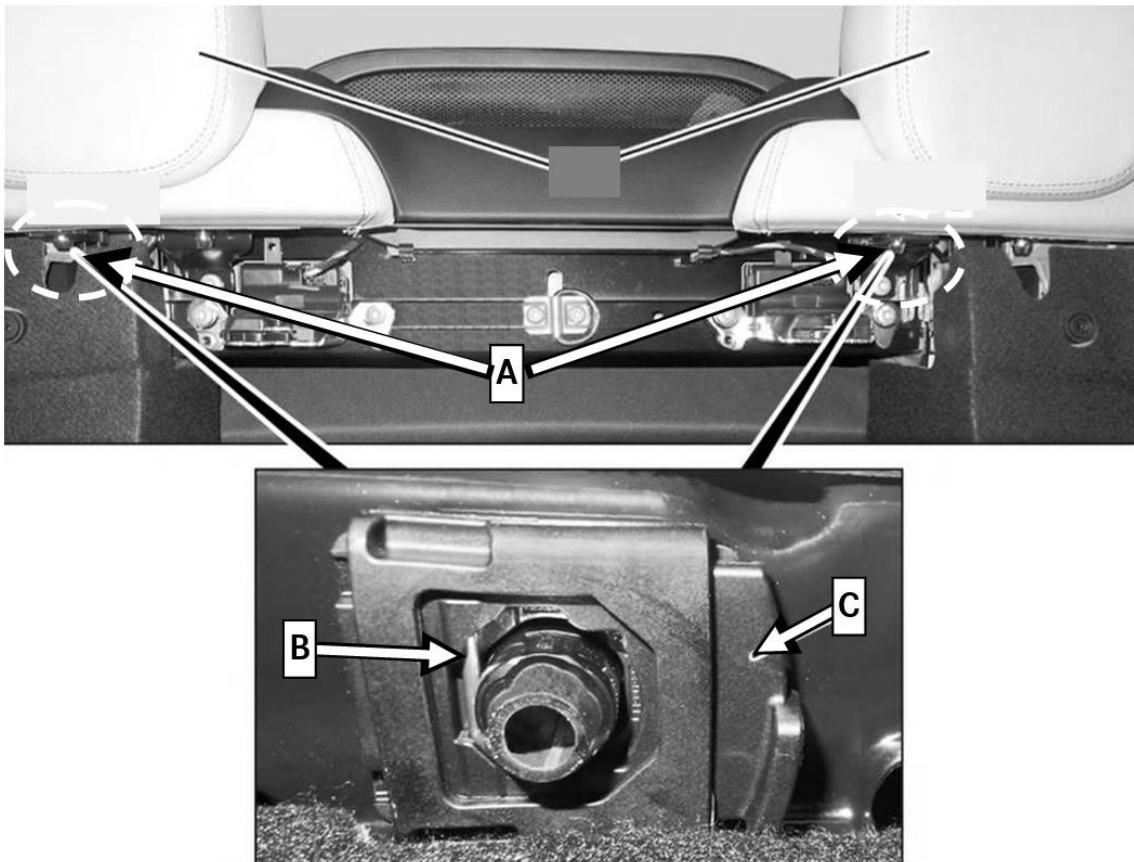
Figure 1

i A head restraint guide sleeve with a locking clip and release lever must be installed in the direction of travel on the **right side of each head restraint (A, Figure 1)**.

i In each case, the **locking clip (B, Figure 1)** must **point toward the right side of the vehicle**.

i In each case, the **release lever (C, Figure 1)** must **point toward the left side of the vehicle**.

- a. Head restraint guide sleeve or sleeves twisted or installed on the wrong side: Carry out **work procedure**.
- b. Head restraint guide sleeves installed **correctly: End measure**.

1. Replace incorrectly installed head restraint guide sleeves (AR91.16-P-1776LWR)
