| <b>Re: Recall Campaign Launch Notification<br/>Model 907 (Sprinter)<br/>Model Years 2020<br/>Inspect Swivel Seat Wiring Harness Routing</b> | DATE: August, 2021 |

Campaign No. 2021070031, August, 2021

SUBJECT: **Model 907 Sprinter, Model Year 2019-2021**  
**Inspect Swivel Seat Wiring Harness Routing**

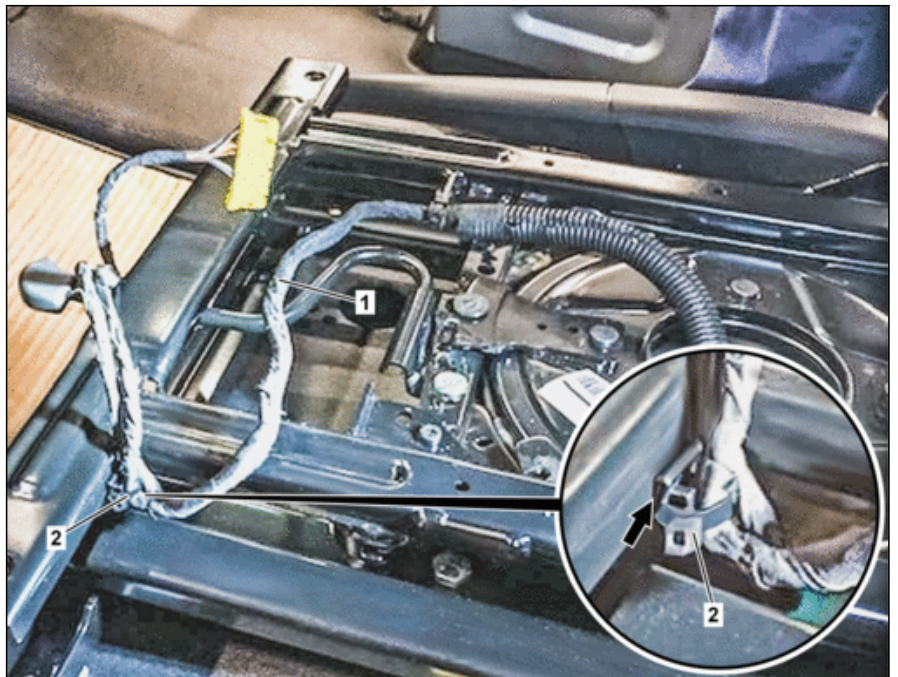
D91.10-A026-76

**Shown on driver's seat with code SF1 (Electrically adjustable driver's seat) and code SR8 (Driver's seat rotating frame)**

- 1 Wiring harness
- 2 Cable tie with retaining clip

| 3 | Subsequently adapt line installation and attachment of wiring harness (1) to respective rotating seat. | <p><b>i</b></p> <p>To do so, check if the wiring harness (1) is correctly fastened to the respective rotating seat frame using a cable tie with retaining clip (2).</p> <p>The wiring harness (1) must be positioned in the corner (arrow) of the rotating seat frame, as shown in the picture, and fixed in place using a cable tie with retaining clip (2).</p> <p>If cable tie with retaining clip (2) is not present,</p> <p style="text-align: center;">↓</p> <p>subsequently fasten wiring harness (1) to rotating seat frame using retaining clip (2). To do so, position wiring harness (1) along cable tie with retaining clip (2) in corner (arrow) of rotating seat frame. See figure.</p> <p>If cable tie with retaining clip (2) is present,</p> <p style="text-align: center;">↓</p> <p>position wiring harness (1) correctly on rotating seat frame. To do so, position wiring harness (1) along cable tie with retaining clip (2) in corner (arrow) of rotating seat frame. See figure.</p> | |

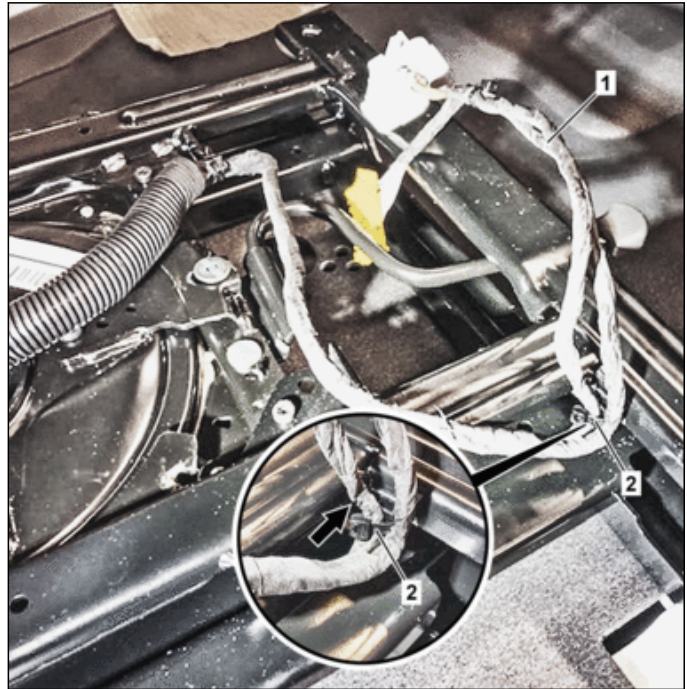
D91.10-A027-82

Shown on driver's seat with code SF2 (Electrically adjustable front passenger seat) and code SR9 (Front passenger seat rotating frame)

- 1 Wiring harness
- 2 Cable tie with retaining clip

If rotating seats are installed on the driver and passenger side, then the line installation of both rotating seats must be checked and adapted, if necessary.
