WARRANTY BULLETIN SAFETY CAMPAIGN

Campaign no.: 2021-0006

Subject: **Move I 1500 Extended Trailer Spindle Weld Failure - Possible Wheel Loss**

2021-4

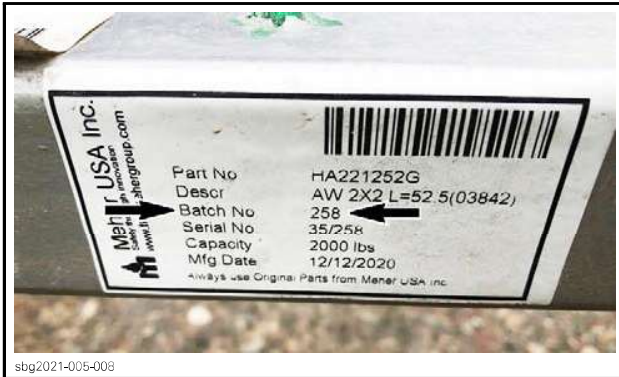
sbg2021-005-003

Inspect axle tag, located in the middle of the axle and take note the Batch number.

NOTE: The axle tag will be either a white sticker (as shown) or a metal plate.

If the trailer is from one of the affected batches, proceed to *AXLE REPLACEMENT*. If not, no further action is required.

In case the batch number is not visible or missing, proceed to *AXLE REPLACEMENT*.
