Recall Service Bulletin RSB21-500-001

DATE: 7/8/2021

APPLIES TO: This Recall service bulletin applies to 2019 through 2021 model year, S-180 model emergency response pumpers built between April 2019 and November 2020.

CONDITION: Incorrect terminal installed on harness connected to pump control solenoid.

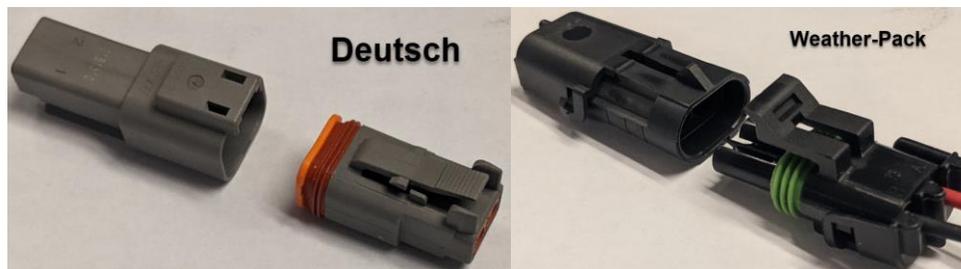
Figure 2.1

1. Locate 2 connectors that connect the harness to the pump shift control solenoid. These are typically located towards the middle of the truck on the drivers side frame rail. Road Solenoid connector will have orange wire labeled ERV738 & black wire labeled ERV510D. Pump solenoid connector will have blue wire labeled ERV739 & black wire labeled ERV510E.
2. Identify type of connector. Deutsch or Weather-Pack. *See Figure 2.1*

3. If connection is made with Deutsch connector no further action is needed. If connection is made with Weather-Pack connector move on to step 4.
4. Disconnect both Weather-Pack connectors that connect the harness to the pump shift control solenoid.
5. Inspect the harness side connector (Female connector assembly) terminals to verify they are a female (sleeve) terminal, not a male (pin) terminal. *See figure 3.1*
