L62X-R.02.21

Rear View Camera not available - Kombi update

Model:Huracán 4WD, Huracán 2WD, Huracán Performante,
Huracán EVO**Model year:**

As a result of continuous product monitoring, Automobili Lamborghini S.p.A. has determined that some vehicles were manufactured with a software bug within the infotainment system which when subjected to temperatures below 41 degrees Fahrenheit and after a long sleep may some-times generate a fault that renders the rear view (back-up) camera inoperable until the next power latch.

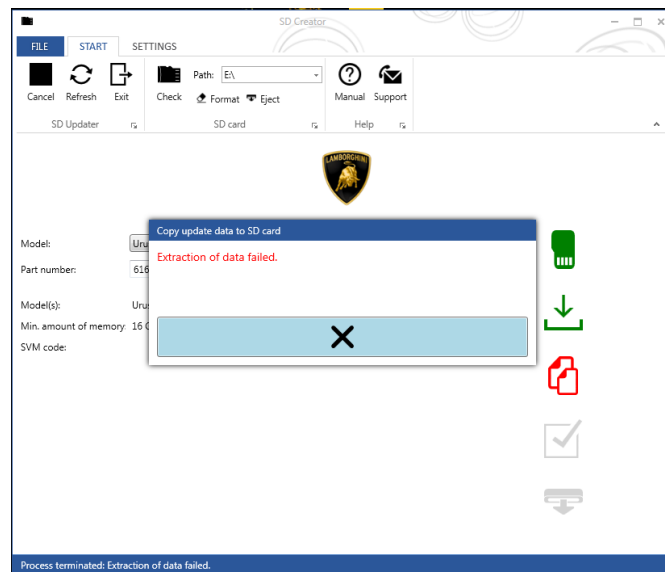
If the error shown in the following image occurs in the download from SD Creator, perform the instructions at the end of this document, in Trouble shooting section.

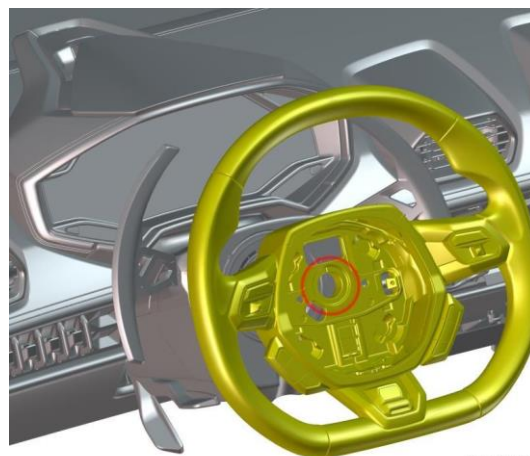
62x15_0000433

- 13.** Straighten the front wheels. Keep the front wheels straight throughout the procedure. Unscrew the retaining bolt and remove the steering wheel. When reinstalling, line up the reference on the steering wheel with the one on the steering column and **make sure to replace the fastener shown in the image below (code N90799102).**

Tightening torque: **30 Nm + 90°**

During the reassembly **DO NOT** re-utilize the old fastener, make sure to install a new one (code N90799102).

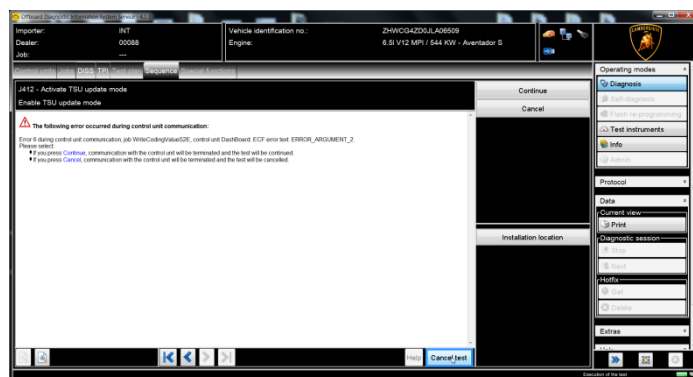
- i. If the following error screen is displayed, abort the guided function by clicking on "Cancel Test" and contact Technical Support.

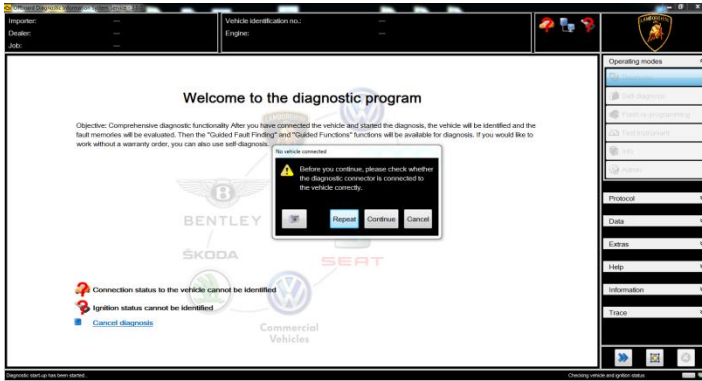
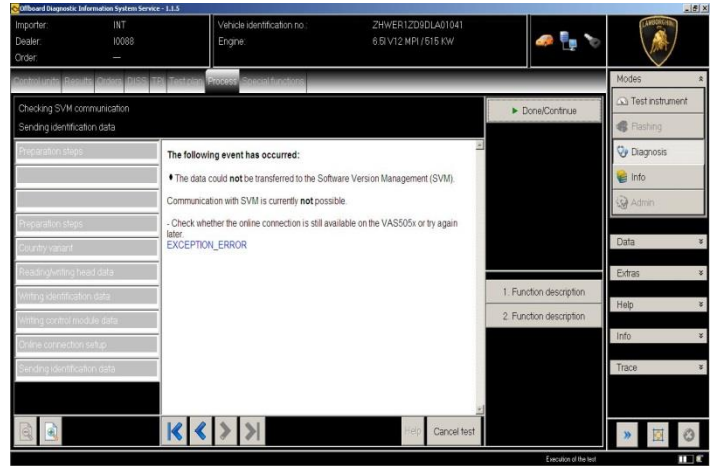
- ii. If an error is displayed that regards the hardware interface, and the "connection to vehicle" and "key state" icons appear as shown in the figure below:

- Click "Cancel";
- Repeat installation of the interface VAS5054/6154/6154A for the instructions in procedure (*)"VCI Manager v2.0", selecting the right-hand "Extras" menu in ODIS and clicking on the "Diagnostic interface" button.

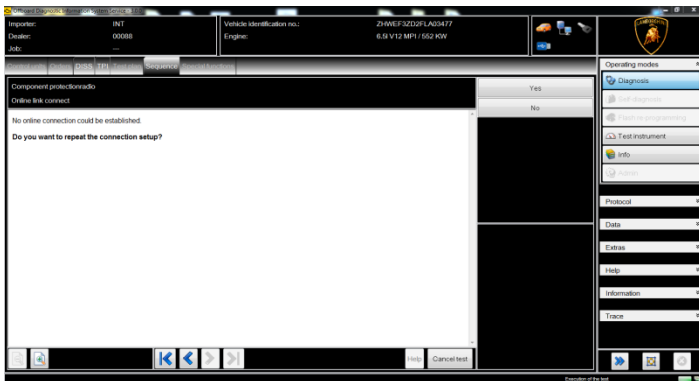
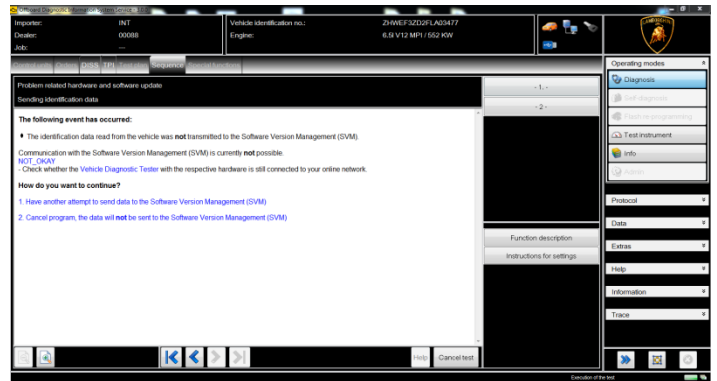
iii. If one of the following connection errors is displayed like in the following example screenshots:

iv. If the connection is dropped during the course of the target/actual comparison during the SVM procedure:

- It is not possible to connect to the central server; check that your laptop is correctly connected to the Internet and retry by clicking on "Yes" or "Done/continue", as appropriate.

- It is not possible to connect to the central server; check that your laptop is correctly connected to the Internet and retry by clicking on "1".

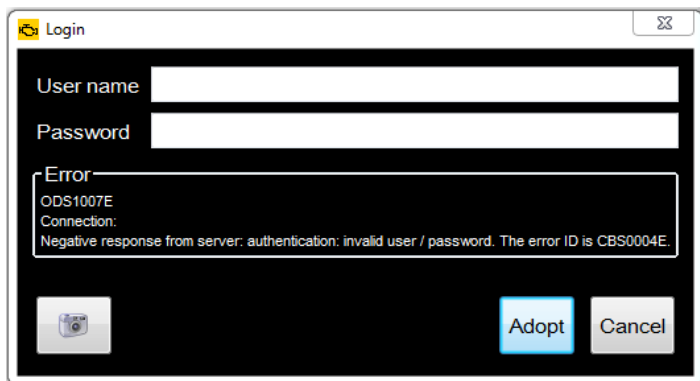
v. If the authentication error as shown in the following screenshot is displayed (error code: ODS1007E):

- Ensure you have a valid GeKo user account
- Ensure that the "GeKo" label is printed on the token you are using
- Ensure you have entered the correct password

- Click on "Cancel" and run the application test (see document "ODIS_ControlloConnessione_Server_SVM_2.0" (*)).

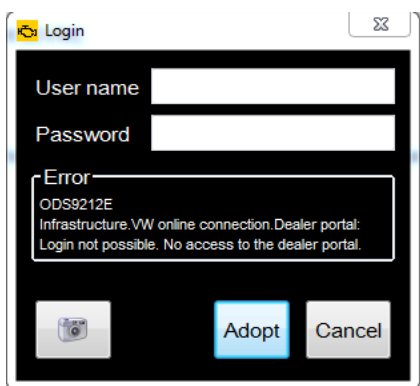
- vi. If the infrastructure error as shown in the following screenshot is displayed (error code: ODS9212E):

- Ensure you have a valid GeKo user account
- Ensure that the "GeKo" label is printed on the token you are using
- Check that the Internet is set in ODIS settings and not CPN (see document "Setup_Iniziale_ODIS_7.0" (*))
- Click on "Cancel" and run the application test (see document "ODIS_ControlloConnessione_Server_SVM_7.0" (*)).

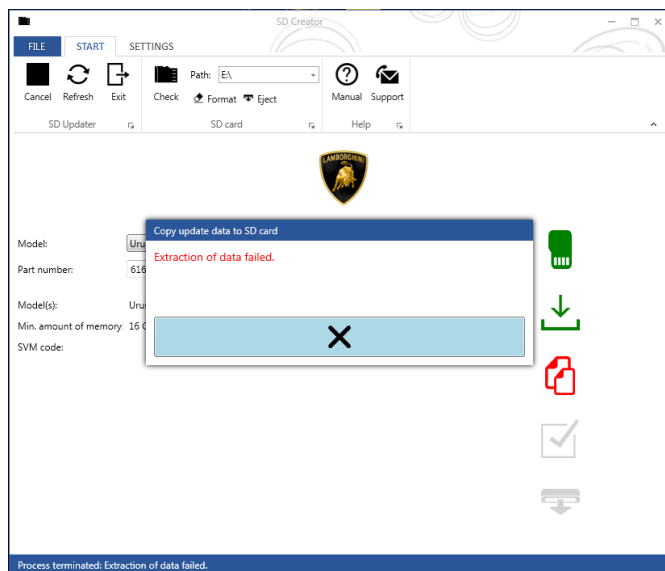
- viii. If the following error should occur, it is necessary to follow the instructions given in **BI.25.18** (Rev.02), which can be downloaded on the Lamborghini HUB portal:
