Product Safety Recall

N212340220 Incorrect SDM Calibration May Affect Timing or Level of Airbag Deployment

Release Date: June 2021

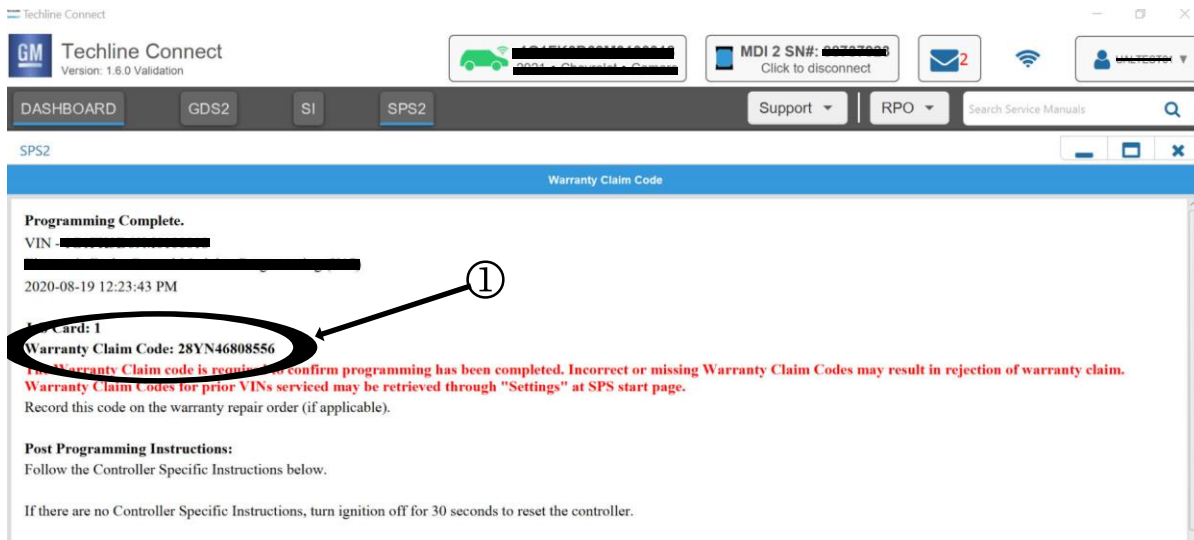
5644478

Note: The screenshots above are an example of module programming and may not be indicative of the specific module that is being programmed. Module selection and VIN information have been blacked out.

1. Reprogram the inflatable restraint sensing and diagnostic module. Refer to *K36 Inflatable Restraint Sensing and Diagnostic Module: Programming and Setup* in SI.
