Product Safety Recall

N212340220 Incorrect SDM Calibration May Affect Timing or Level of Airbag Deployment

Release Date: June 2021

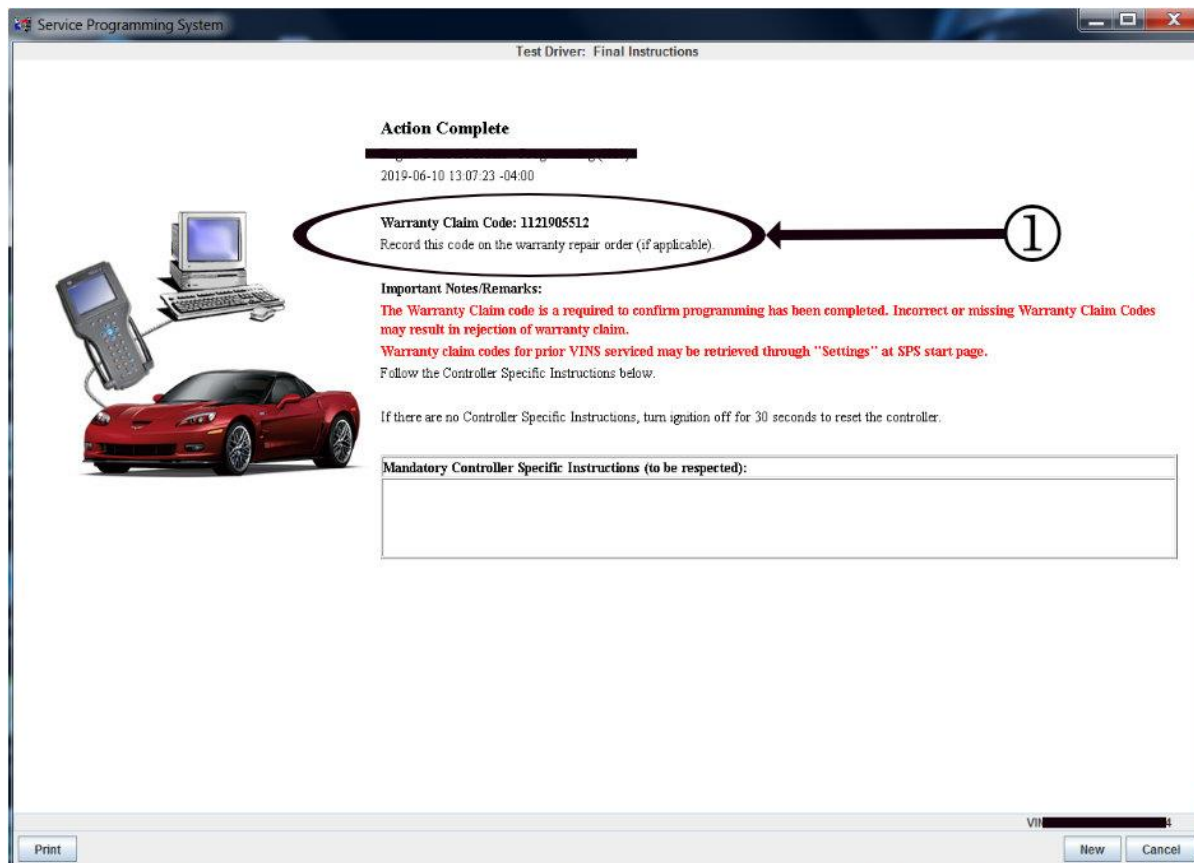
Important: To avoid warranty transaction rejections, you **MUST** record the warranty claim code provided on the Warranty Claim Code (WCC) screen shown above on the job card. Refer to callout 1 above for the location of the WCC on the screen.

- Record SPS Warranty Claim Code on job card for warranty transaction submission.
