RECALL CAMPAIGN BULLETIN

Classification: RS21-005A	Reference: NTB21-060A	Date: August 24, 2021
------------------------------	--------------------------	--------------------------

VOLUNTARY SAFETY RECALL CAMPAIGN 2021 ROGUE; REAR SEAT TETHER INSPECTION

CAMPAIGN ID #: PC812
APPLIED VEHICLES: 2021 Rogue (T33)

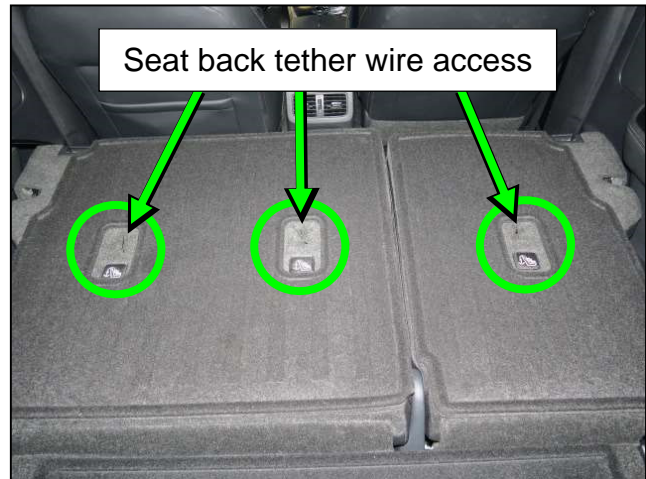
Figure 2

3. Locate the 3 seat back tether wire access holes.

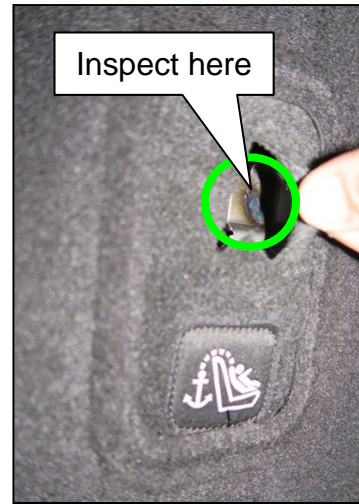
Figure 3

4. Lift the seat back cover at the access hole in order to inspect for the weld heat signature of each tether wire (Figure 3).
 - A flashlight may be needed to inspect for the weld heat signature marking on both sides of the tether wire.

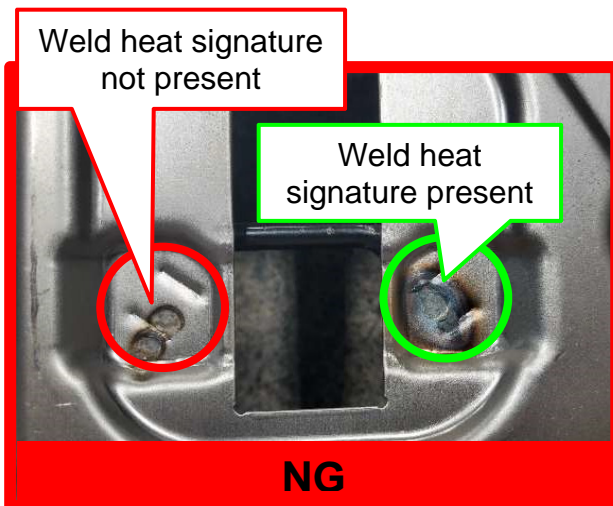
Figure 4

5. Inspect both sides of ALL 3 seat back tether wires for a weld heat signature marking.
 - If there is a tether wire that does not have a weld heat signature marking (Figure 4), the inspection result is **NG**. Proceed to step 6 to replace the affected seat back.
 - If there is a weld heat signature marking on both sides of ALL 3 tether wires (Figure 5), the inspection result is **OK**. Return both rear seats to their upright position and skip to the **CLAIMS INFORMATION** table on page 4.

6. Replace the affected seat back assembly.
 - For seat back replacement, refer to the ESM section below.
 - **BODY INTERIOR > SEAT > REMOVAL AND INSTALLATION > REAR SEAT > Removal and Installation**
