Safety Recall

Mack Trucks Inc.
Greensboro, NC USA

Date	Number	Release	Page
06.2021	SC0426	01	1(6)

Watson & Chalin Pivot Bolt Replacement GR

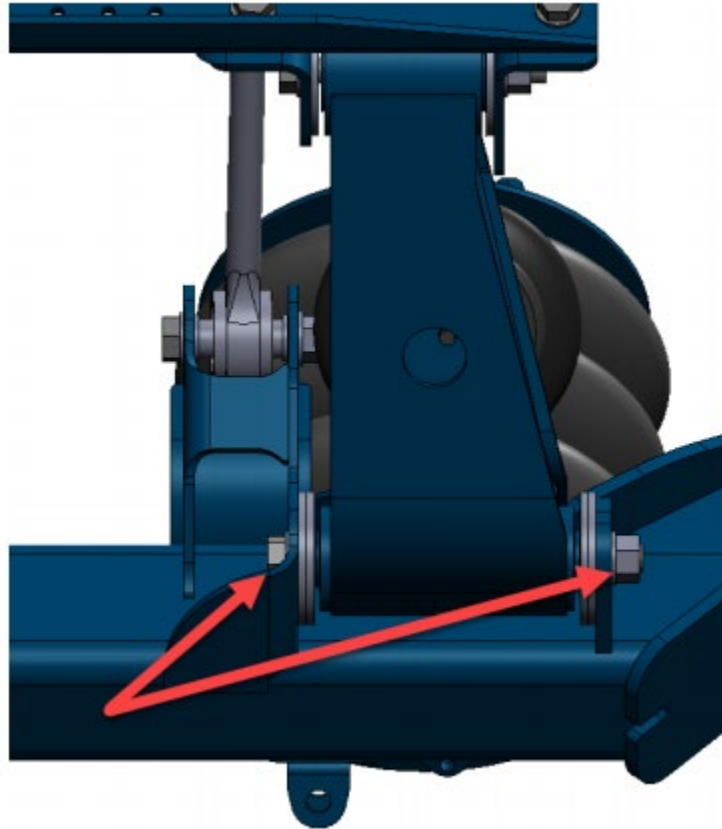
These suspensions may be equipped with lower rear pivot cap screws that are not long enough to sufficiently engage the locking feature of the corresponding nuts.

18. Remove the axle-side fasteners:

- a. Make note of the lower control arm spacer washer locations. These are the large diameter washers inside of the axle flanges. If required, mark the locations or take photographs to reference during re-installation. NOTE THAT WASHER LOCATIONS MAY DIFFER FROM THE ABOVE PICTURE. Spacer washers may be left in and reused if they are free from damage.
- b. Use 1-5/16-inch wrenches and/or sockets to remove the nuts.
- c. If required, use a grinder and cutoff wheel to remove stuck fasteners. Take care not to damage the axle flange, axle tube, or any other vehicle components when using the grinder.
- d. Secure the control arm with a jack stand, so it does not fall, and knock out the cap screw using punches and a hammer. USE CAUTION, AS CONTROL ARM MAY SHIFT WHEN THE FASTENER IS REMOVED.

19. Install the replacement fasteners:

- a. If required, place a floor jack or other lifting device under the lower control arm, then raise it into the axle.
- b. Install the lower control arm spacer washers. An alignment or center punch inserted from the outboard side may be used to hold them in place until the cap screw is inserted. For correct washer locations, reference notes taken in Step 18a.
- c. Install the lower control arm pivot cap screw, washers, and nut, but do not tighten.
- d. Use 1-5/16-inch wrenches and / or sockets to snug the lower pivot fastener. Confirm fastener is fully engaged with the joint.
- e. Secure the heads of the cap screws with a combination wrench and tighten the nuts to 400 lb-ft torque. DO NOT TORQUE FROM HEAD OF CAP SCREW.
