TO: Mercedes-Benz Dealer Principals, General Managers, Sales Managers, Service Managers, Parts Managers	FROM: Gregory Gunther, Department Manager, Vehicle Compliance and Analysis, Engineering Services
RE: Recall Campaign Launch Notification Check Carbon-Fiber Driveshaft Bonding –Wave 1 MY16-17 190 (AMG GT-Class)	DATE: October 1 st , 2021

Campaign No. 2021090008, October 2021

SUBJECT: **Model AMG GT-Class vehicles (190 platform)**
Model Year 2016-2017
Check and Replace **Carbon-Fiber Driveshaft**

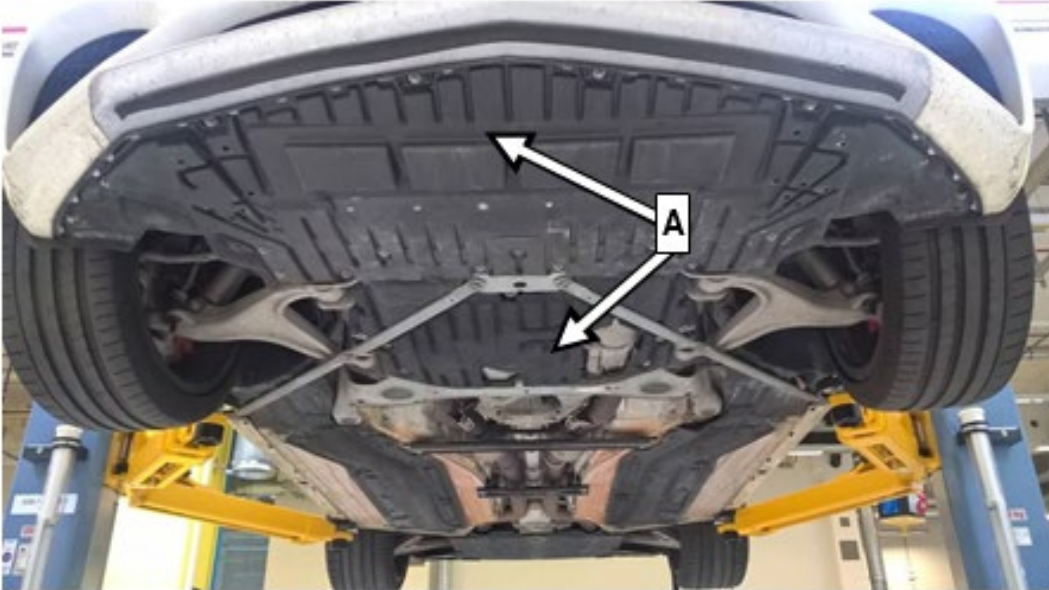
**Figure 1**

1. Remove lower engine compartment lining (A, figure 1).

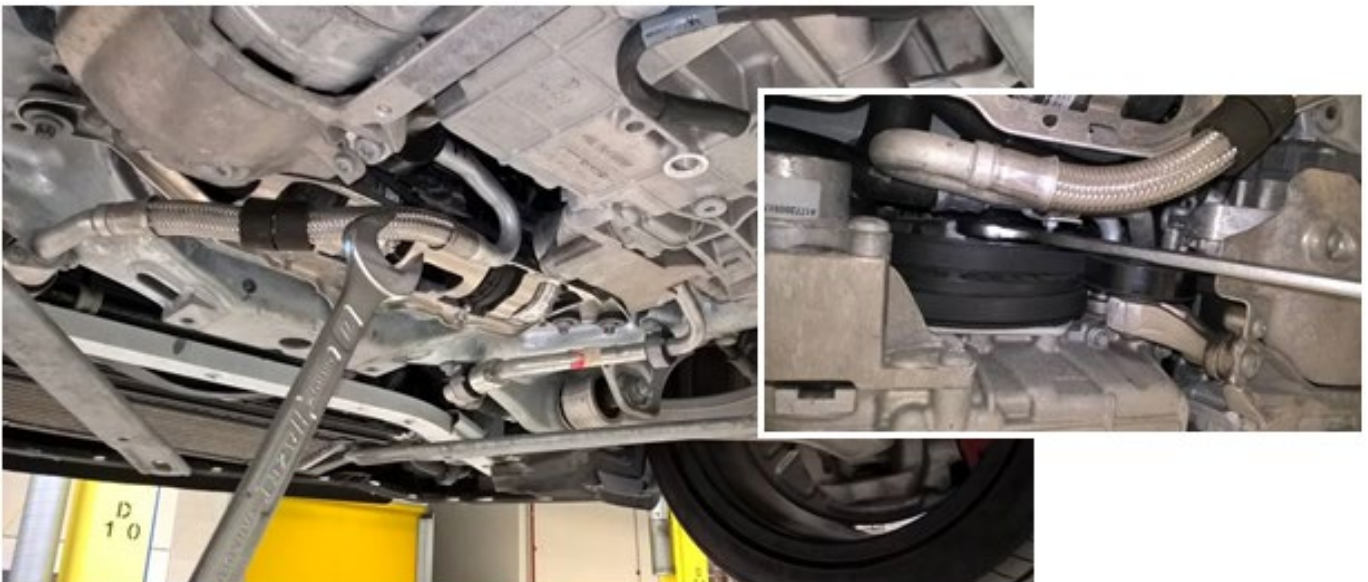
**Figure 2**

2. Open maintenance access on engine-side drive shaft housing.

Rotate engine at center bolt in direction of rotation until affixed label on drive shaft is visible.

i Rotate engine at center bolt in direction of rotation with a 27 mm open end wrench.
