Mercedes-Benz

Campaign No. 2021090008, October 2021

SUBJECT: **Model AMG GT-Class vehicles (190 platform)**
Model Year 2016-2017
Check and Replace **Carbon-Fiber Driveshaft**

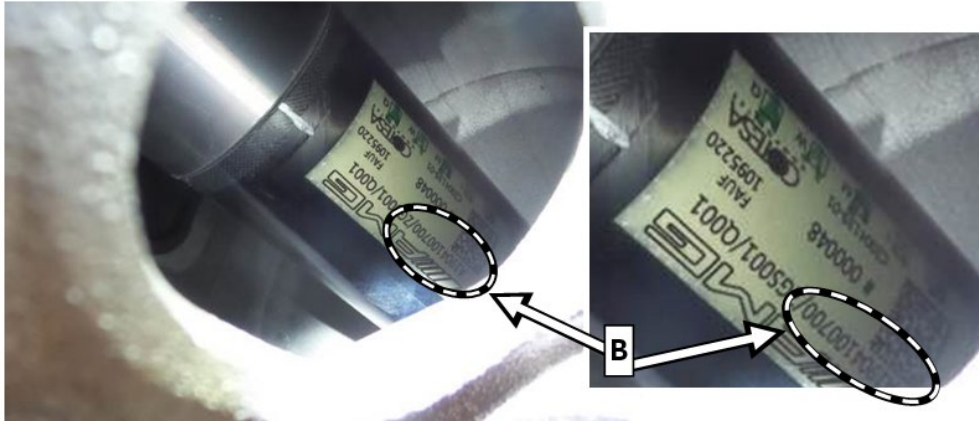
Figure 3

3. Check part item number (**B, figure 3**) of drive shaft.

- a. If part item number is **A 190 410 07 00**:
Carry out **work procedure**.
- b. If part item number is **A 190 410 06 00** or **A190 410 14 00** or **A 190 410 23 00**:
End measure.

1. Replace drive shaft.
i For basic data, see **AR41.10-P-0051MNB**.
