February 2022
FL893A-G
NHTSA #21V-481
Transport Canada #2021-399

Subject: Aluminum Battery Cable Failure

Models Affected: Specific model years 2019-2022 Freightliner Cascadia vehicles; and Western Star 47X RHD, 48X RHD, and 49X vehicles manufactured April 28, 2018, through June 11, 2021.

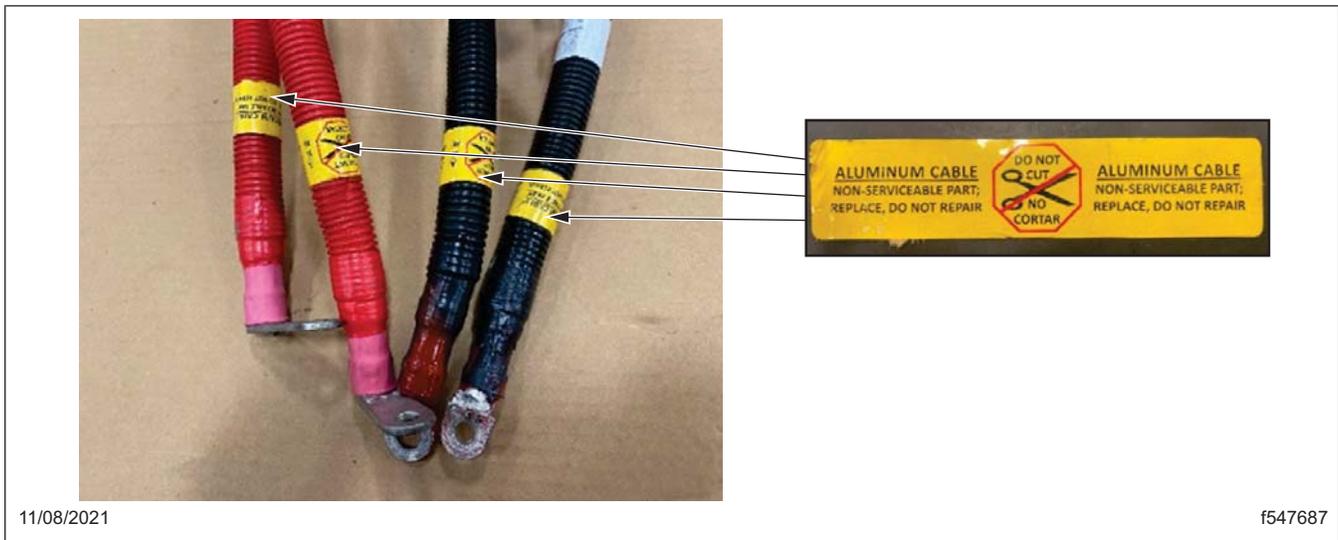
Fig. 7, Powernet Battery Cables Made of Aluminum

4. Inspect each of the four main powernet battery cables to identify those made of aluminum. Aluminum cables can be identified as follows:
 - The aluminum 4/0 cables have a larger outer diameter than the copper 4/0 cables.
 - The aluminum 4/0 cables are attached with a yellow label on each end indicating they are made of aluminum. See [Fig. 7](#).

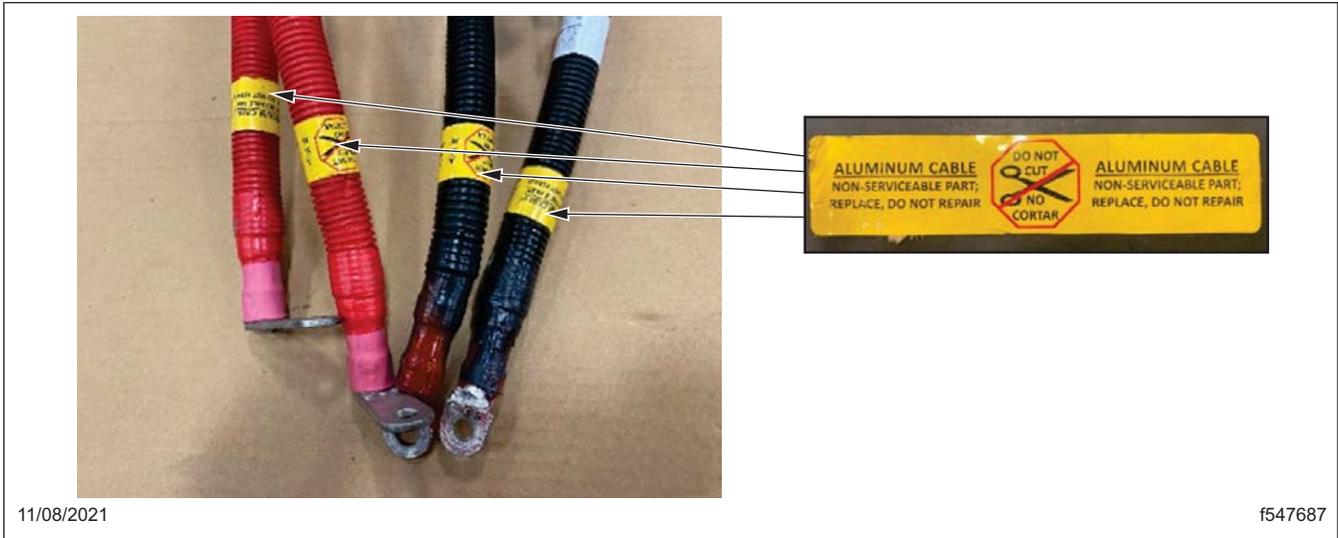
Fig. 16, Powernet Battery Cables Made of Aluminum

4. Inspect each of the four main powernet battery cables to identify those made of aluminum. Aluminum cables can be identified as follows.
- The aluminum 4/0 cables have a larger outer diameter than the copper 4/0 cables.
 - The aluminum 4/0 cables are attached with a yellow label on each end indicating they are made of aluminum. See [Fig. 16](#).

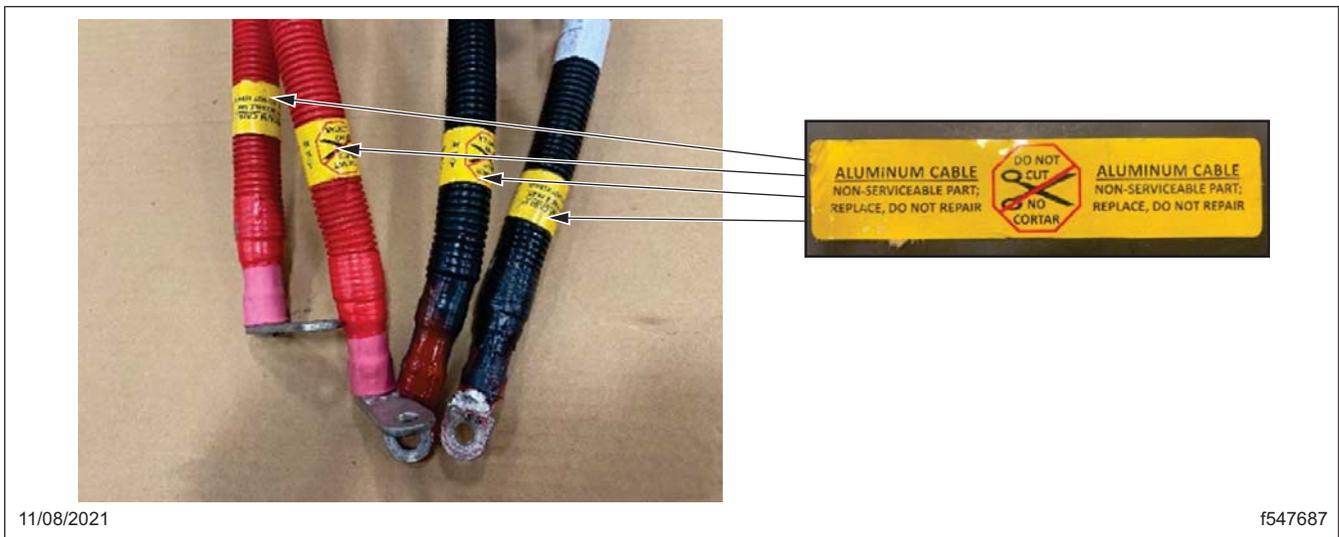
Fig. 21, Powernet Battery Cables Made of Aluminum

4. Inspect each of the four main powernet battery cables to identify those made of aluminum. Aluminum cables can be identified as follows.
 - The aluminum 4/0 cables have a larger outer diameter than the copper 4/0 cables.
 - The aluminum 4/0 cables are attached with a yellow label on each end indicating they are made of aluminum. See [Fig. 21](#).

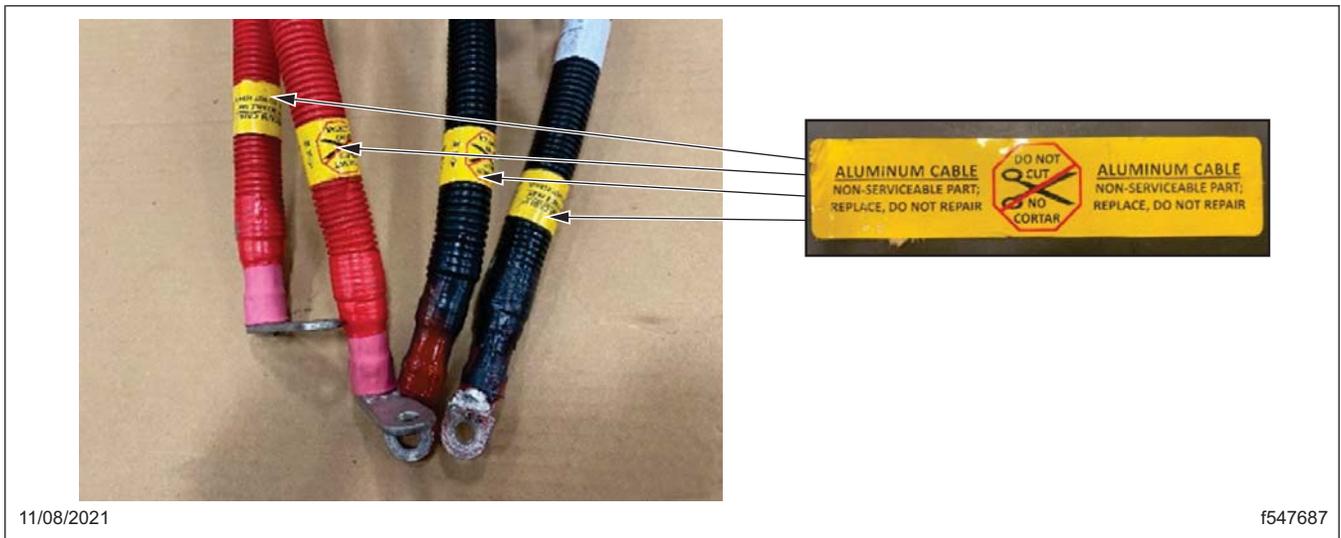
Fig. 23, Powernet Battery Cables Made of Aluminum

4. Inspect the positive 4/0 cable routed from the batteries to the BCA to identify those made of aluminum. Aluminum cables can be identified as follows.
 - The aluminum 4/0 cables have a larger outer diameter than the copper 4/0 cables.
 - The aluminum 4/0 cables are attached with a yellow label on each end indicating they are made of aluminum. See [Fig. 23](#).

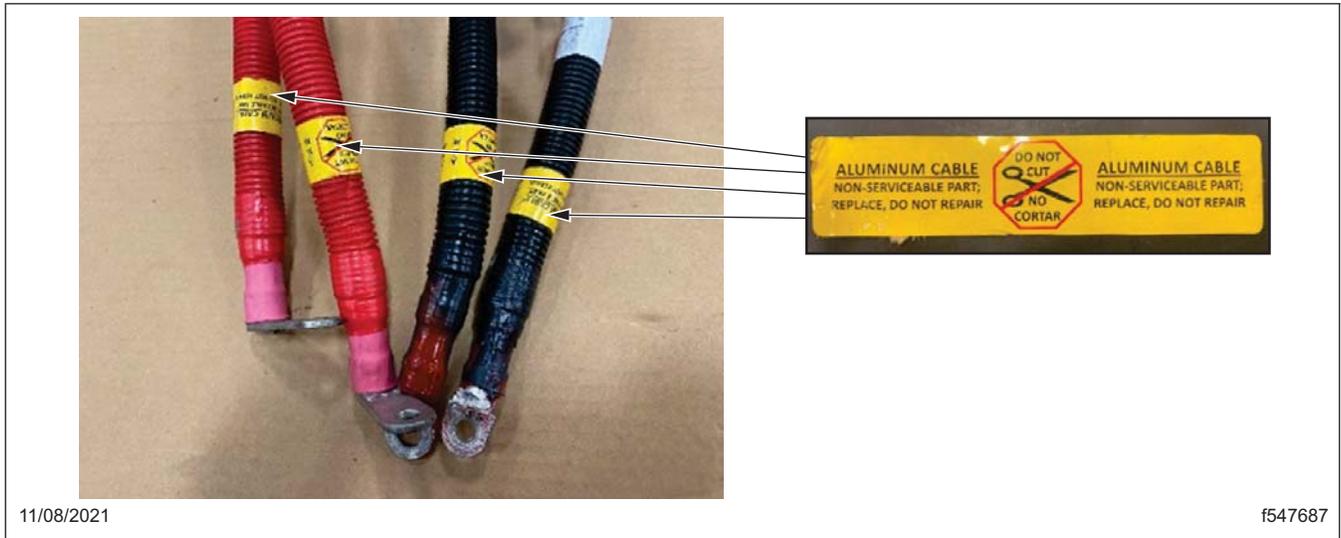
Fig. 29, Powernet Battery Cables Made of Aluminum

4. Inspect the negative 4/0 cable routed from the battery frame stud to the MGJB to identify those made of aluminum. Aluminum cables can be identified as follows.
 - The aluminum 4/0 cables have a larger outer diameter than the copper 4/0 cables.
 - The aluminum 4/0 cables are attached with a yellow label on each end indicating they are made of aluminum. See [Fig. 29](#).

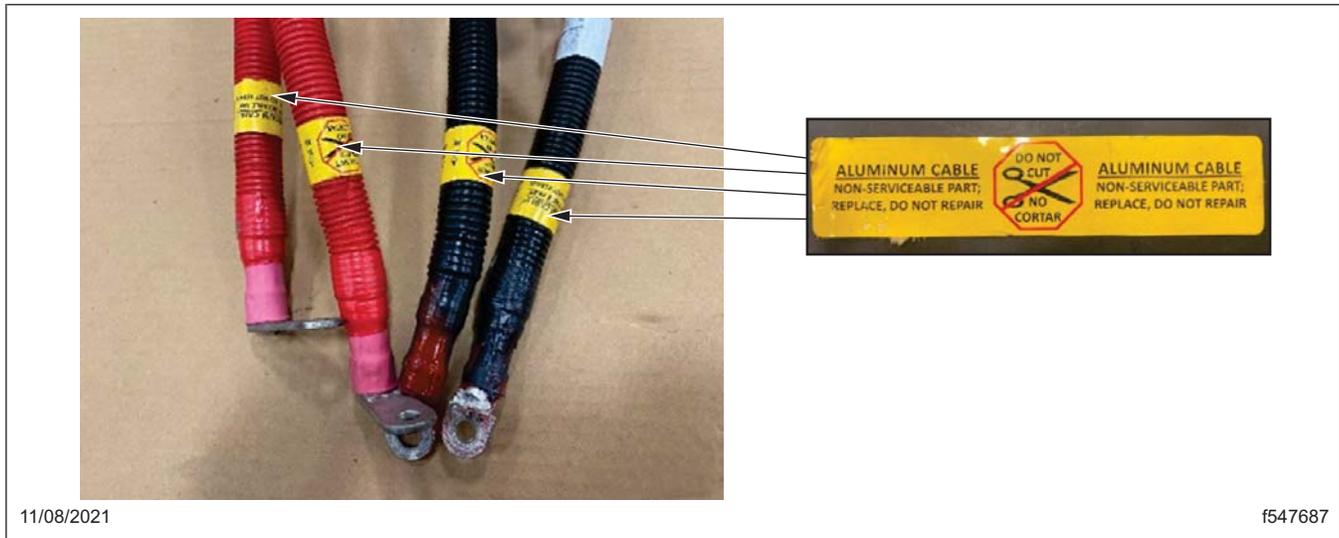
Fig. 32, Powernet Battery Cables Made of Aluminum

4. Inspect the positive 4/0 cable routed from the batteries to the starter to identify those made of aluminum. Aluminum cables can be identified as follows.
 - The aluminum 4/0 cables have a larger outer diameter than the copper 4/0 cables.
 - The aluminum 4/0 cables are attached with a yellow label on each end indicating they are made of aluminum. See [Fig. 32](#).

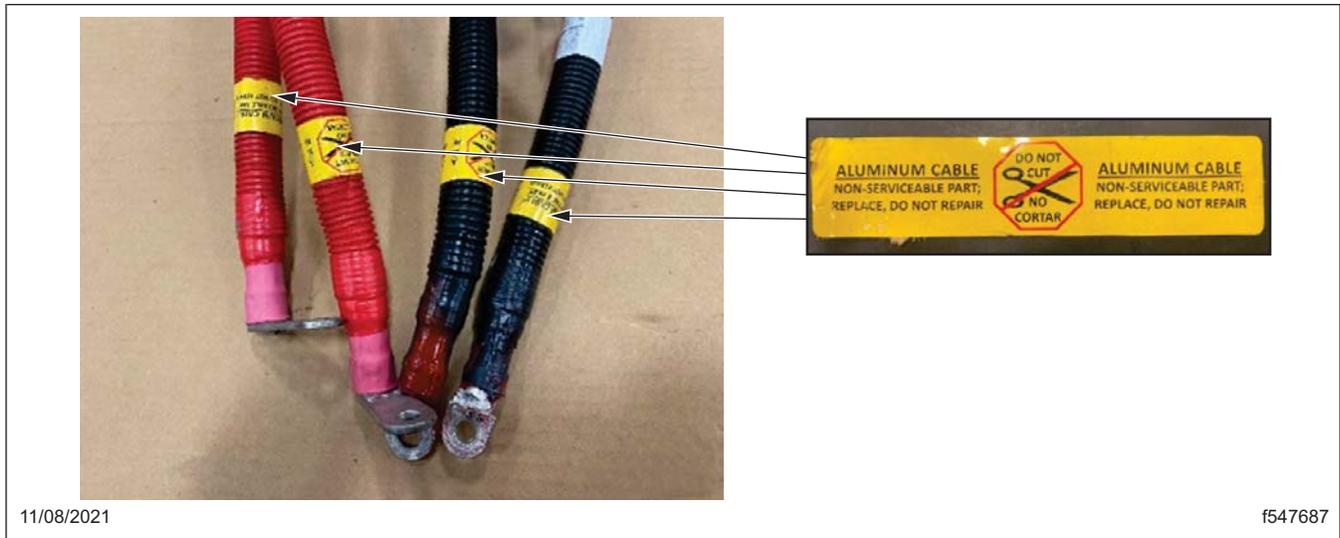
Fig. 34, Powernet Battery Cables Made of Aluminum

- Inspect the negative 4/0 cable routed from the battery frame stud to the flywheel housing to identify those made of aluminum. Aluminum cables can be identified as follows.
 - The aluminum 4/0 cables have a larger outer diameter than the copper 4/0 cables.
 - The aluminum 4/0 cables are attached with a yellow label on each end indicating they are made of aluminum. See [Fig. 34](#).
