Subject: New Cascadia Aluminum Battery Cable Replacement

Models Affected: New Cascadia Vehicles without Cummins engines or in-rail battery boxes built from 11/26/2018 to the present

CAL FTL 54-018

(Preliminary work for recall FL893/NHTSA 21V-481)

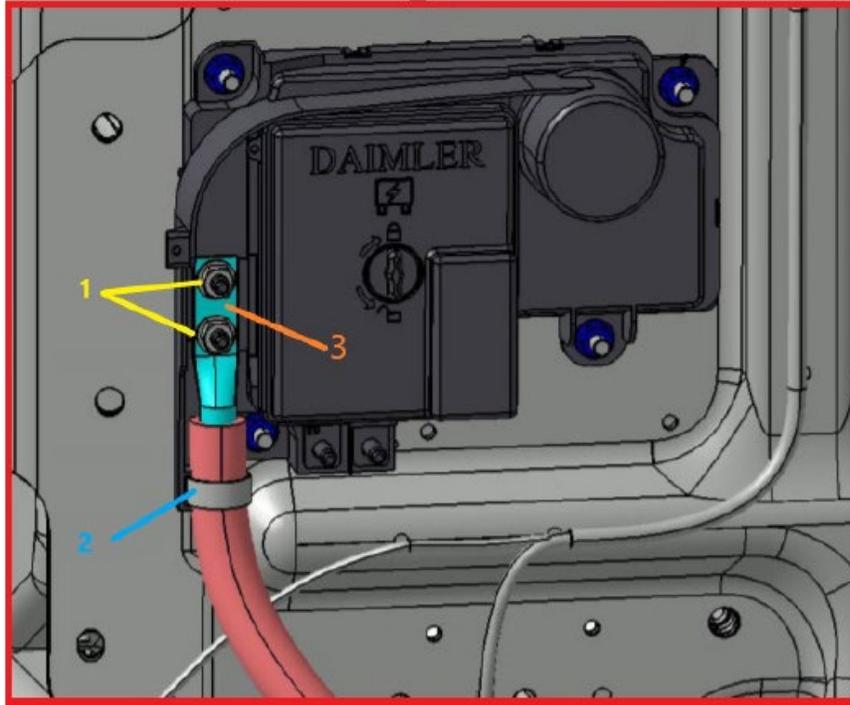
Fig. 1, Battery Cable Access Location

1. Studs Securing Main Positive 29A cable to the BCA.
2. Zip Tie Securing Cable to BCA
3. Cable End and BCA Plate Connection

7. Locate the two studs that secure the main positive 29A cable to the BCA. See callout 1 in **Fig. 1**. The 29A cable may be covered in a red dielectric coating.

8. Hold the ends of the studs in the non-threaded area with vice grip pliers to avoid the stud spinning in the case of the BCA during removal.
9. Using a 13 mm box end wrench, turn the nuts counterclockwise to remove them from the studs.
10. Remove the 29A positive cable and set it aside.
11. Replace it with the appropriate copper cable from the crossover parts list.
12. Replace the nuts on the stud with fresh stainless steel patchlock nuts (part number 23-14592-008) or non-patchlock stainless steel equivalent. Apply a drop of LOCTITE® Blue 242 to the area of the studs the tightened nuts will overlap.

NOTE: If the stud(s) start to turn in the BCA, do not discard the BCA. The BCA will not be damaged by minor rotation of the 29A cable-mounting studs.
