Safety Recall

Code: 69CK

Subject	Airbag Control Module Fixation Holes																									
Release Date	March 08, 2022																									
Revision Summary	Updated outside labor operation in the claim entry instructions																									
Affected Vehicles

Subject: Safety Recall 69CK -Airbag Control Module Fixation Holes

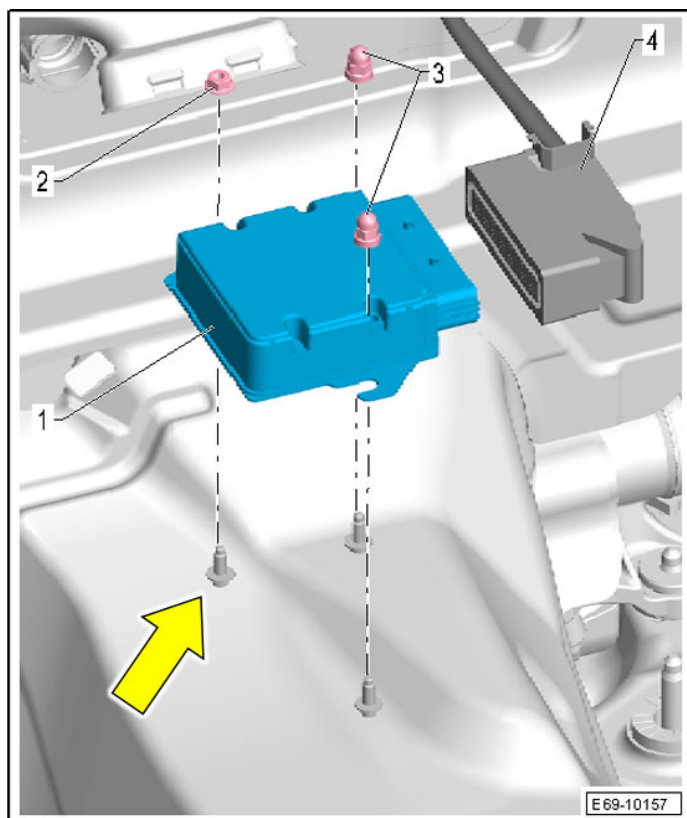
- Rework front left airbag control module mounting stud <arrow> and replace airbag control module.
