# Safety Recall

## Code: 69CK

| Subject | Airbag Control Module Fixation Holes | | | | | | | | | | | | | | | | | | | | | | | | | | | | |
|---|---|---|---|---|---|---|---|---|---|---|---|---|---|---|---|---|---|---|---|---|---|---|---|---|---|---|---|---|---|
| Release Date | January 25, 2022 | | | | | | | | | | | | | | | | | | | | | | | | | | | | |
| Affected Vehicles |

**Subject: Safety Recall 69CK -Airbag Control Module Fixation Holes**

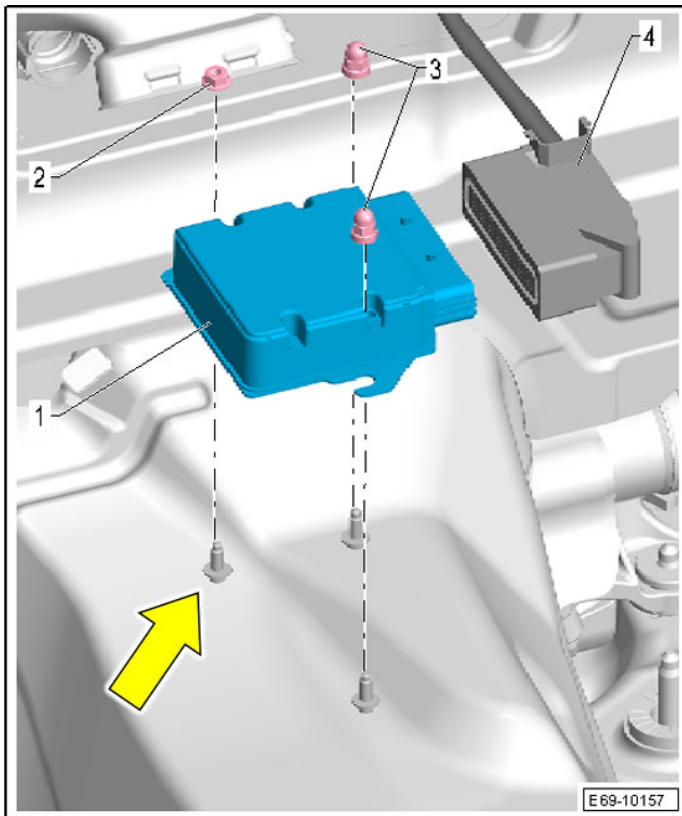
- Rework front left airbag control module mounting stud <arrow> and replace airbag control module.

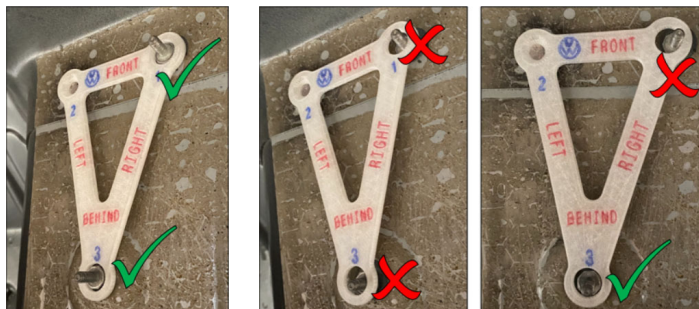
Correct Installation

Incorrect Installation

- Ensure the template is positioned over the base of the studs <arrows>.
