Product Safety Recall

N212336560 Airbag Cover Not Fully Secured

Release Date: July 2021

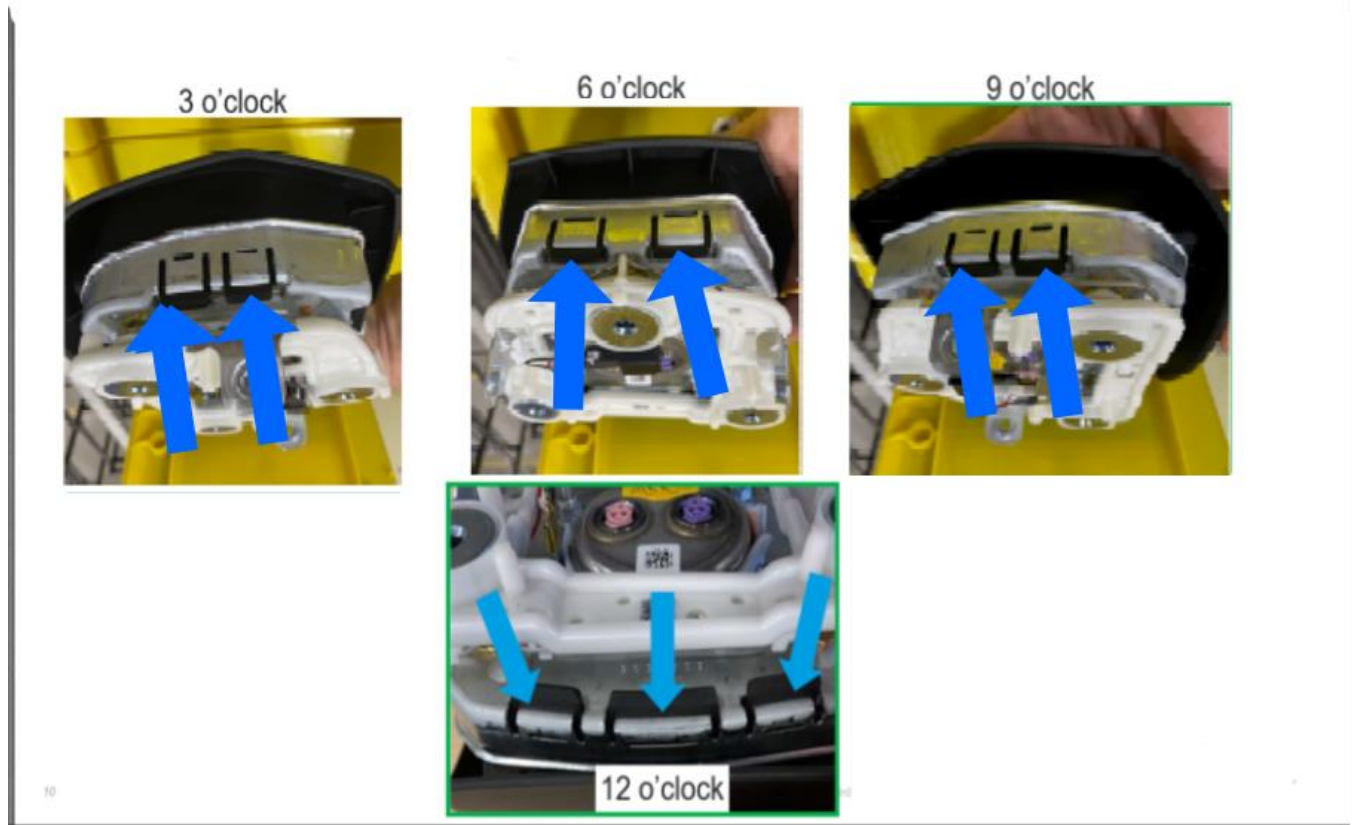
5871499

Good Tab Example Photos

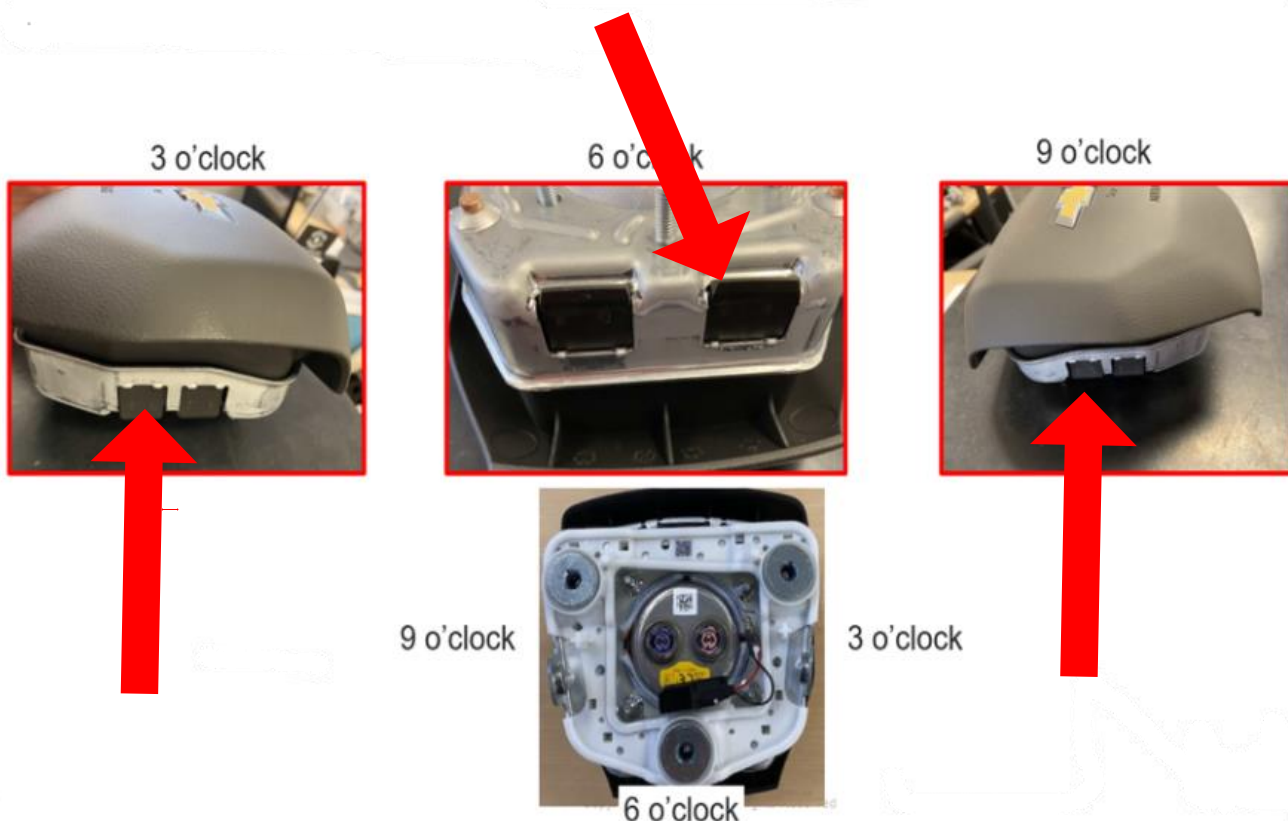
5869873

Unacceptable Tab Example Photos

3. Inspect the left, right, top and bottom of the airbag assembly for the presence of the retaining tabs (9 tabs total).
 - If all the tabs are present and engaged, no further action is required. Reinstall the steering wheel airbag. Refer to *Steering Wheel Airbag Replacement* in SI.
 - If any of the tabs are missing, mis-shaped or suspect, replace the steering wheel airbag. Refer to *Steering Wheel Airbag Replacement* in SI.
