SERVICE ALERT BULLETIN

Alert Subject: R25160 Wallace Forge Adjustable Coupler

Recall 21V505 (Wallace Forge Recall 21E-051)

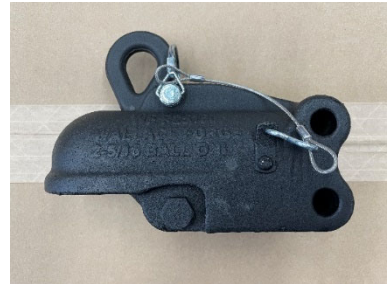
Certain 2021 and 2022 B Wise and Bri-Mar Trailers manufactured with adjustable couplers may potentially have couplers with excessive play when coupled with a 2 5/16" ball hitch. The suspect couplers are labeled Wallace Forge R25160

- 4) All units that are confirmed to have a coupler with the incorrect internal locking mechanism should have the coupler replaced. Contact recall@bwisemfg.com to initiate coupler replacement. The trailer VIN number will be required.

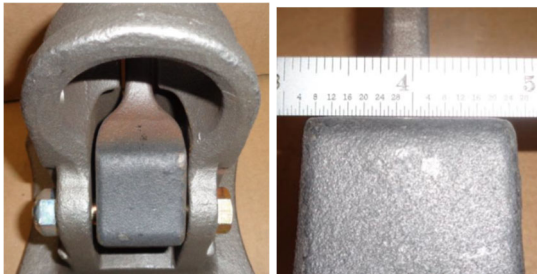
INCORRECT LOCKING MECHANISM
INTERNAL LOCK IS STRAIGHT

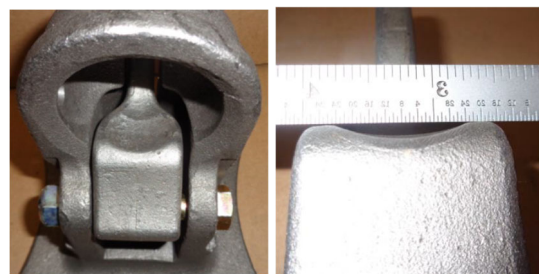
CORRECT LOCKING MECHANISM
INTERNAL LOCK HAS A RADUIS
