SIB 52 08 21

RECALL 21V-521: CIS MAT

2021-08-12

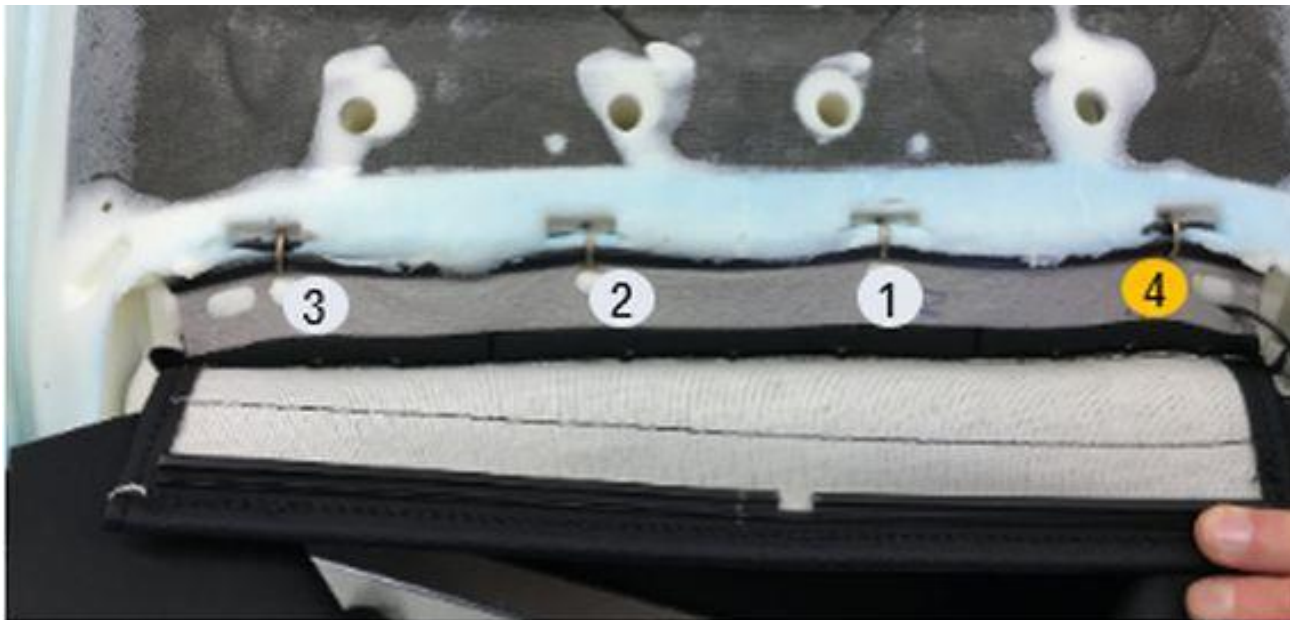
Due to an incorrect mounting of the seat cover, one or more of the hog rings (clamps) could contact the seat heating cable harness near the area of the seat cushion and thigh support. Over time, this could affect CIS Mat functionality. Hog rings are small metal clamps which fasten the seat cover to the seat frame.

New: The sequence in which the hog ring clamps are installed must be observed.

First clamp items 1-3, then clamp the area of the cable outlet 4 to prevent the seat heater line from being contacted and/or damaged by clamps.

2. **Note: There is a changed procedure for clamping when installing the front seat cover- the new procedure below has not yet been incorporated into the repair instructions.**

For section: Installing the seat cover for the front seat REP-TAT-P-5216-02-G01_3
