TO: Mercedes-Benz Dealer Principals, General Managers, Sales Managers, Service Managers, Parts Managers	FROM: Gregory Gunther, Department Manager, Vehicle Compliance and Analysis, Engineering Services
RE: Recall Campaign Launch Notification Check the Side-impact Crash Sensor MY20-21 CLS-Class, E-Class, G-Class, AMG GT-Class, GLC-Class and S-Class (213, 222, 253, 257, 290 and 463 platform)	DATE: August 20, 2021

Campaign No. 2021070032, August 2021

SUBJECT: **Models various**
Model year 2020-2021**Check the Side Crash Sensor (Front and Rear Doors)**

Check airbag-pressure sensors in the front doors and rear doors and replace if necessary

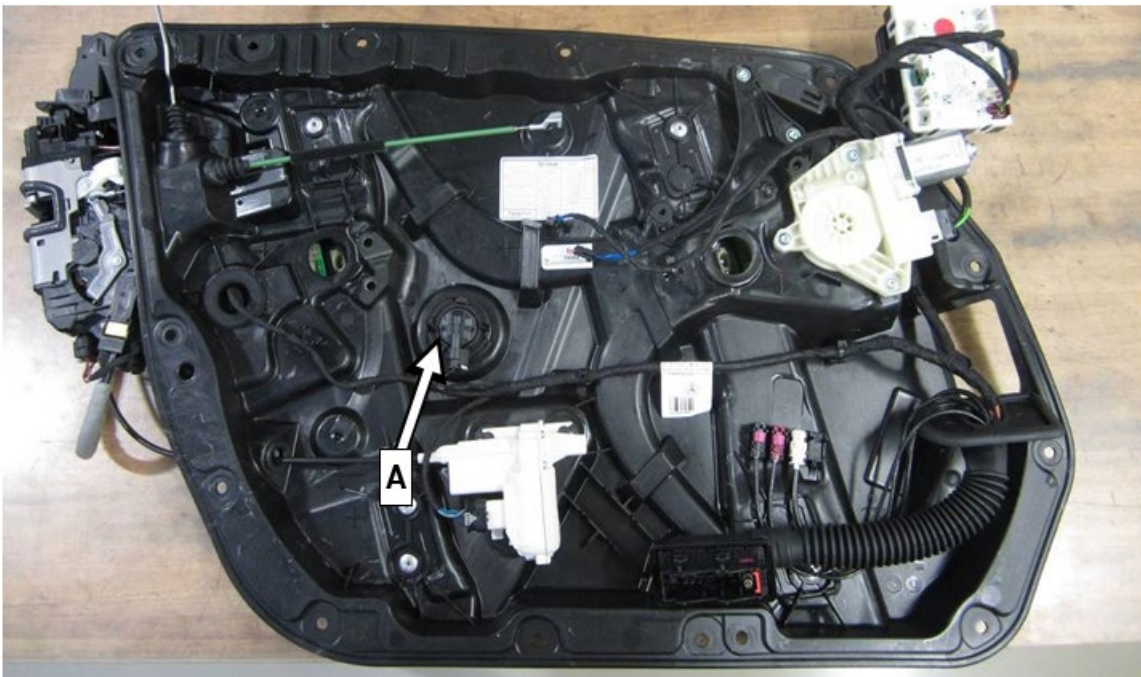
Figure1, shown on model 213

3. Disconnect the plugs on all four airbag pressure sensors (**A, Figure 1**) and check whether the two catch tabs (**B, Figure 2**) are present.

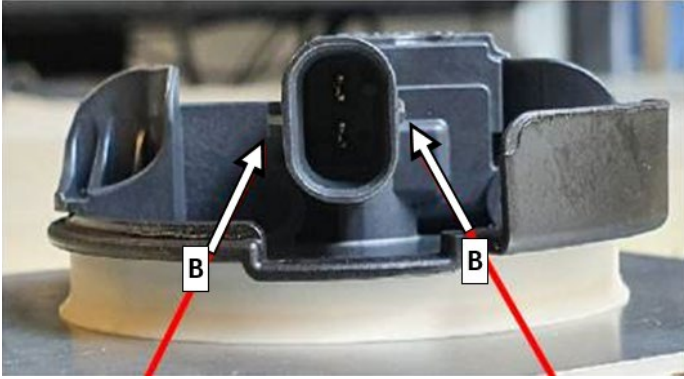
Figure 2

i **Two catch tabs must be present!**

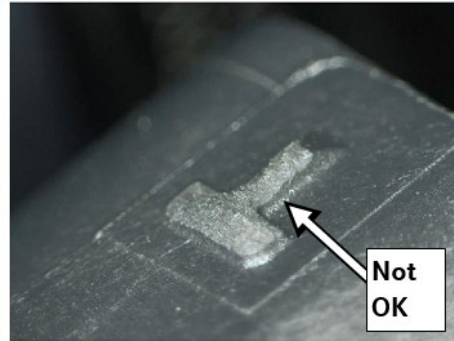
Figure 3, not OK

i Figure 3: **Not OK** depiction.

- a. If there is only one catch tab: Carry out work procedure.
- b. If two catch tabs are present: End measure.

1. Replace defective airbag pressure sensor.
