SUBJECT: **NEW VEHICLE DEMONSTRATION / DELIVERY HOLD Safety Recall 21S31**
 Certain 2020 - 2021 Model Year F-350 Pickup Trucks Equipped with 6.7L Diesel Engine and Single Rear Wheel Axle – **Supplement #5**
 Spring Seat Weld

NEW VEHICLE DEMONSTRATION / DELIVERY HOLD Safety Recall 21S31 - Supplement #5

Certain 2020 - 2021 Model Year F-350 Pickup Trucks
Equipped with 6.7L Diesel Engine and Single Rear Wheel Axle
Spring Seat Weld

CERTAIN 2020 - 2021 MODEL YEAR F-350 PICKUP TRUCKS EQUIPPED WITH 6.7L DIESEL ENGINE AND SINGLE REAR WHEEL AXLE — SPRING SEAT WELD

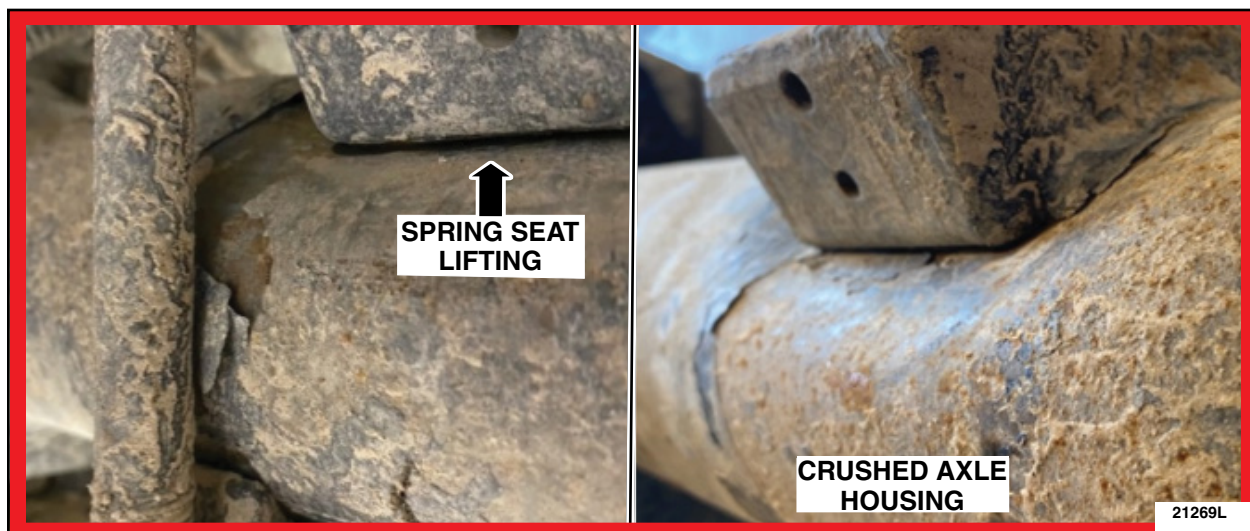
FIGURE 1

3. Visually inspect the front of the rear axle housing assembly below the leaf spring seat brackets for damage (dents, creases). See Figure 1.
4. Visually inspect the rear of the leaf seat spring bracket for damage (rips or breaks in the metal or welds) and to see if the leaf spring seat bracket is pulling away from the rear axle housing assembly. See Figure 1.
5. Inspection results. Is there damage present to either the LH or RH rear leaf spring seat brackets?

Yes - Fails visual inspection, the rear axle housing will require replacement. Please follow the WSM procedures in Section 205-02A.

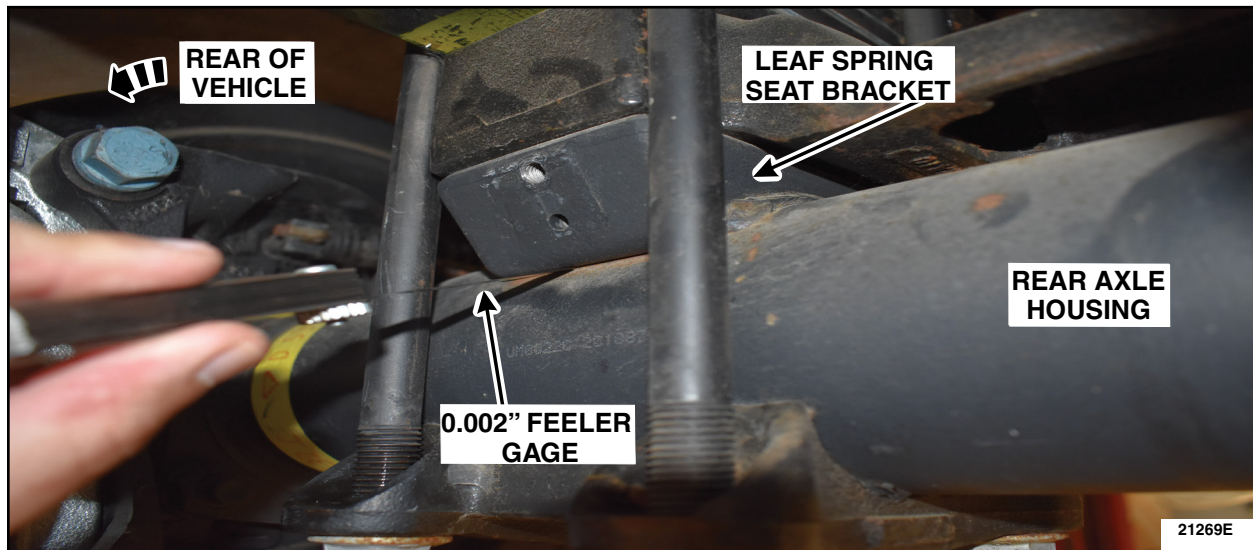
FIGURE 2

6. Using a 0.002" feeler gage measure the gap along the rear of the leaf spring seat bracket to the rear axle housing assembly. Is the gap greater than 0.002" on either the LH or RH side? See Figure 2.

YES - The rear axle housing will require replacement. Please follow the WSM procedures in Section 205-02A.

NO - Proceed to the Leaf Spring Seat Bracket Interface Weld Repair Procedure on Page 3.
