SUBJECT: NEW VEHICLE DEMONSTRATION / DELIVERY HOLD Safety Recall 21S31
 Certain 2020 - 2021 Model Year F-350 Pickup Trucks Equipped with 6.7L Diesel
 Engine and Single Rear Wheel Axle
 Spring Seat Weld
 REF: NEW VEHICLE DEMONSTRATION / DELIVERY HOLD - Advance Notice
 Safety Recall 21S31
 Dated: July 16, 2021

#### **NEW VEHICLE DEMONSTRATION / DELIVERY HOLD Safety Recall 21S31**

# CERTAIN 2020 - 2021 MODEL YEAR F-350 PICKUP TRUCKS EQUIPPED WITH 6.7L DIESEL ENGINE AND SINGLE REAR WHEEL AXLE — SPRING SEAT WELD

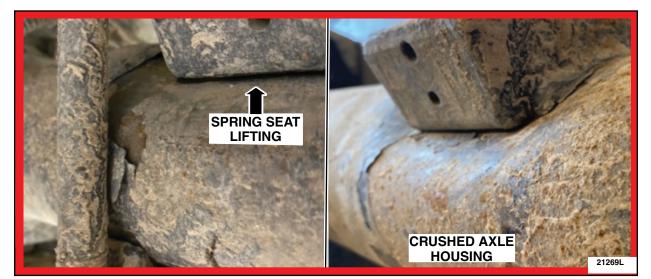
## FIGURE 1

- **NOTE:** This inspection is to be preformed on the Left Hand (LH) and Right Hand (RH) leaf spring seat brackets.
- 3. Visually inspect the front of the rear axle housing assembly below the leaf spring seat brackets for damage (dents, creases). See Figure 1.

- 4. Visually inspect the rear of the leaf seat spring bracket for damage (rips or breaks in the metal or welds) and to see if the leaf spring seat bracket is pulling away from the rear axle housing assembly. See Figure 1.

- 5. Inspection results. Is there damage present to either the LH or RH rear leaf spring seat brackets?
  - Yes Fails visual inspection, the rear axle housing will require replacement. Currently parts are not available for this repair. Vehicle cannot be safely driven. Contact SSSC.

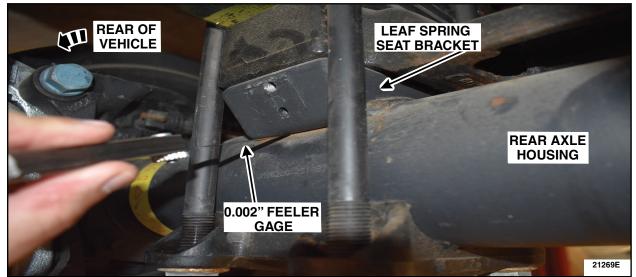
**FIGURE 2**

- 6. Using a 0.002" feeler gage measure the gap along the rear of the leaf spring seat bracket to the rear axle housing assembly. Is the gap greater than 0.002" on either the LH or RH side? See Figure 2.
  - YES The rear axle housing will require replacement. Currently parts are not available for this repair. Vehicle cannot be safely driven. Contact SSSC.
  - NO Proceed to the Leaf Spring Seat Bracket Interface Weld Repair Procedure on Page 3.
