N212343883 High Voltage Battery May Melt or Burn

Release Date: November 2021 Revision: 00

| Condition | General Motors has decided that a defect which relates to motor vehicle safety exists in certain 2019 model year Chevrolet Bolt EV vehicles. The high voltage batteries in these vehicles may pose a risk of fire when charged to full, or very close to full, capacity. |
| Correction | Dealers will replace defective battery modules in the recall population. Until the updated recall remedy is performed, dealers will update the software on the Hybrid Powertrain Control Module (HPCM2), Battery Energy Control Module (BECM), and Body Control Module (BCM) modules using ZFA - Field Action Multimodule Coordinated Sequence. |

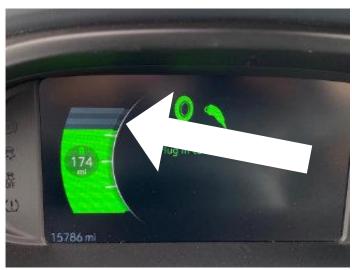
5924268

Important: Verify the vehicle SOC is less than 80%. This can be determined by looking at the bars on the power level indicator. If four or more empty bars (not showing green) are displayed, the SOC is at an acceptable level. If the power level indicator shows an SOC of greater than 80% The SOC must be adjusted before proceeding with the recalibration.

If required, reduce the SOC as follows:

- Vehicle in PARK, Vehicle ON.
- Headlamps Low Beam: ON.
- Temp Control: Hi (Max Heat High) (note: windows should be down).
- Distribution: MAX Defrost (Engages AC Compressor).
- Fan Speed: High (8).
- Select: Fresh Air (Not recirc).
- Select: Heat & A/C .
- If equipped, turn heated seats to hi position.
- Verify SOC after 60 minutes. If the SOC is still greater than 80%, allow additional time for the loads listed above to reduce the SOC to less than 80%.
- When the SOC adjustment is completed return the HVAC controls to 72 Deg. AUTO, Set the headlamp control
 to AUTO.

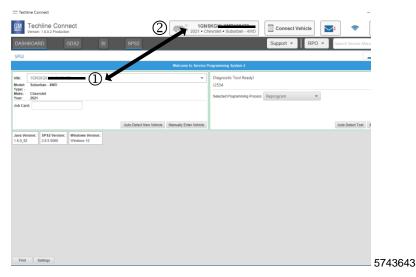
Caution: Be sure the VIN selected in the drop-down menu (1) is the same as the vehicle connected (2) before beginning programming.

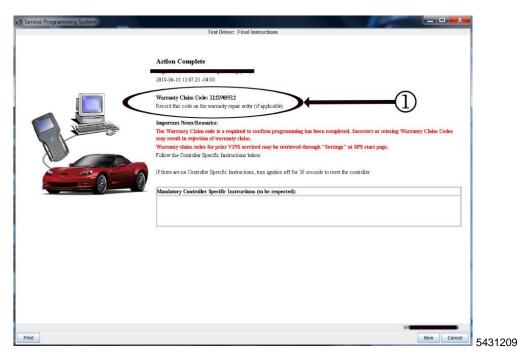
Important: To avoid warranty transaction rejections, you MUST record the warranty claim code provided on the Warranty Claim Code (WCC) screen shown above on the job card. Refer to callout 1 above for the location of the WCC on the screen.
