SAFETY RECALL NOTICE

McLaren Voluntary Safety Recall Inspect and Replace If Necessary, Certain Brake Flexi Hose Banjo Bolts

Bulletin type:	Safety Recall Campaign
Reference number:	SRC 00 C 001
Affected vehicles:	McLaren 570S, McLaren GT, McLaren 600LT, McLaren 720S
Attention:	All Retailer Staff
Situation:	Voluntary Safety Recall - Potential for brake flexi hose banjo bolt(s) to have been incorrectly manufactured
Procedure:	Please refer to the information outlined in this document to remove and inspect each brake flexi hose banjo bolt at each brake calliper and replace it if it is found to be incorrectly manufactured
Date:	26 th August 2021

Urgent Safety Recall Campaign - Inspection - Brake Flexi Hose Banjo Bolt

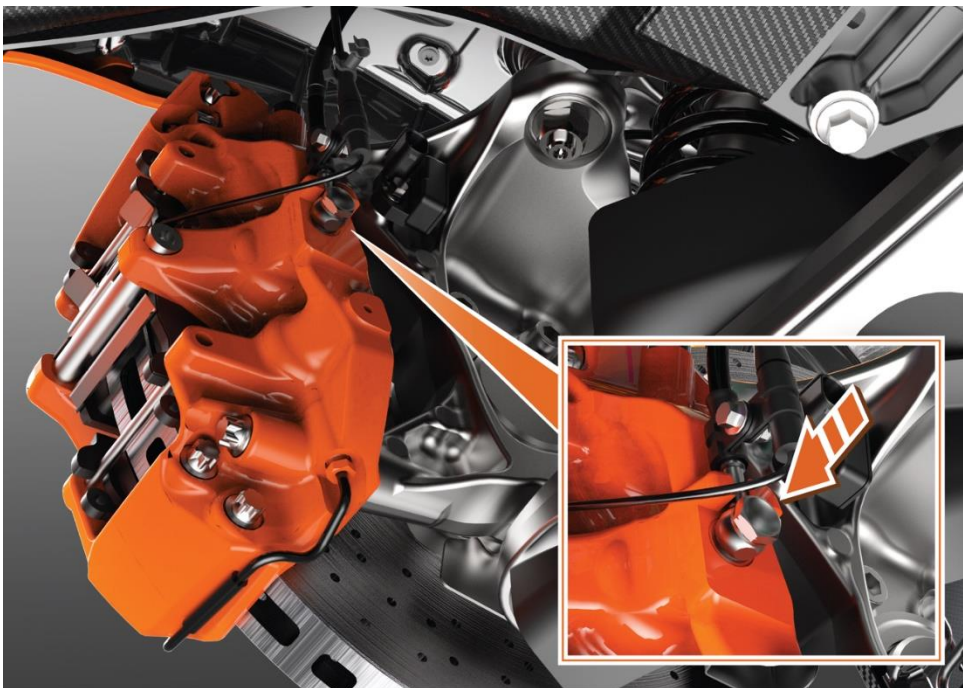
The covered vehicles may have been fitted with an incorrectly manufactured banjo bolt, which would result in no hydraulic pressure to the brake calliper on the relevant corner of the vehicle. This could result in the vehicle pulling to one side under braking, particularly when braking from a high speed, which could increase the risk of a crash.

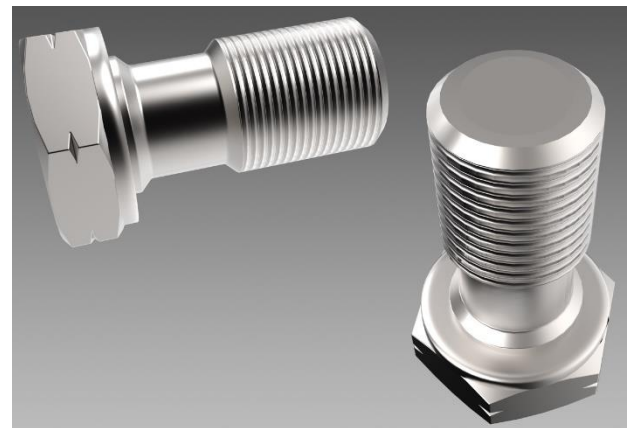
3b. NOT OK Condition

If a bolt is replaced due to not being manufactured correctly (holes not present), the removed part(s) must be retained and stored according to the standard McLaren Warranty policy. There is no requirement to retain the washer(s) replaced during the check procedure.

1. Secure/Lift vehicle on platform
2. Remove all wheels
3. Remove and Inspect each banjo bolt for the brake flexi hose connection at each brake calliper:
 - a. If holes are present as per image '3a, OK condition', re-install bolt with new washers and torque bolt to specification as per SIS for the respective model
 - b. If holes are NOT present as per image '3b, NOT OK condition', replace the bolt (new washers are included with the bolt) and torque to specification as per SIS for the respective model
4. Perform brake bleed procedure as per SIS for the respective model
5. Install all wheels and torque to specification as per SIS for the respective model
6. Check functionality
