# SAFETY RECALL BULLETIN

SUBJECT:			No:	SR-21-007REV
SEAT BELT AUTOMATIC LOCKING RETRACTOR			DATE:	September 2021
(ALR) - SAFET	Y RECALL CAMPA	IGN - REVISION	MODEL:	2022 Outlander
CIRCULATE TO:	[ X ] GENERAL MANAGER	[ X ] PARTS MANAGER	[ <b>X</b> ] TEC	CHNICIAN
[ X ] SERVICE ADVISOR	[ X ] SERVICE MANAGER	[ X ] WARRANTY PROCESSOR	[ <b>X</b> ] SAL	LES MANAGER

This Campaign Bulletin provides instructions for inspecting the lot number on the passenger front and two outboard (left and right)  $2^{nd}$  row seatbelts and replacing the seatbelt(s), if necessary.

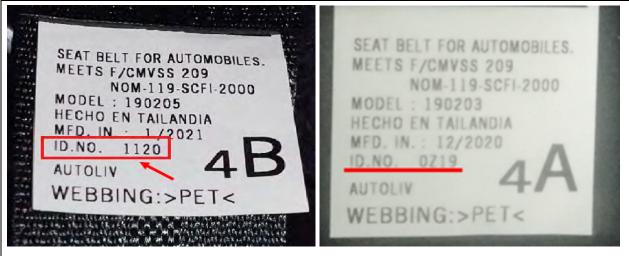
Sample : OK Tag Sample: NG Tag
