L636-R.04.21

Rear seat belt middle position replacement

Urus

2021

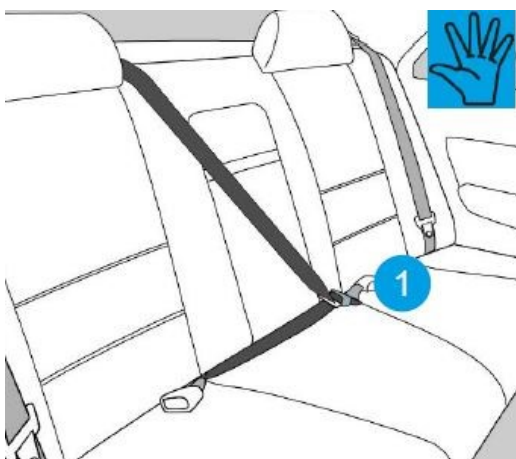
1. Put the safety belt across the empty vehicle seat and insert the metal tongue of the belt into the buckle.

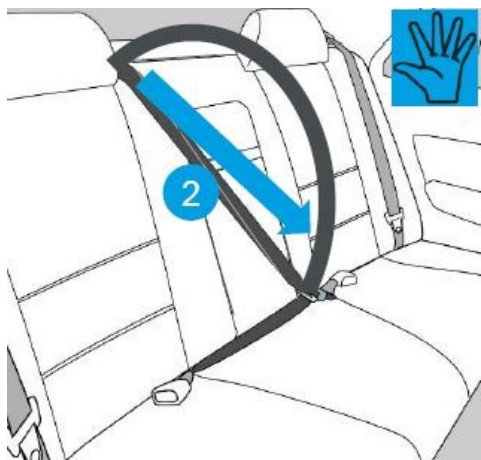
2. Pull the safety belt all the way out of the retractor to activate the Automatic Locking Retractor (ALR).

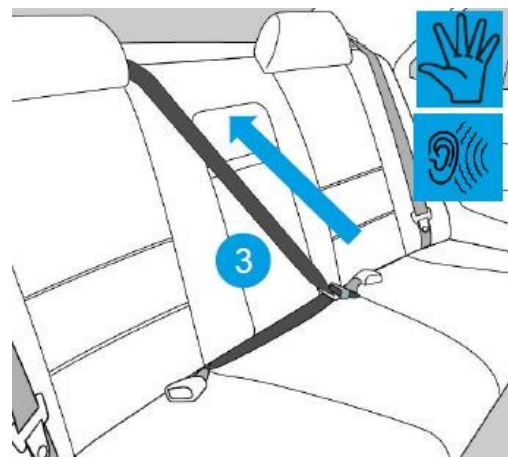
3. Carefully let the safety belt retract fully into the retractor while the belt remains buckled, which simulates a restrained child seat. You will notice that when in ALR mode, there is a ratcheting/clicking noise from the retractor. This is normal.

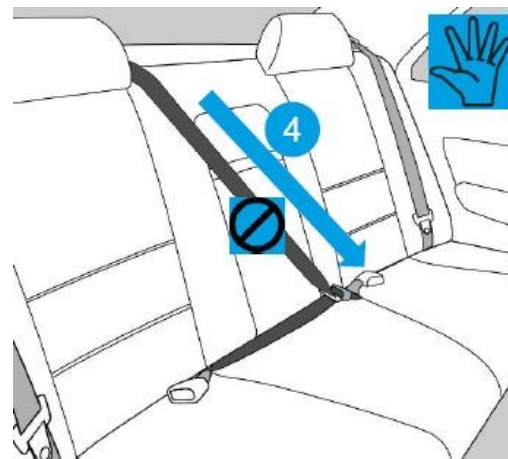
4. Grasp the torso portion of the safety belt and carefully pull on the belt in an attempt to pull the belt back out of the retractor. The belt should not pull out of the retractor.

If the safety belt has not locked so that the strap can be pulled out of the retractor in step 4.

ALR does not work properly, the safety belt must be replaced according to the repair instructions.

To replace the rear seat belt follow the instructions on the workshop manual at the path:

08 Body → Passive safety systems → Rear Center Safety Belt
